St Giles: 7 Denmark Street

Timber Roof Structure: Condition & Repair

May 2018

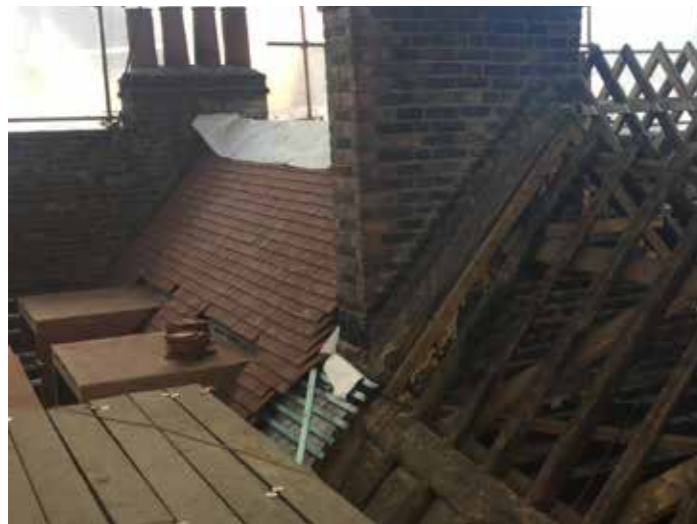
6 Denmark Street: Tiled Roof
7 Denmark Street: Exposed Structure

Following the repair of the roof structure of no.6, red tiles have been laid to restore the roof to its original appearance. No.7 would receive the same repair and finishes

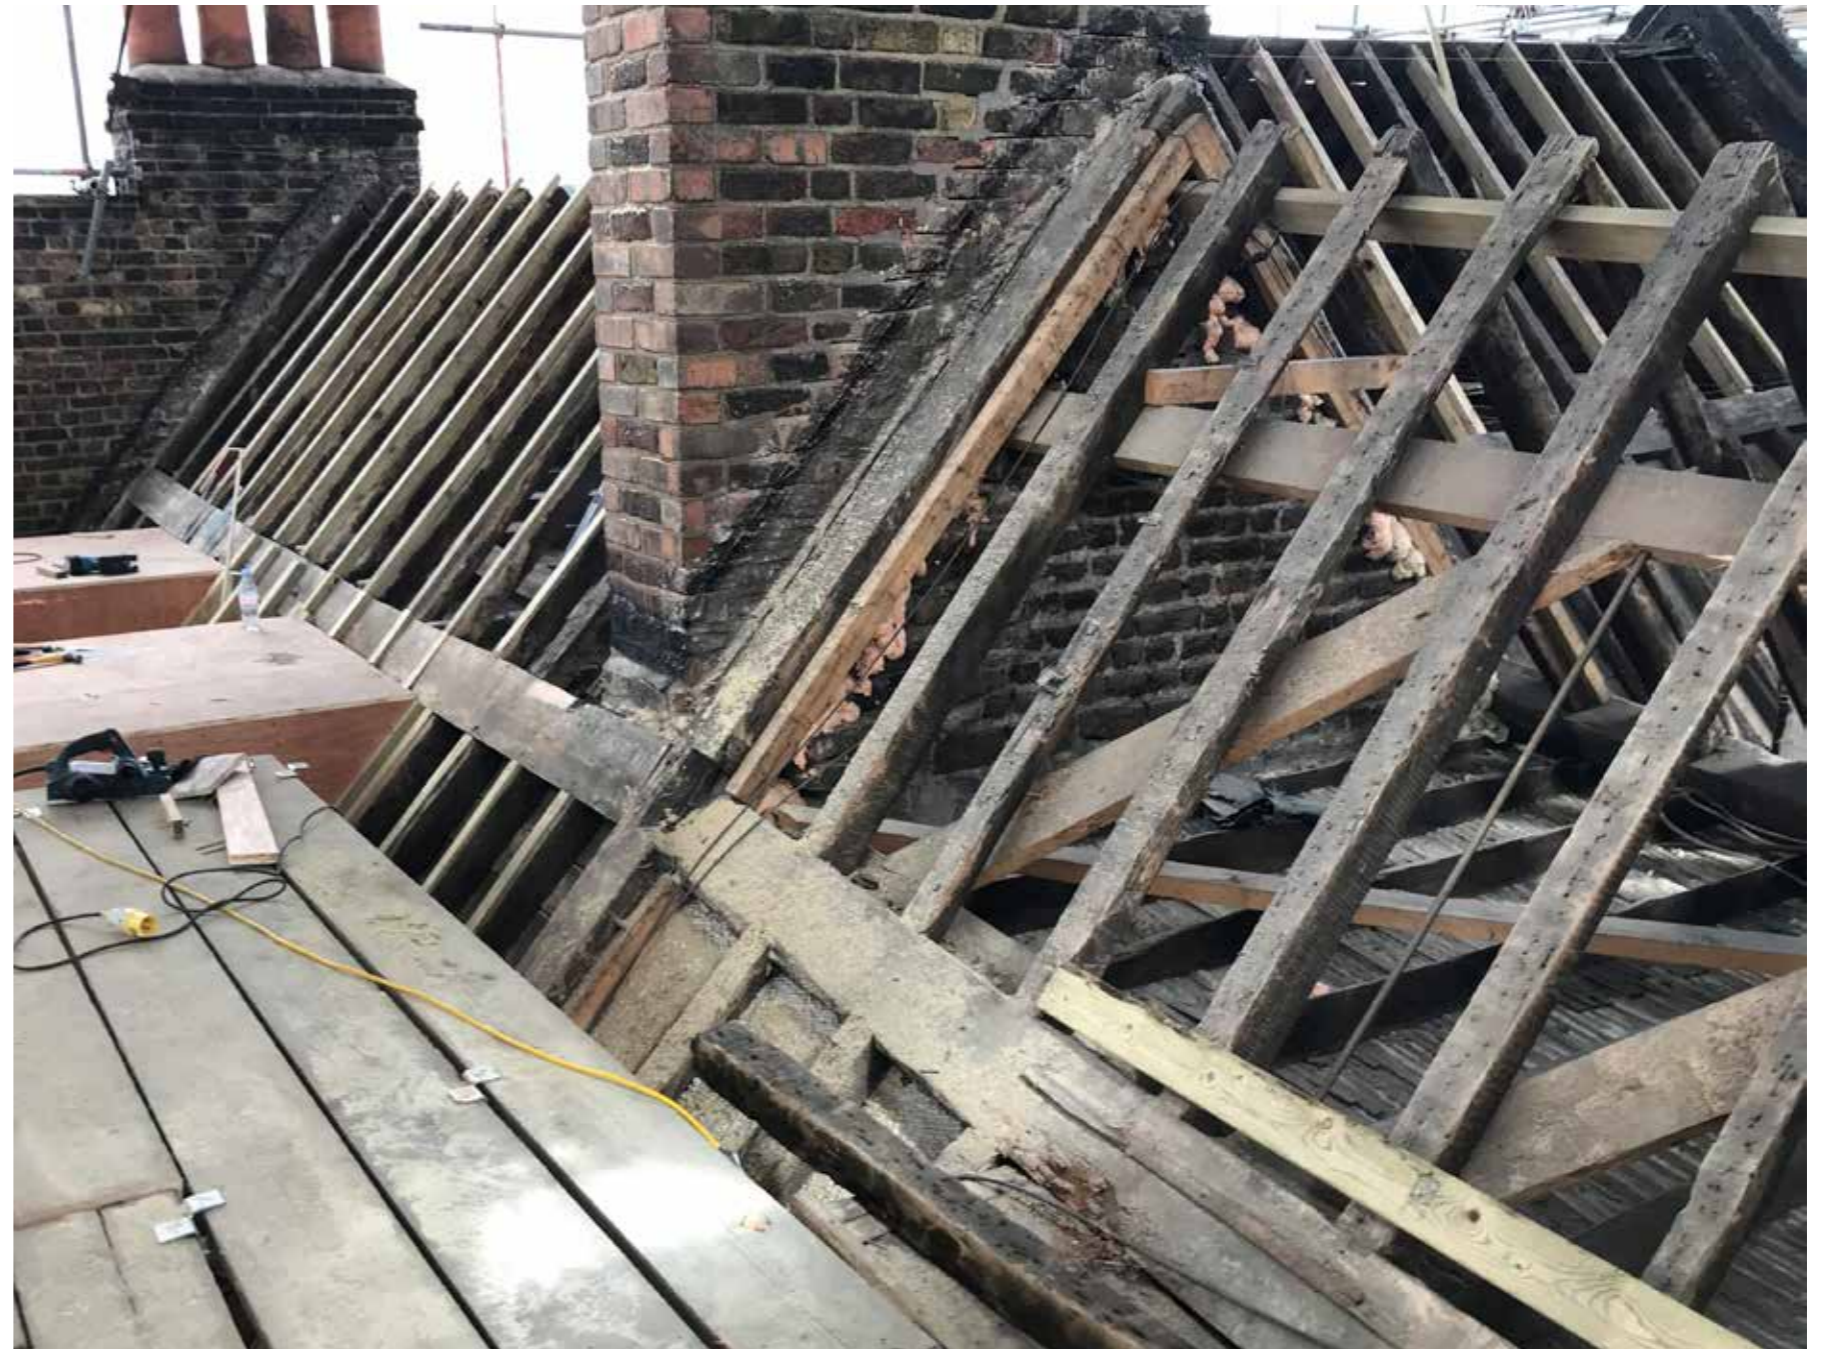
Comparing no.6 & no.7 even more closely, where they meet at the party wall, reveals how urgent the need for repair on the roof of no.7 is.

The level of deflection is so great that the purlin is being pulled from the party wall and distorting the rafters as it moves. Splits have occurred across a number of the timber members, decreasing the structural integrity of the roof. Later bracing, strapping and repairs are not solving the problem. Like-for-like repairs are required.

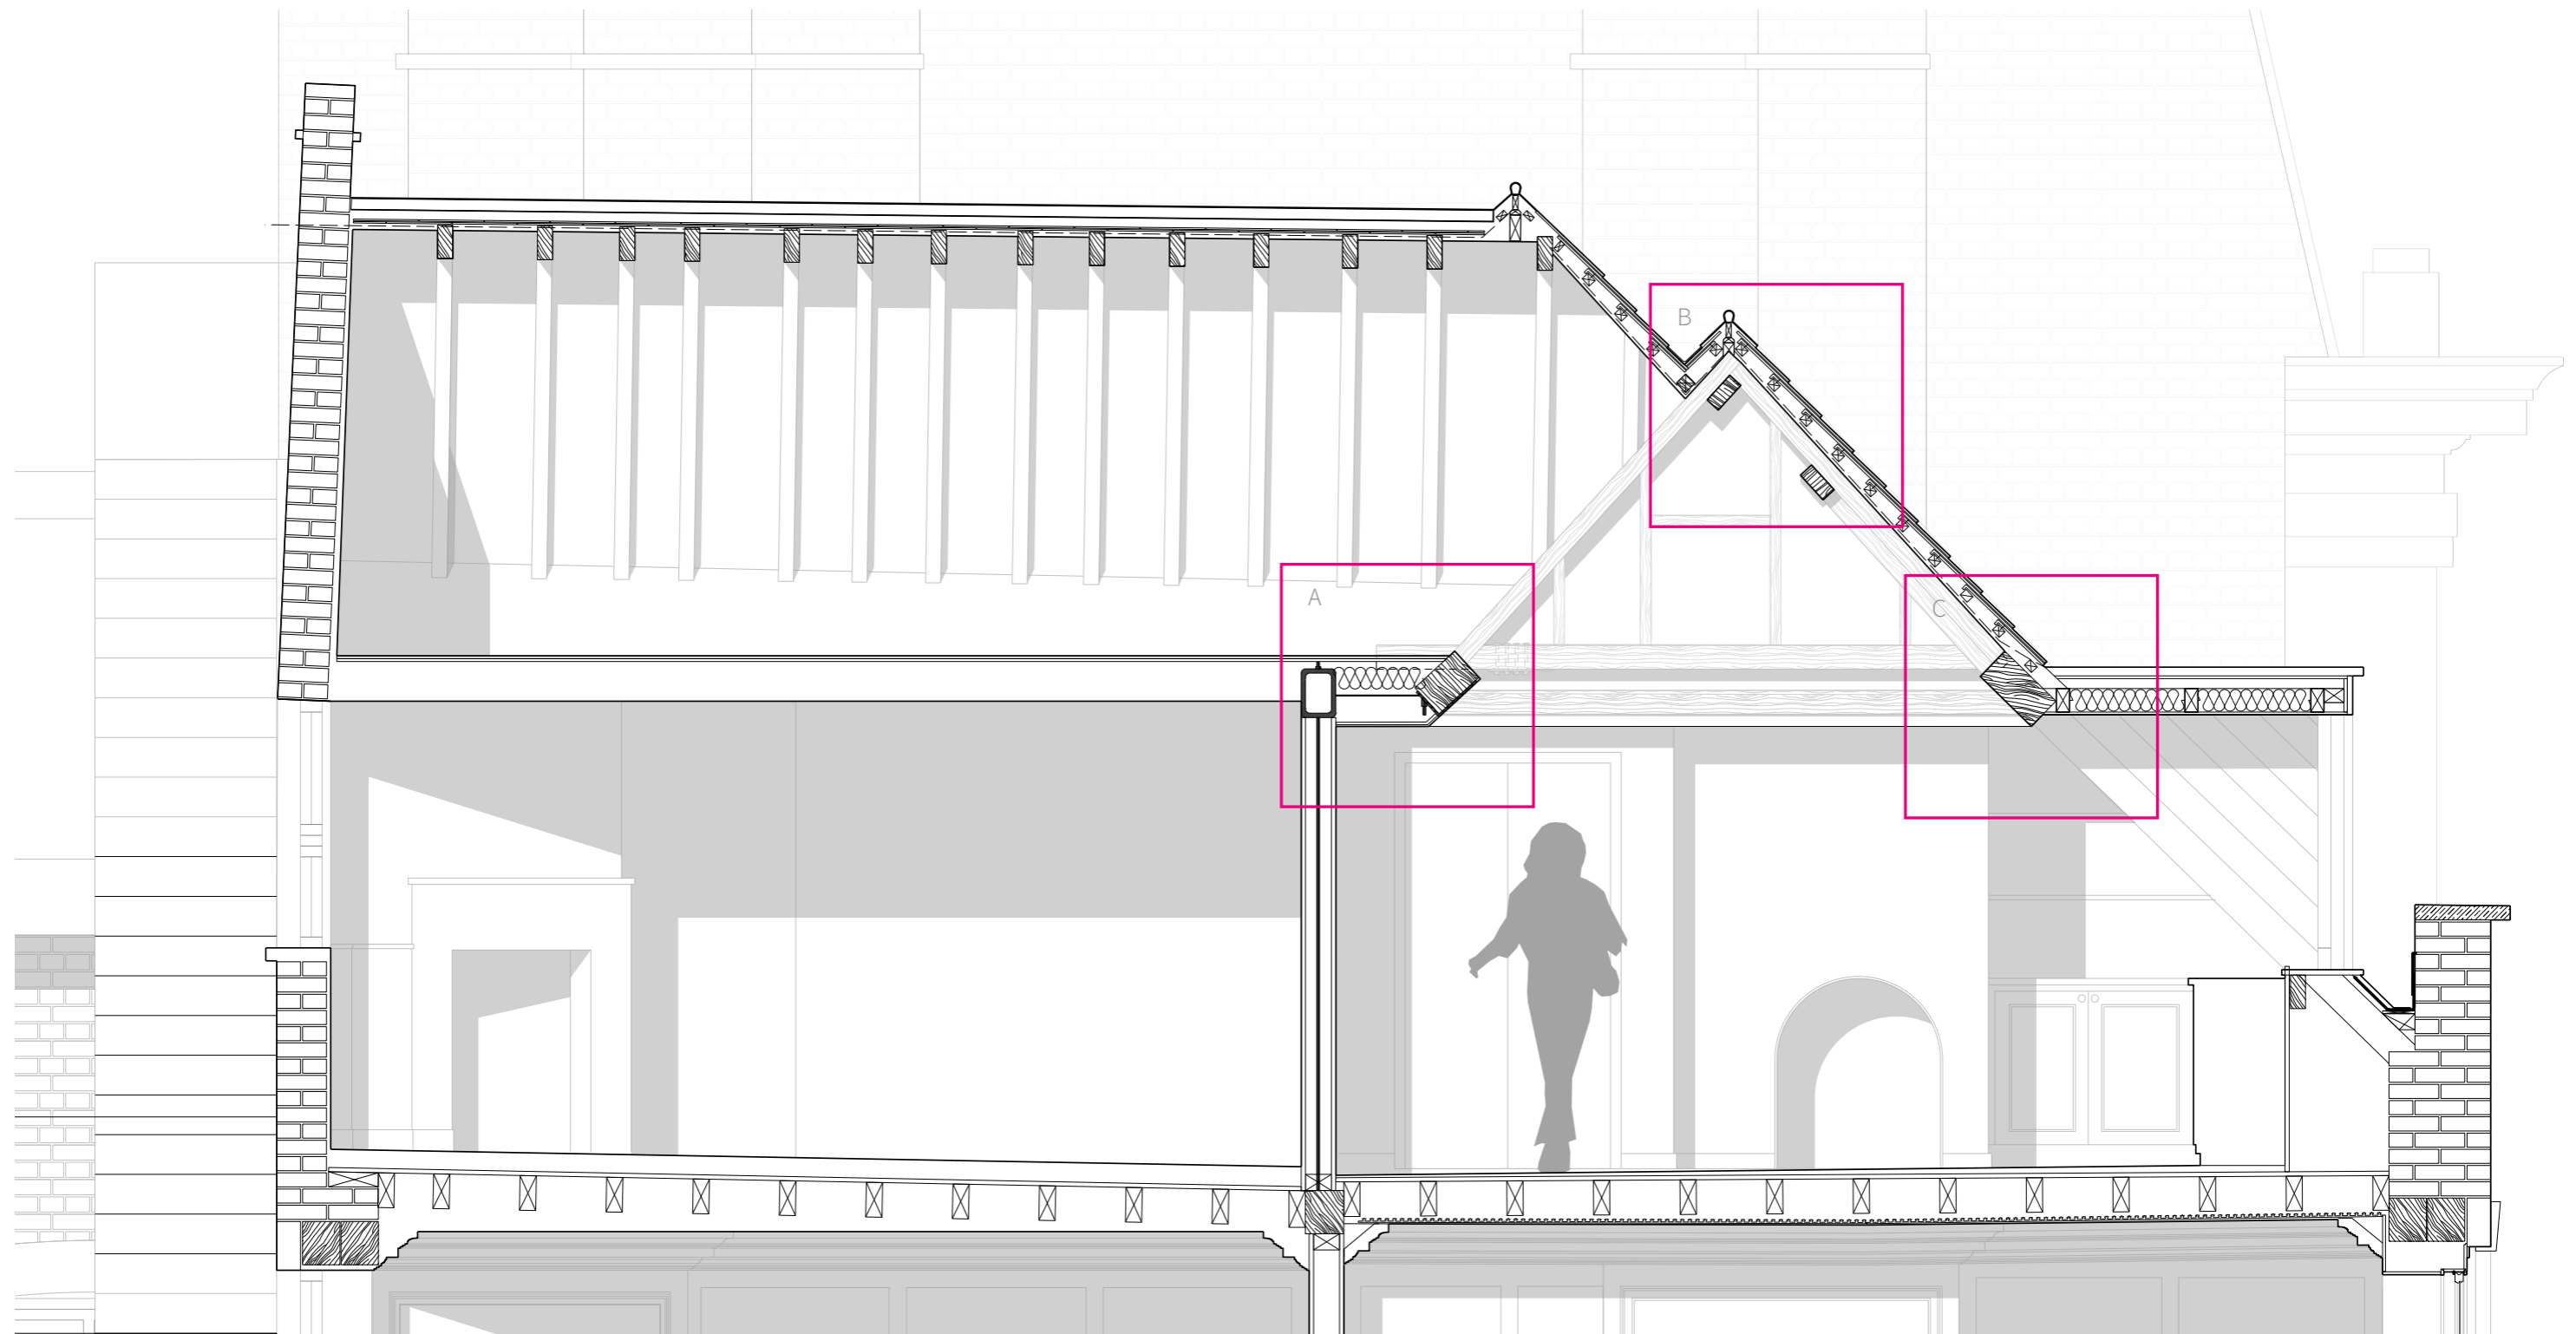
Existing Detail A

Steel supports improve the integrity of the original structure and are to be retained

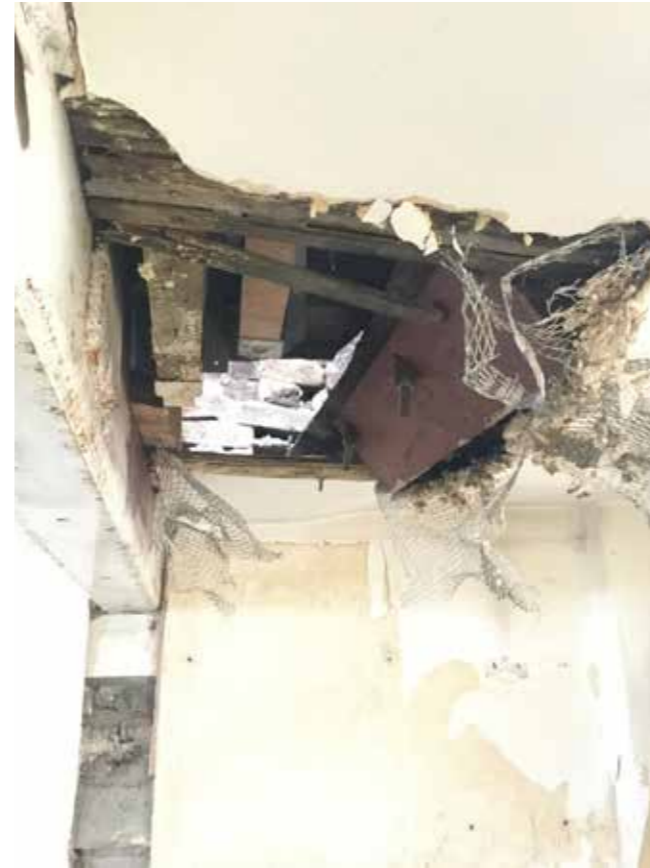
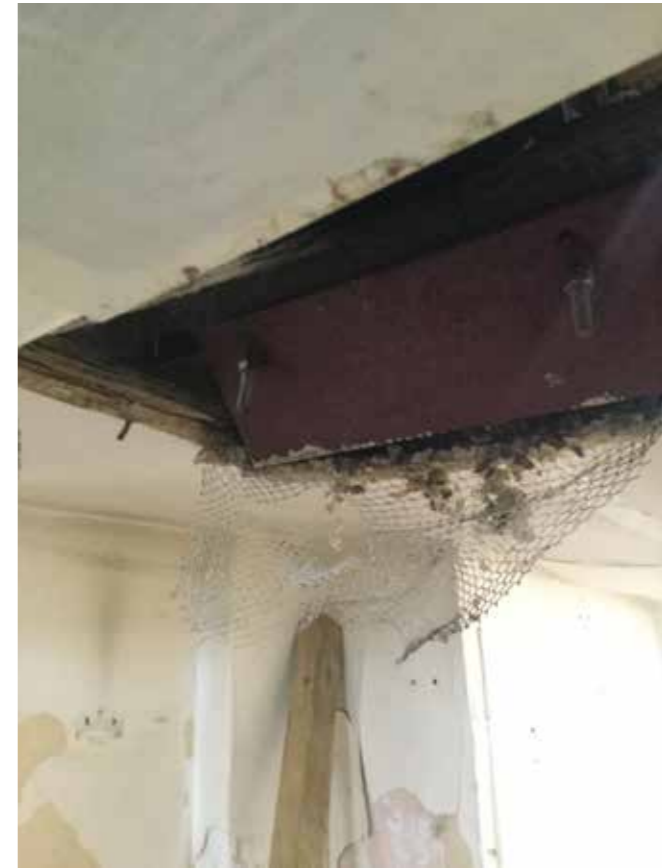
Existing Detail B

New timber bracing within the void of the front roof improves the stability of the structure. However, the current struts will no longer be needed once the replacement purlin is in place and existing rafters repaired

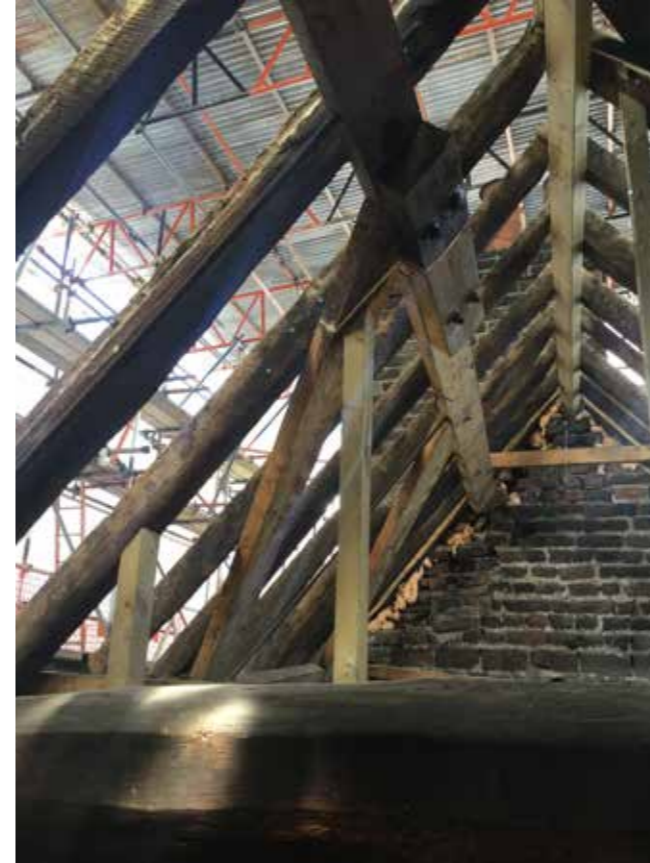
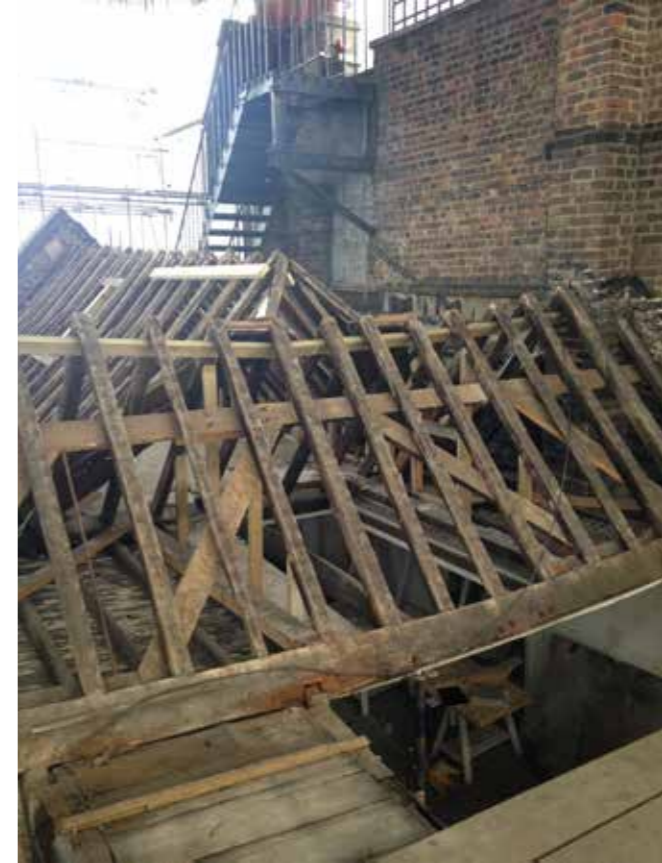
Existing Detail C

As the image adjacent demonstrates clearly, the front purlin is patently beyond repair and will be replaced with a 'seasoned' timber purlin as a like-for-like swap

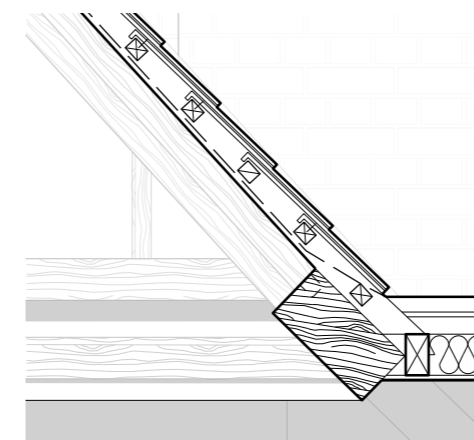
Current Purlin Location

As the photo above demonstrates, the severely deflected purlin now falls below the ceiling line. The movement of this member has also affected the rafters adjoining it

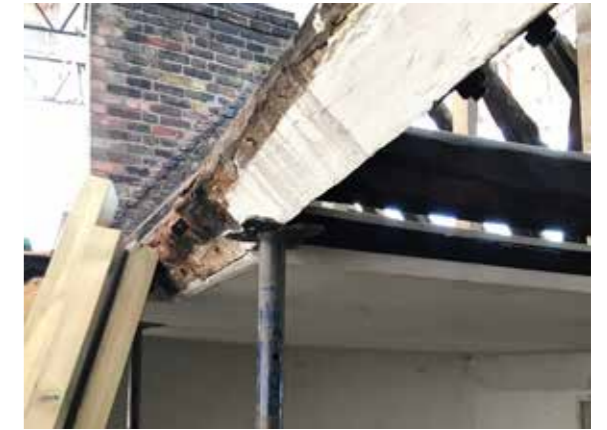
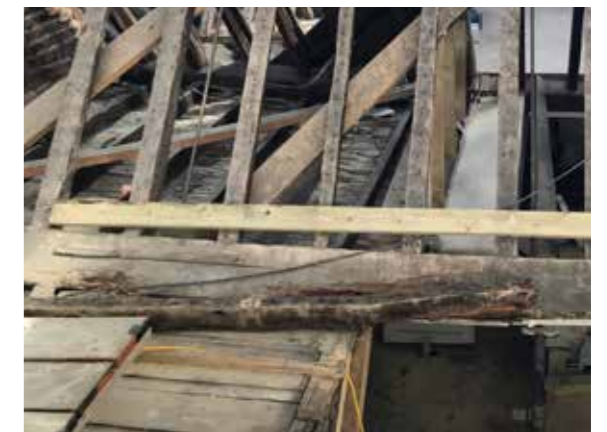
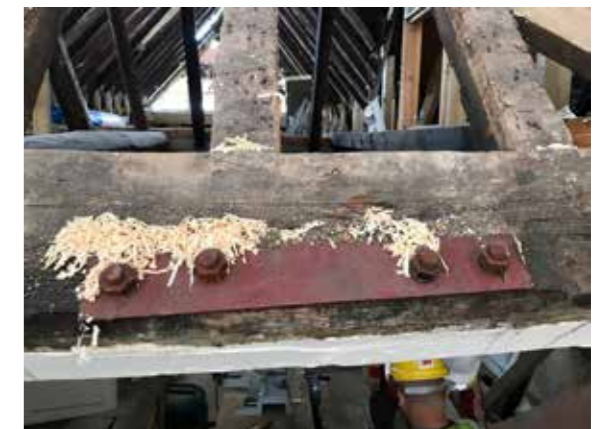
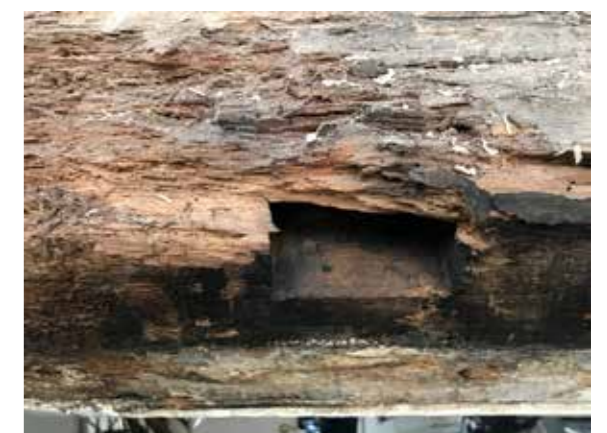
No.6 Denmark Street Purlin Decay - Scarfing

The extent of the rot and splitting across the purlin is apparent in the adjacent photos. Localised repair with scarf joints was considered but given the scale of the works needed, little of the original purlin would remain. This issue would be compounded by the fact that the tenons at each end have suffered extensive decay, as have the joints between the purlin and the rafters

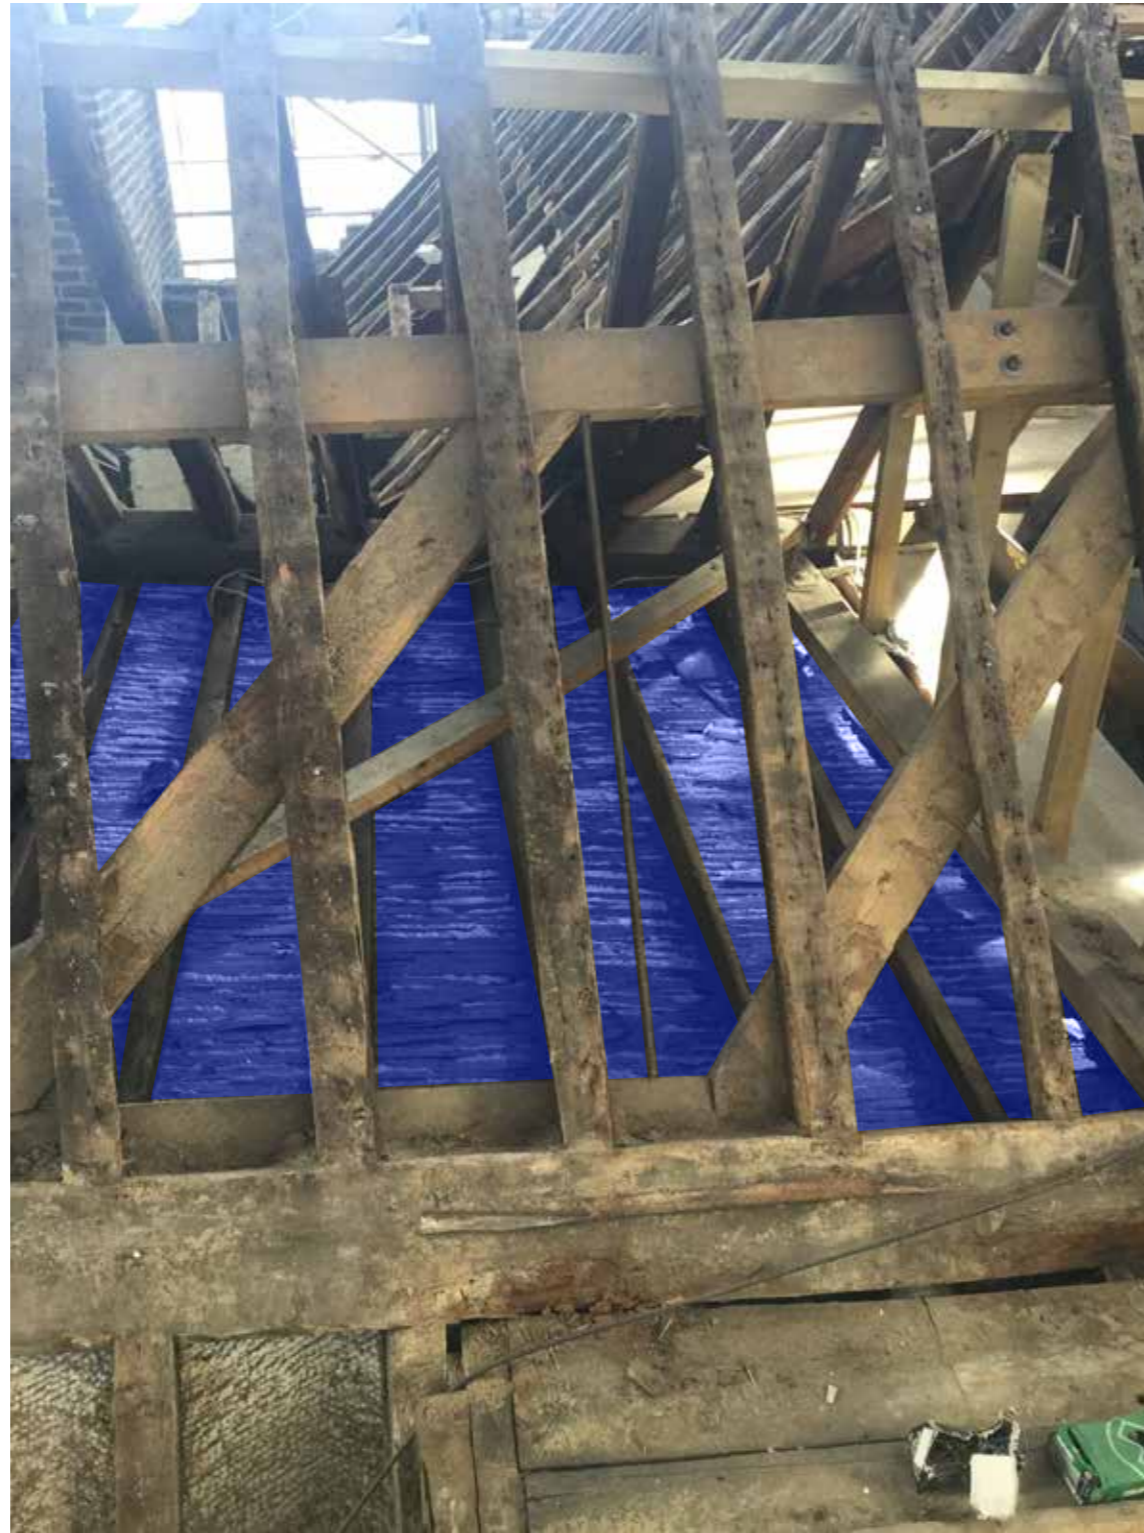
Given the extent of potential repair to the roof, the planned retention of the historic ceilings could be compromised. In addition, when installing a new, straighter purlin, the ceiling would be lower than the structure, making retention more difficult.

7 Denmark Street: Existing Ceiling
Remains of existing lath and plaster ceilings

This will be reviewed on an ongoing basis as works commence. All stages will be recorded with photographs.

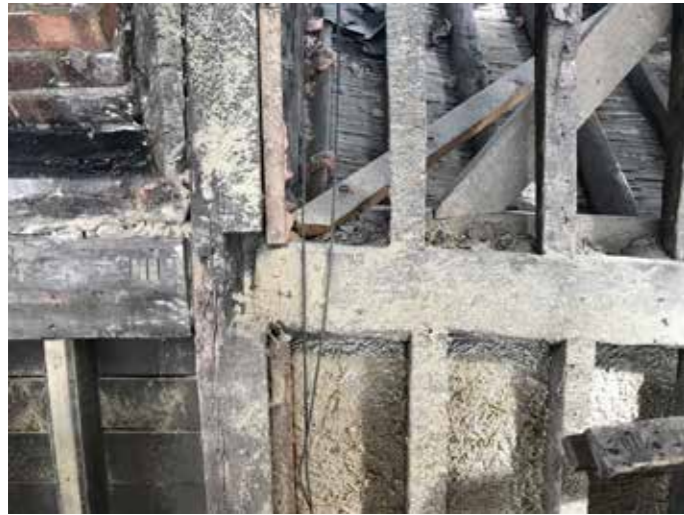
01 Damaged/Rotten/Failing Roof Members

The front purlin that stretches between the party walls shows the greatest level of damage, with rot, splits and deflection all clearly visible

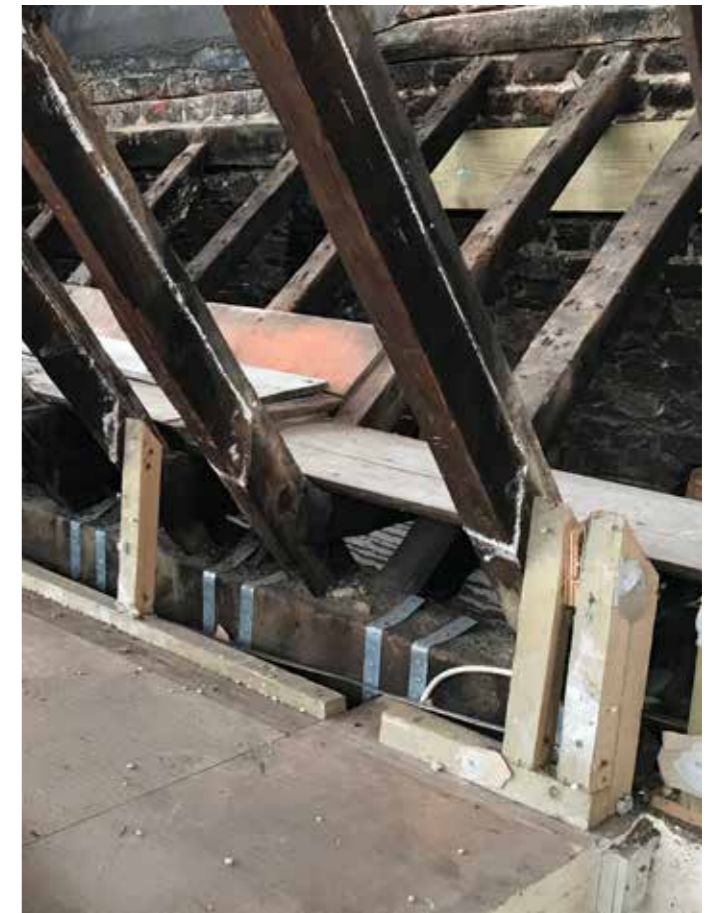
08 Gutter

Valley to be maintained and repaired, with fall towards the rear of the building, rather than the front and through the roof void which has caused long term decay through water ingress
