**DEFECTS REPORT**

**27 BUCKLAND CRESCENT  
LONDON  
NW3 5DH**

**BUTA LIMITED  
57a BELSIZE PARK GARDENS  
LONDON  
NW3 4JN**

DATE OF SURVEY: 21<sup>st</sup> FEBRUARY 2018  
DOC REF: 18.069.DR  
WEATHER: MILD

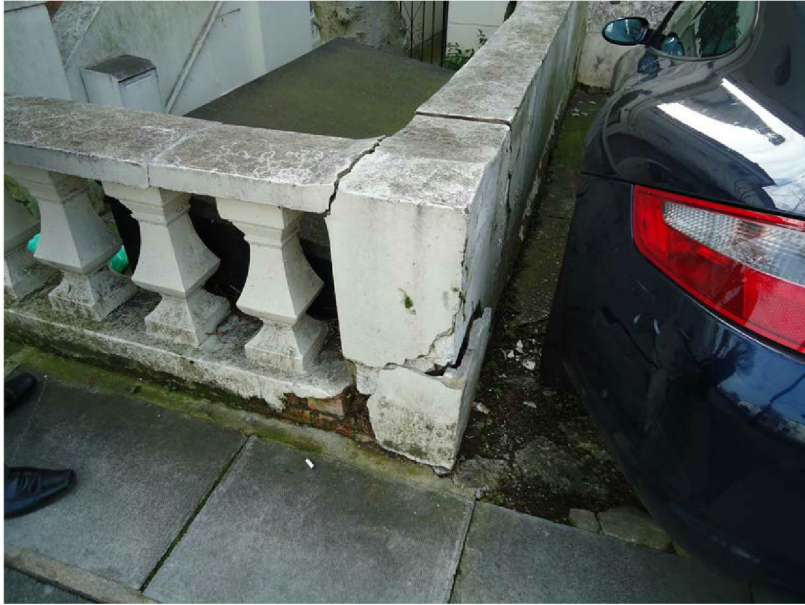
- 5.5 The party fence wall between the adjoining property which is close to the tree is also suffering from movement. The spine wall close to the front elevation separating the lower ground floor courtyard is also cracking.

Photo 1 – Party fence wall

- 5.7 Repairs to the paving and side elevation party fence wall can be undertaken once the tree is removed.
- 5.8 There is also lime tree on the other side of the site, which is slightly further away from the building, which is currently not causing any damage.

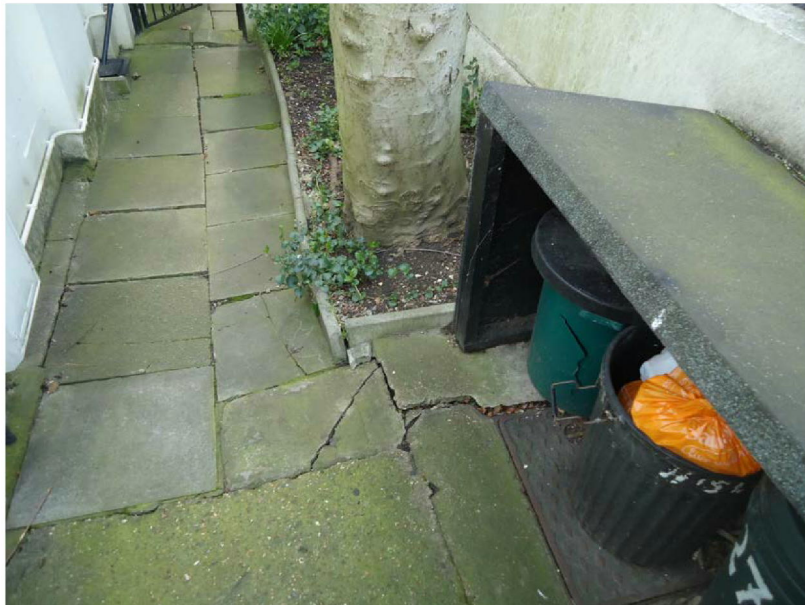
- 5.4 The roots from the tree are clearly visible though the paving which is leaving the paving uneven and a trip hazard. The paving has had constant work on it over the years to minimise the risk of trips but has got worse recently.

Photo 2 – Uneven paving leading into the lower ground floor

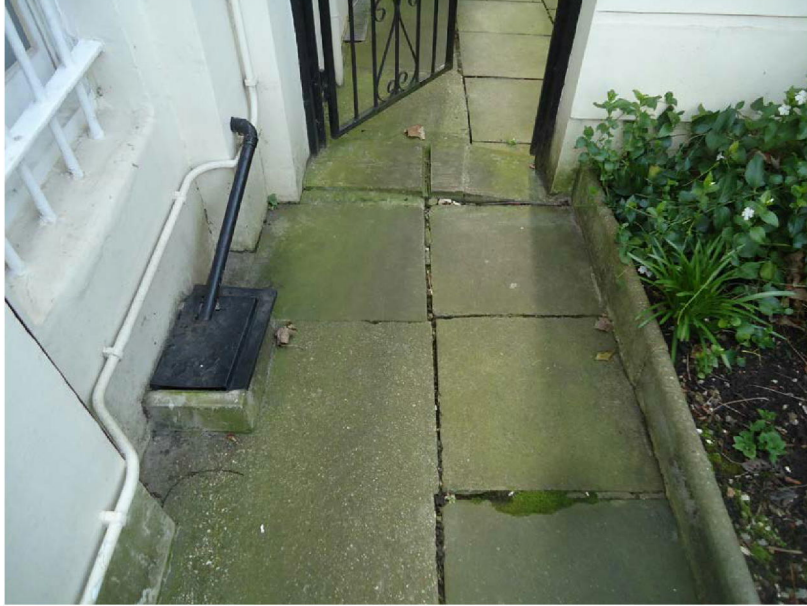
Photo 3 - Uneven paving leading into the lower ground floor
