# FACTUAL REPORT OF TRIAL PIT & BOREHOLE INVESTIGATION 1

**Level Monitoring**

**From:** Little, Tom  
**Sent:** 15 May 2018 10:07  
**To:** Planning  
**Cc:** Bell, Nick  
**Subject:** FW: 2018/1984/T 62 Fitzjohn's Avenue, NW3 5LT REAR GARDEN (near boundary with 12 Akenside Road): 1 x Lime (T4) - Fell and treat stump. Agent: OCA  
**Attachments:** 62 Fitzjohns Ave Comment on Factual Report.pdf.docx; 62 Fitzjohns Ave Monitoring Levels with comments.pdf.docx

This is a Notice of Intent to fell a lime tree following on from the felling of a cherry tree in 12 Akenside Road, purportedly because trees are causing subsidence of 12 Akenside Road.

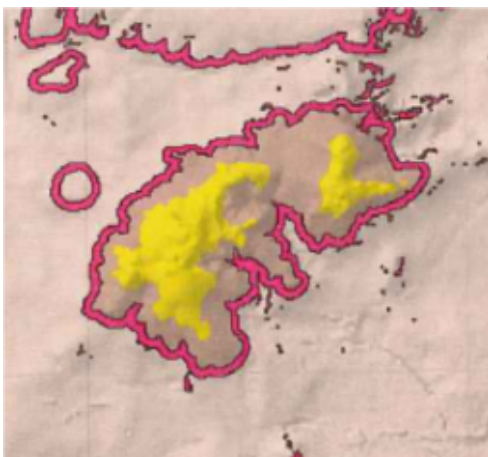
Areas of significant  
Landslide potential

**From Figure 1 – GIS Map of Area of potential landslide vulnerability, Based on causative landslide factors; geology, slope angle, hydrology and know landslide activity: BGS Sheet Memoir 256 North London from the 1:50,000 Series Bedrock and Superficial Deposits for England and Wales**

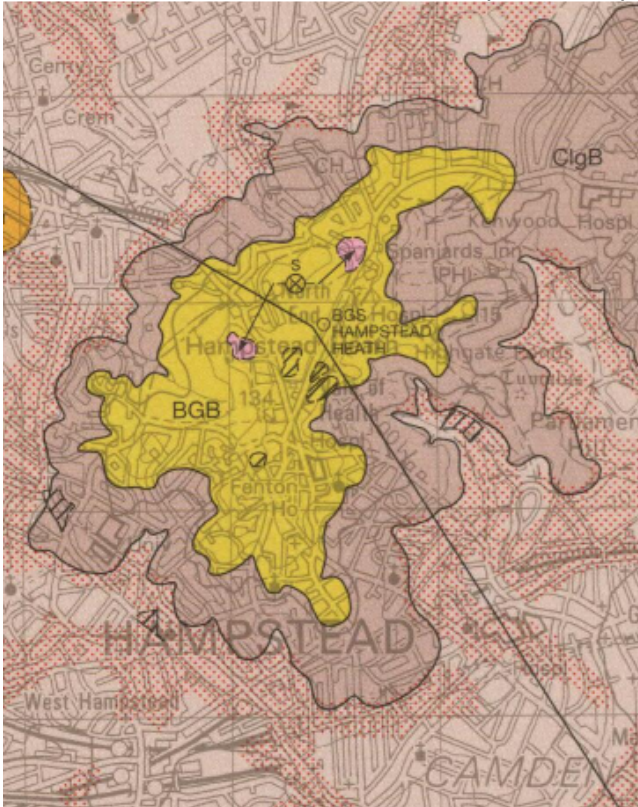
BGB = Bagshot Beds (yellow); ClgB = Claygate Beds (grey)

**From 'BGS North London Bedrock & superficial geology map'**

This map shows the relationship between the local geology and the landslide potential of Hampstead. 62 Fitzjohns Avenue will be roughly below where the A of 'HAMPSTEAD' printed on the map is.

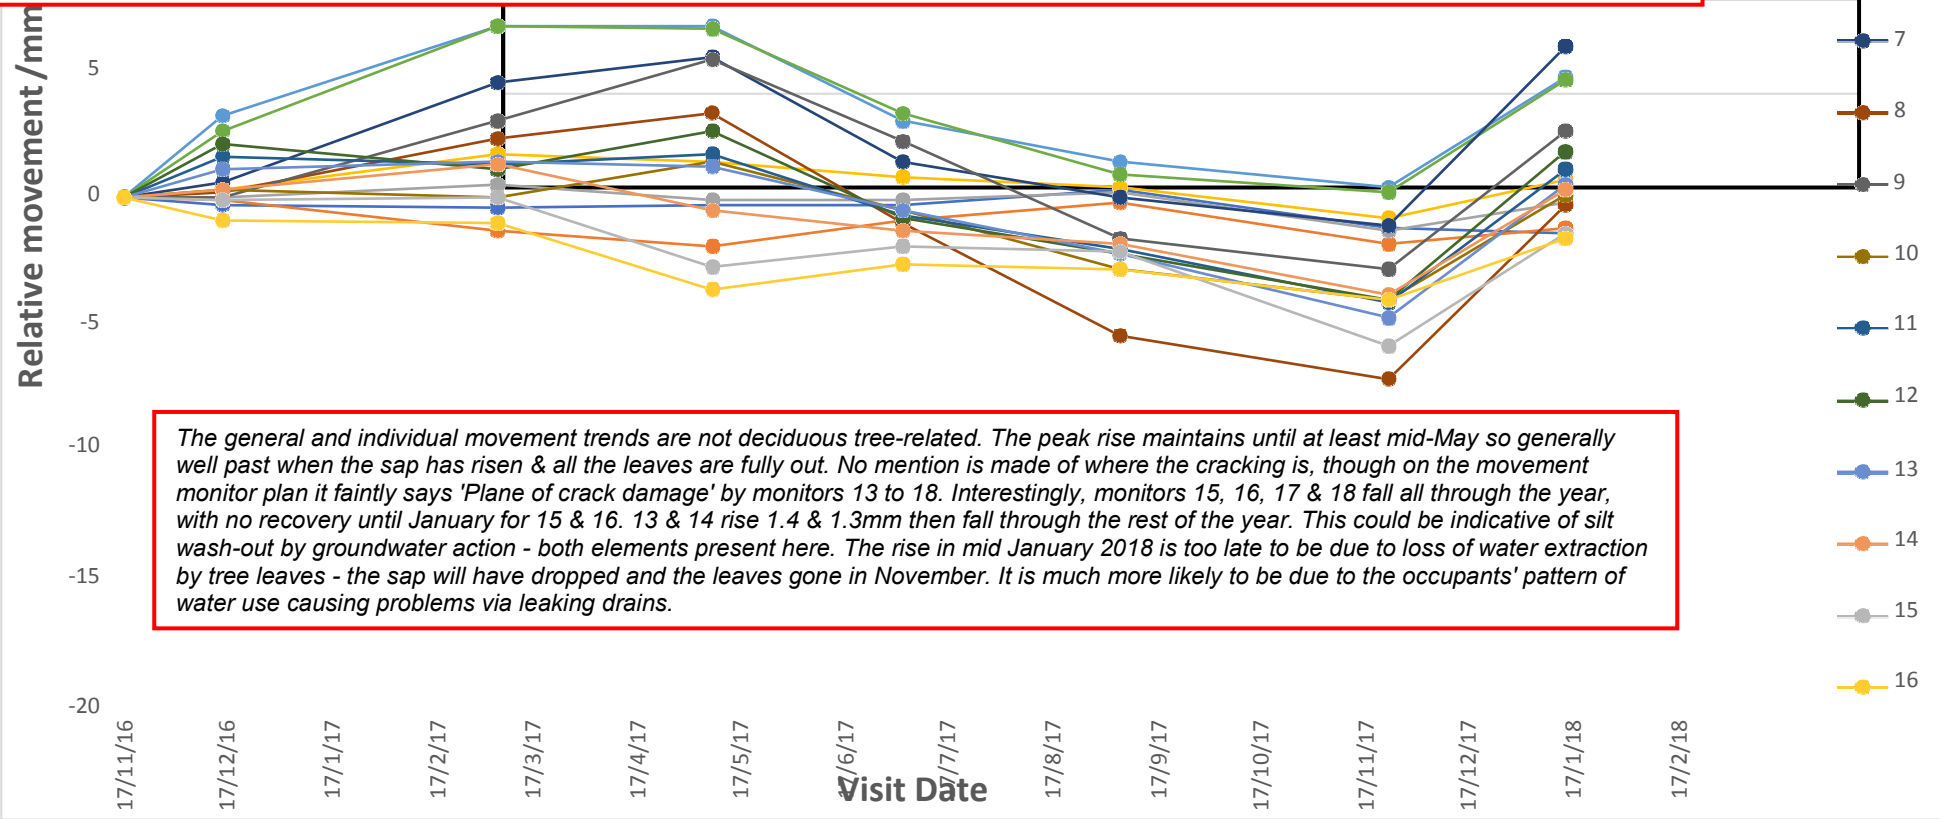
Level Monitoring - Movement relative to datum against Date

**Movement data colour-coded and placed against rainfall data to demonstrate inadequate of relationship with the seasons for trees or for actual rainfall.**

*The general and individual movement trends are not deciduous tree-related. The peak rise maintains until at least mid-May so generally well past when the sap has risen & all the leaves are fully out. No mention is made of where the cracking is, though on the movement monitor plan it faintly says 'Plane of crack damage' by monitors 13 to 18. Interestingly, monitors 15, 16, 17 & 18 fall all through the year, with no recovery until January for 15 & 16. 13 & 14 rise 1.4 & 1.3mm then fall through the rest of the year. This could be indicative of silt wash-out by groundwater action - both elements present here. The rise in mid January 2018 is too late to be due to loss of water extraction by tree leaves - the sap will have dropped and the leaves gone in November. It is much more likely to be due to the occupants' pattern of water use causing problems via leaking drains.*

I also consider that a proper drains survey should be done, including pressure testing to establish if there is any leaking occurring. While I consider it likely that silt erosion is the more major cause, I don't need to remind you of the consequences of leaking drains - a now well-accepted causative mechanism for subsidence - which could be having additional impact here. Leaking drains should be fixed before any tree felling or remedial work is done otherwise both are futile and a lot of money is wasted.

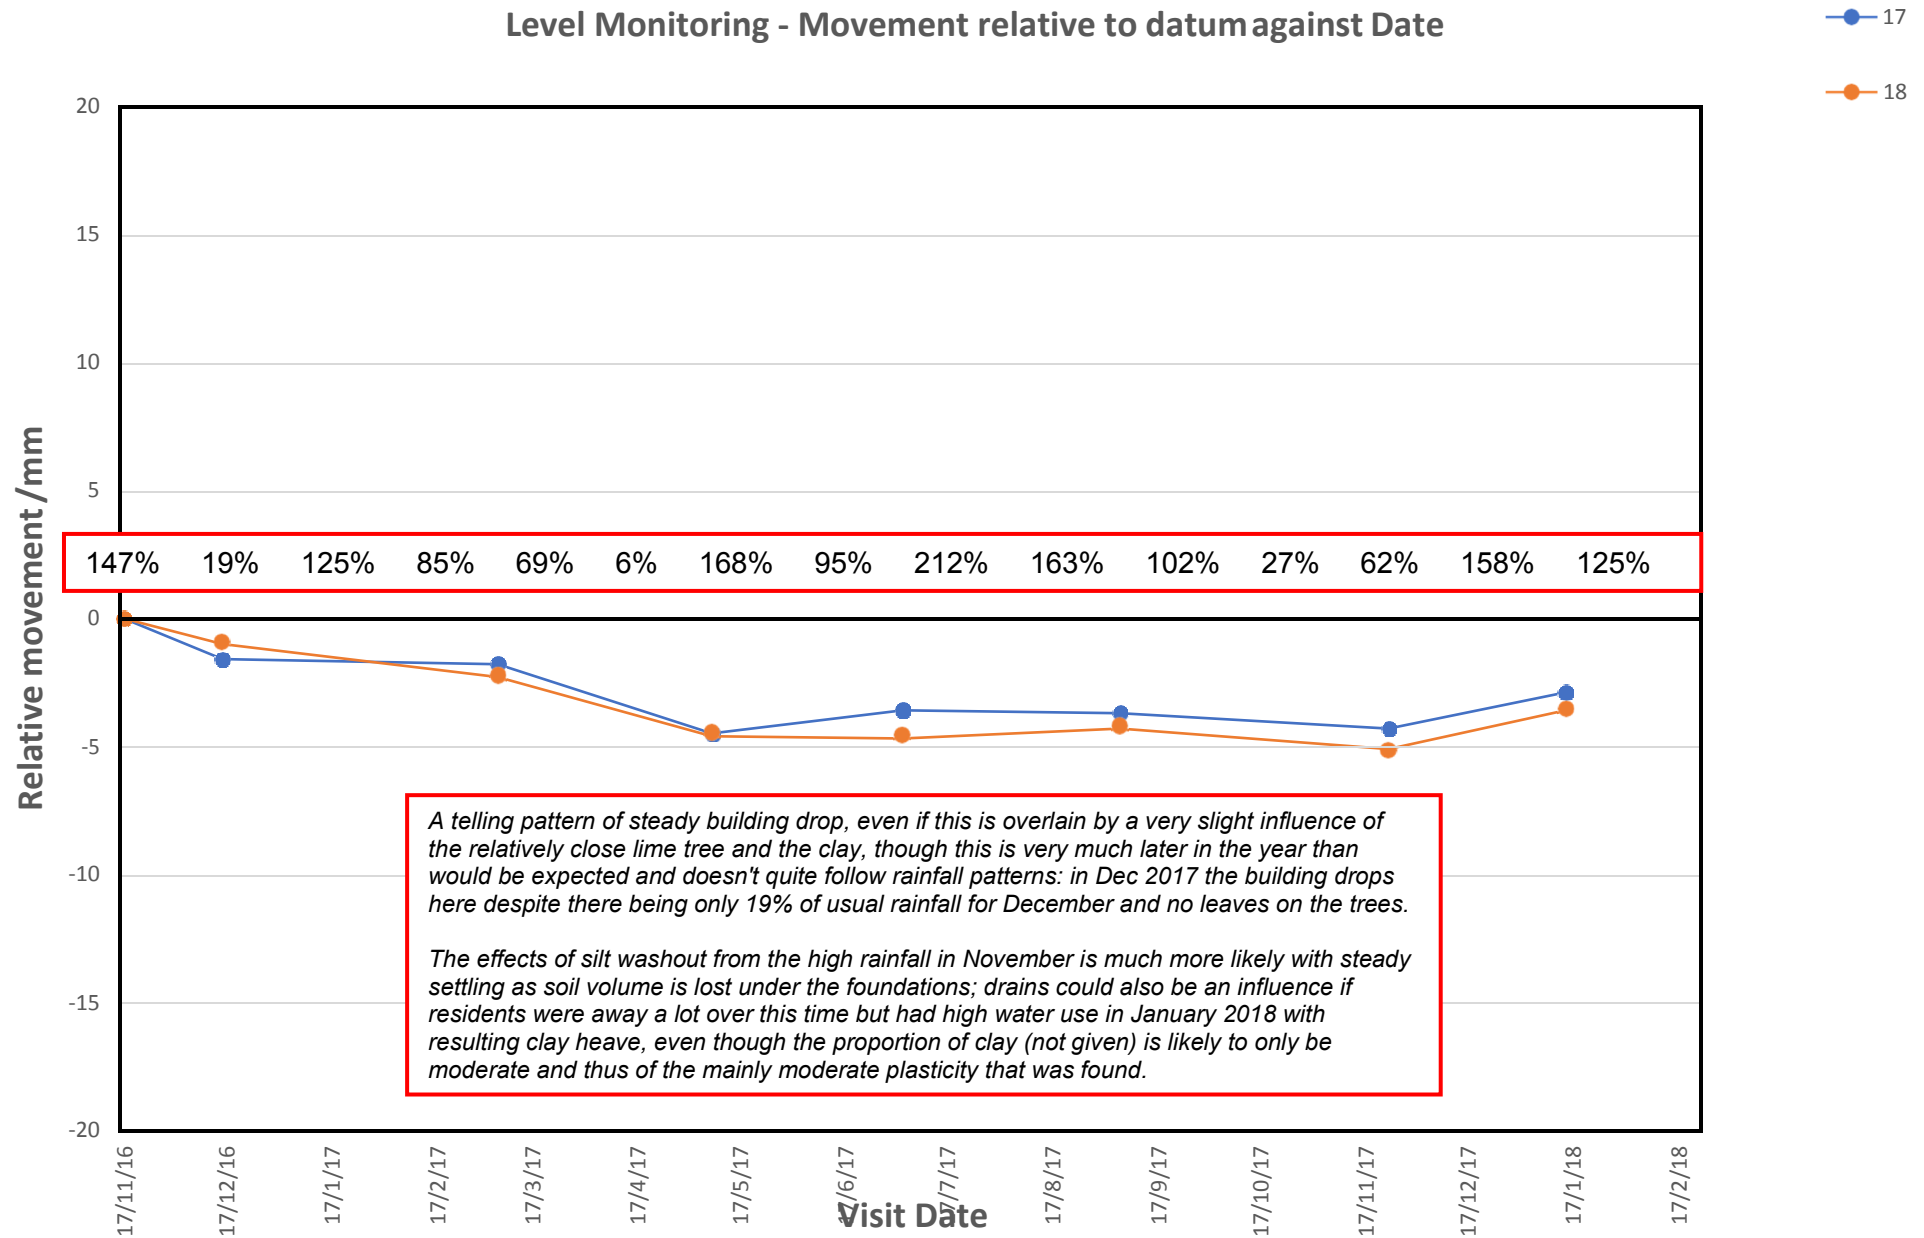
Level Monitoring - Movement relative to datum against Date

- The movement data does demonstrate continuing loss of volume below part of the building - where 'plane of crack damage' is written on the plan(?) - indicating that this house is no different from others in Fitzjohn's Avenue and much of Hampstead: it is suffering from erosion of the high proportion of silt from within the Claygate Beds by the action of groundwater.
