**BRAHAM SEARS & PARTNER**  
S U R V E Y O R S · V A L U E R S

## **BUILDING SURVEY**

**6 SHARPLES HALL STREET  
LONDON  
NW1**

**MR AND MRS S HURWITZ**

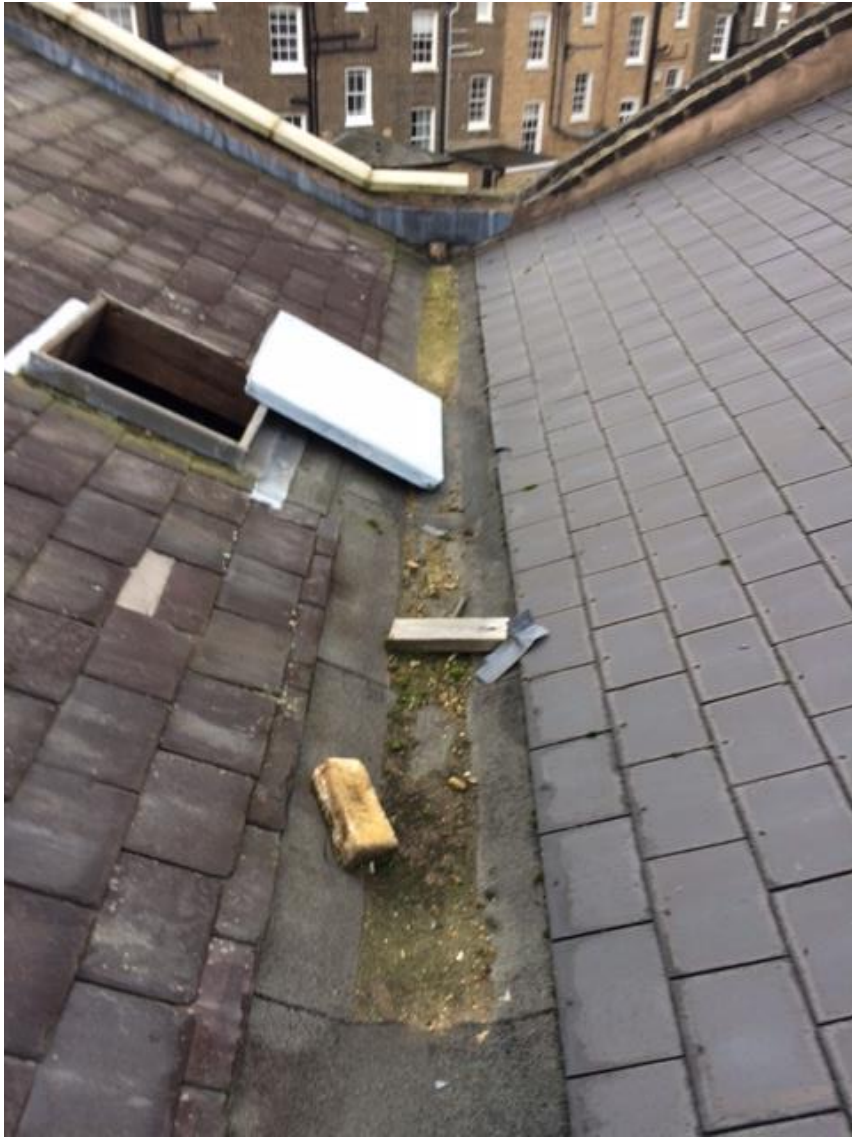
The centre valley is covered with mineralised felt. The valley is blocked with windblown debris and silt. The valley appears not to have been laid to a correct fall as staining was recorded to the felt indicating that it may not flow freely from the front towards the rear drainage outlet. This is probably due to variations in the falls which have occurred with general settlement through the building as a result of age and possibly even any poor workmanship when the felt was last renewed.

**Blocked felt valley gutter**

We would recommend that you arrange for a bona-fide Roofing Contractor to provide an estimate for the replacement of the valley gutter and in conjunction with the roof overhaul works. You should appreciate however that to replace a valley gutter will inevitably cause considerable disturbance to the lower levels of the roof which will greatly increase the costs of the works. At the same time the condition of the concealed roof and ceiling timbers which are built into the long term areas of damp penetration should be exposed to determine as to whether they have been affected by rot decay.

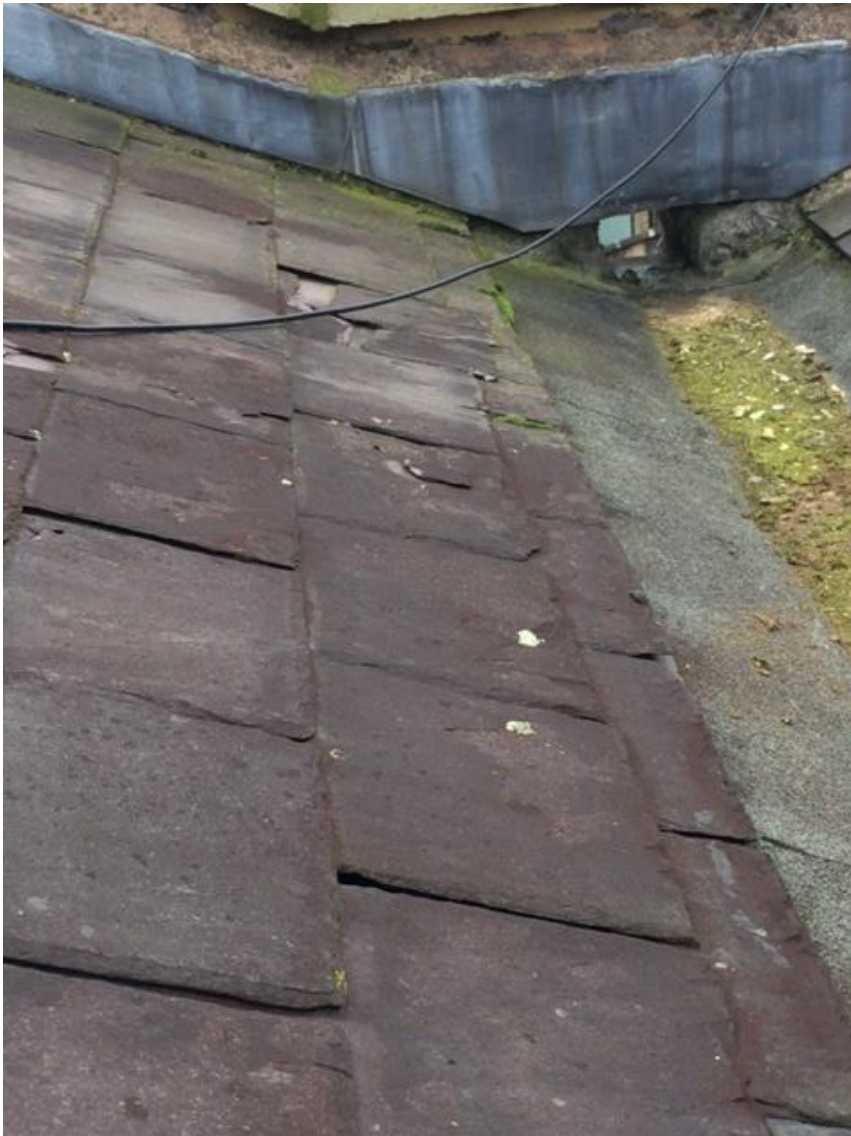
An examination of the roof revealed that there are approx. 12-24 No cracked, broken, damaged and taped slates. Whilst the roof is capable of an overhaul, replacing the damaged and defective slates, in view of the modernisation and extensive refurbishment proposed we would consider that it would be preferable and more cost effective in the long term for the roof covering to be replaced.

**Cracked and defective slates to left hand slope**

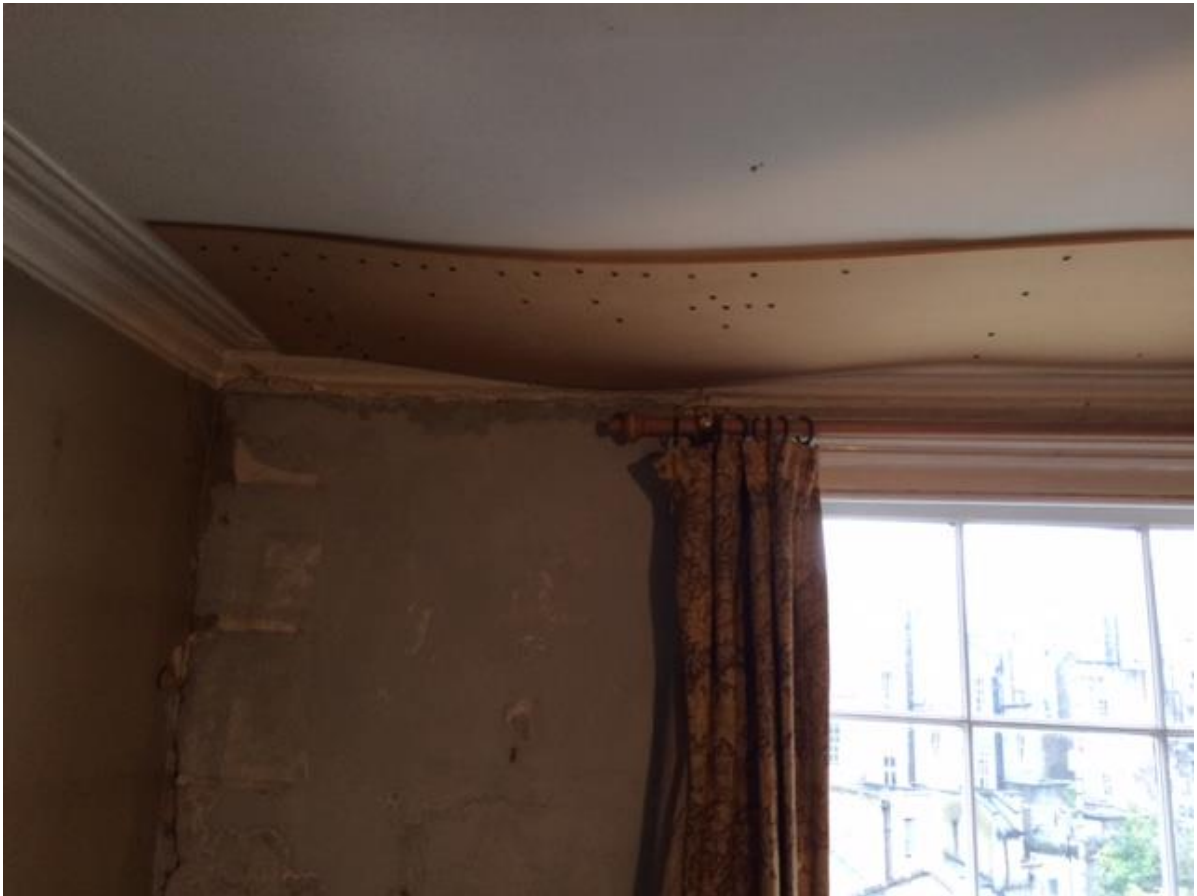
**Collapsed rear Bedroom ceiling**

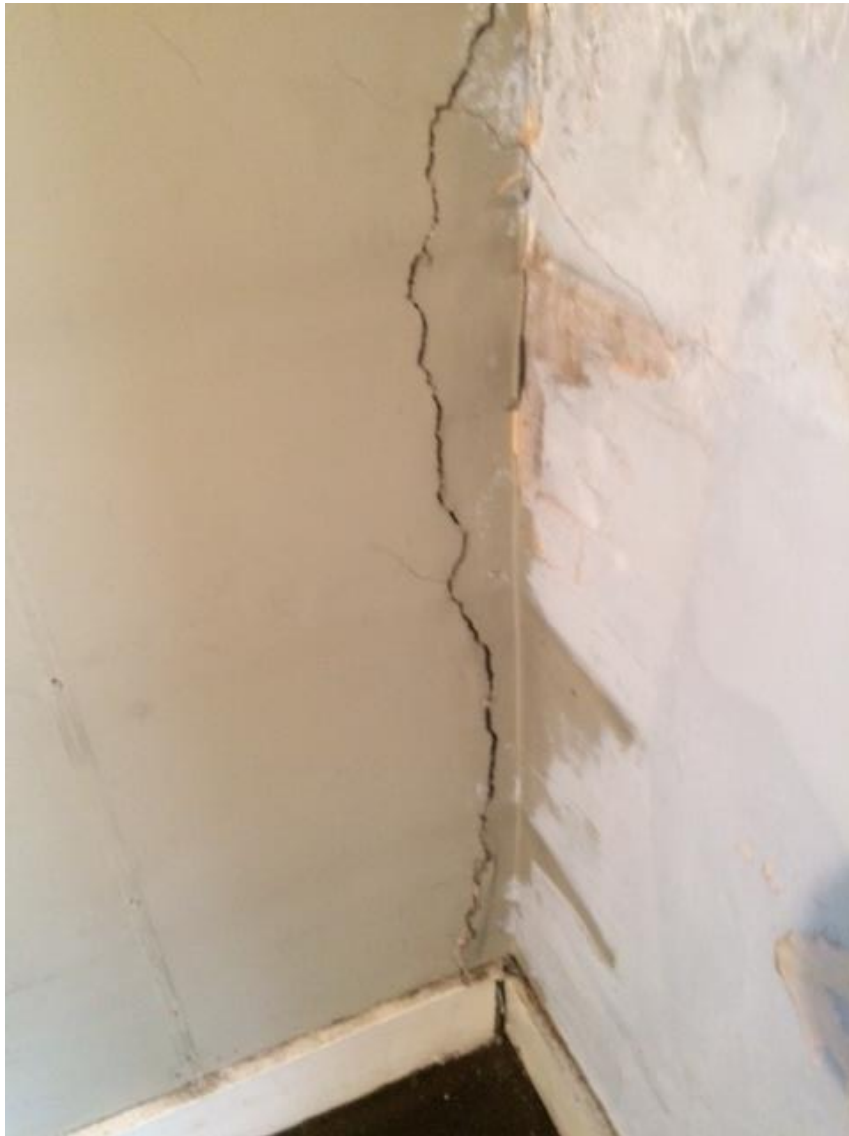
**Cracking in Second Floor rear Bedroom partition**

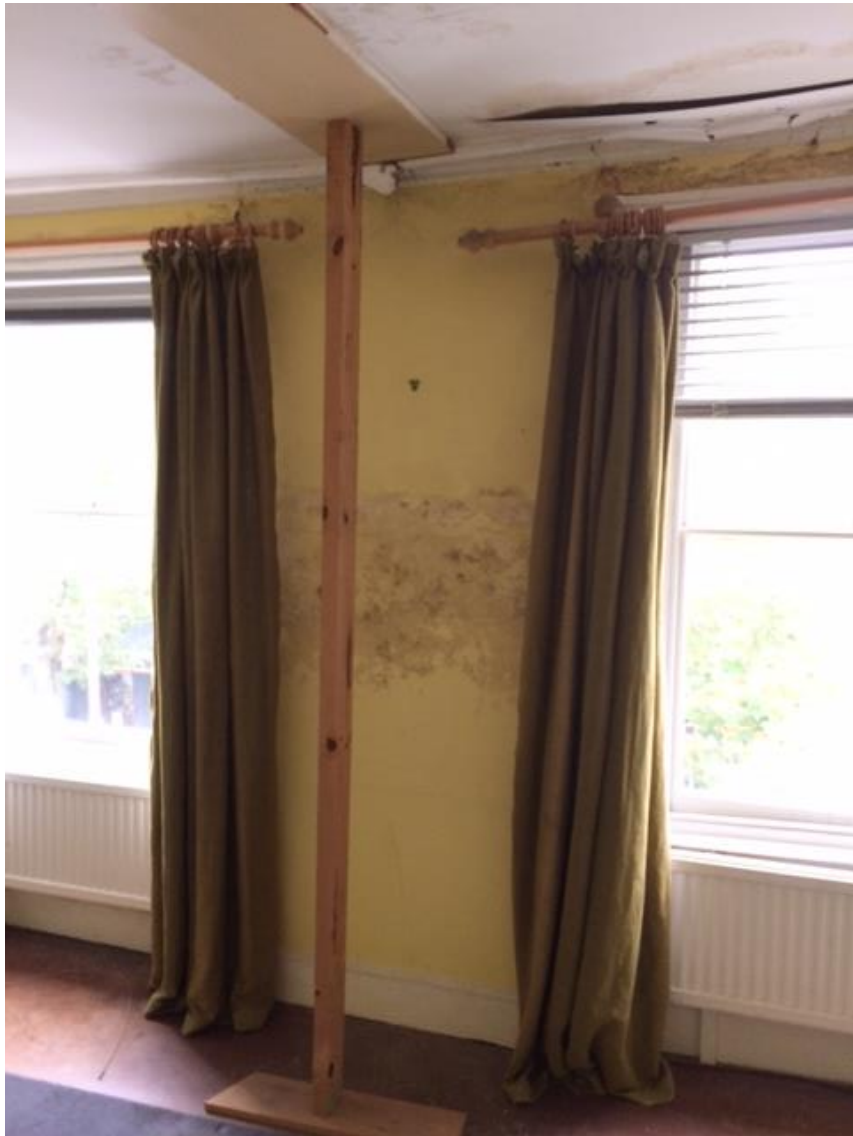
**Collapsing front Bedroom ceiling and water penetration**

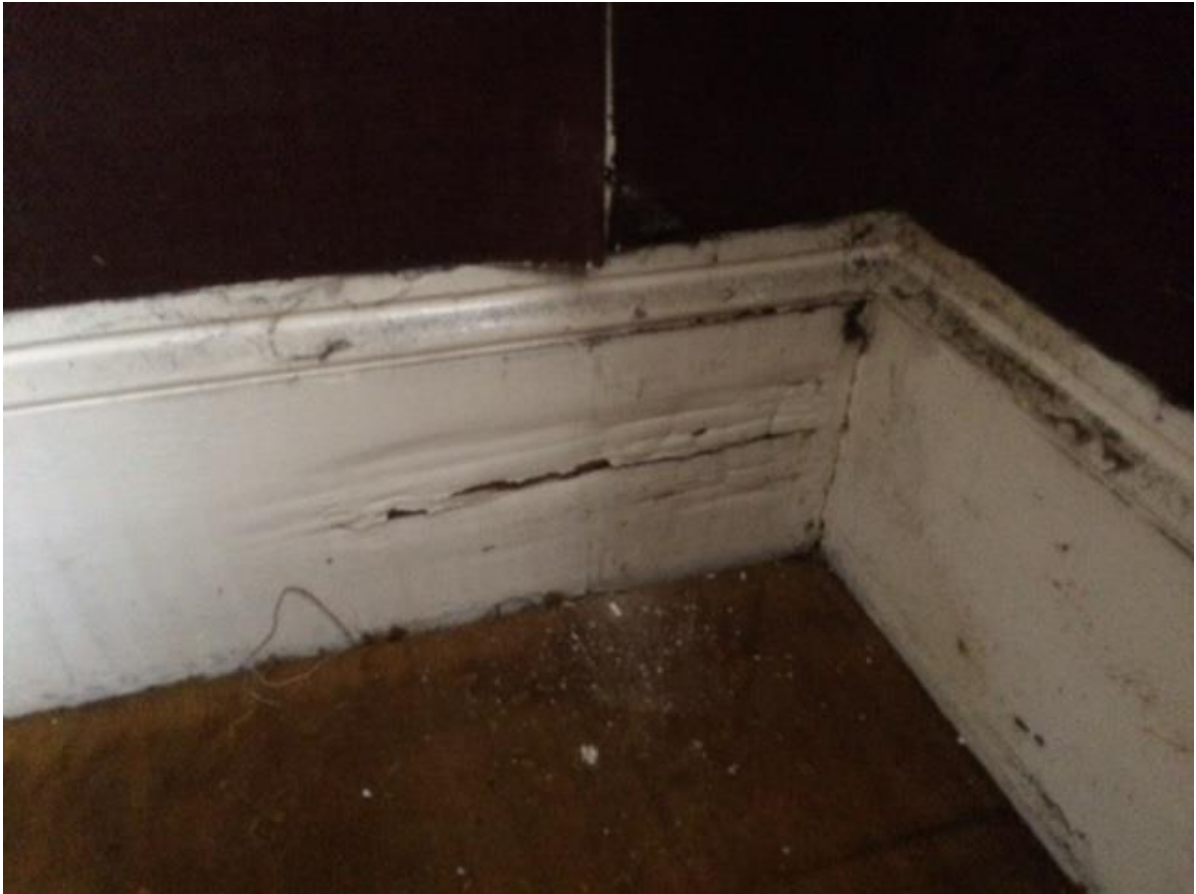
**Rot infection in front Living Room skirtingboard**

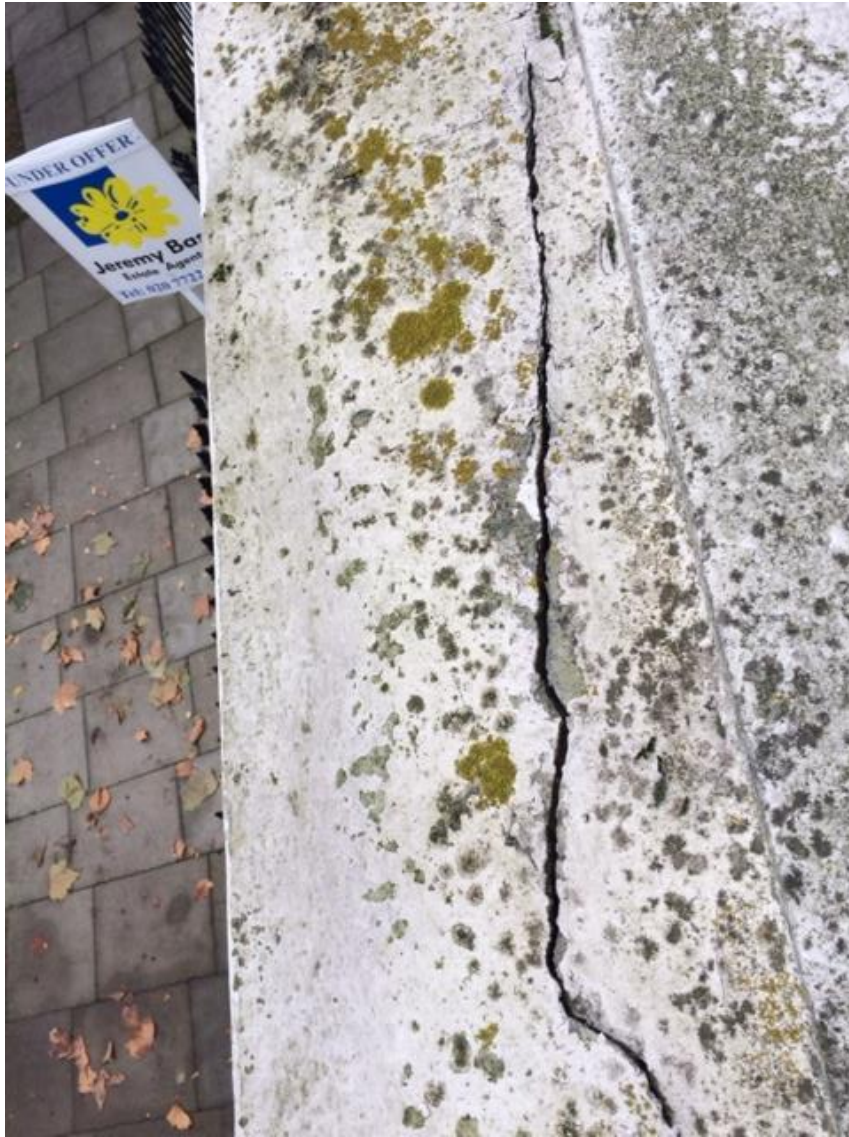
There is some slight hairline cracking over the left hand corner of the Ground Floor window opening and in the banded rendered course. The cracking at its current level is not considered significant but will need to be cut out and made good.

Some areas of the render are cracked and crazed and a certain amount of raking out and repairs should be budgeted for. Where the rendered bracket projects above the head of the Ground Floor window opening this is invariably cracked and crazed and this may be permitting a certain amount of damp/water penetration and compromising the concealed timber bressummer that supports across the opening. The render should be cut out and repaired and vegetation growth removed. It would be prudent to expose the condition of the bressummer to confirm that it is not compromised by rot decay.

**Cracking in front corbelled banded projection**

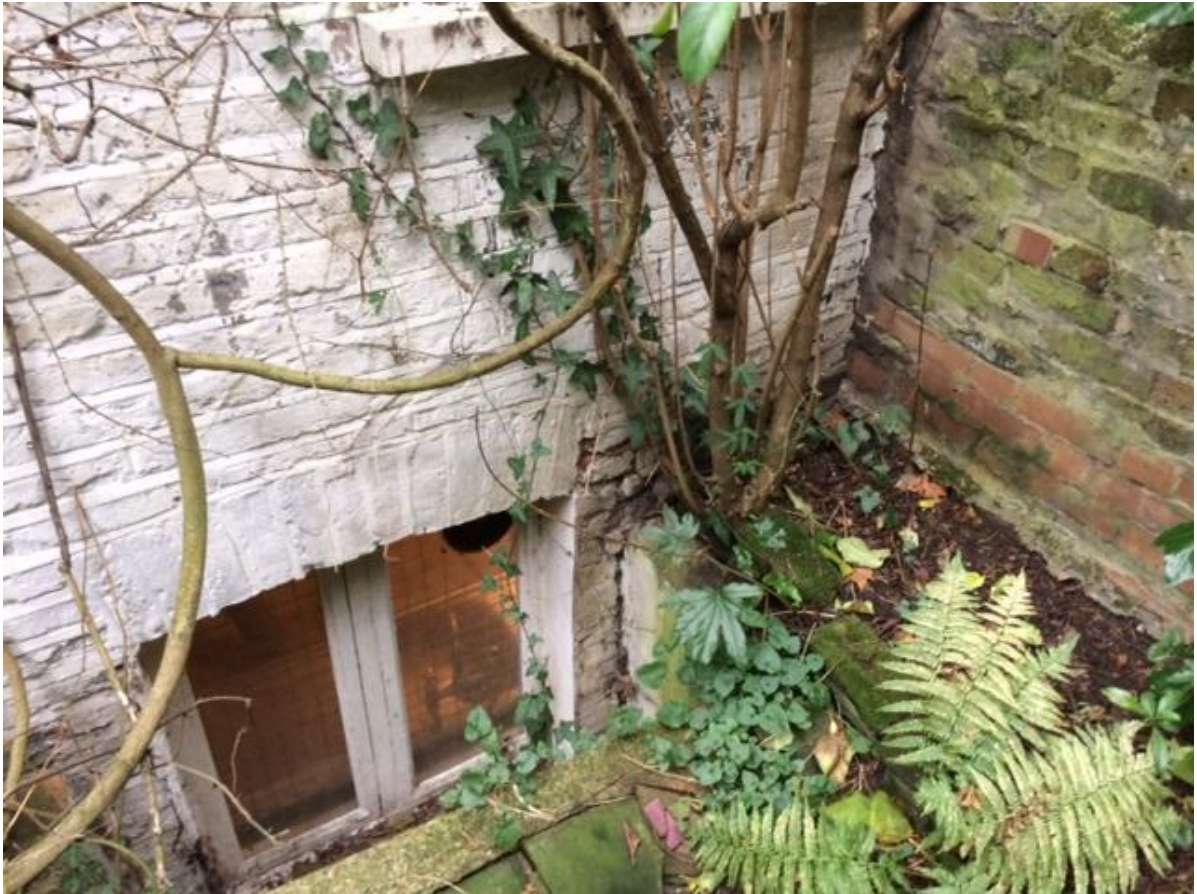
Tree roots can exaggerate ground movements by extracting moisture and causing shrinkage of the clay. The cracking may also be attributable to some slight foundation movement. There is a semi mature tree which grows into the base of the rear wall and other established areas of bushes and trees in the rear garden. The structure may be influenced by the tree. The risk should be reduced by controlling or removing the trees in accordance with the recommendations of an Arboriculturist. Depending on the advice received it would be beneficial in the long term for them to be removed.

**Bush/tree growing into rear addition wall**

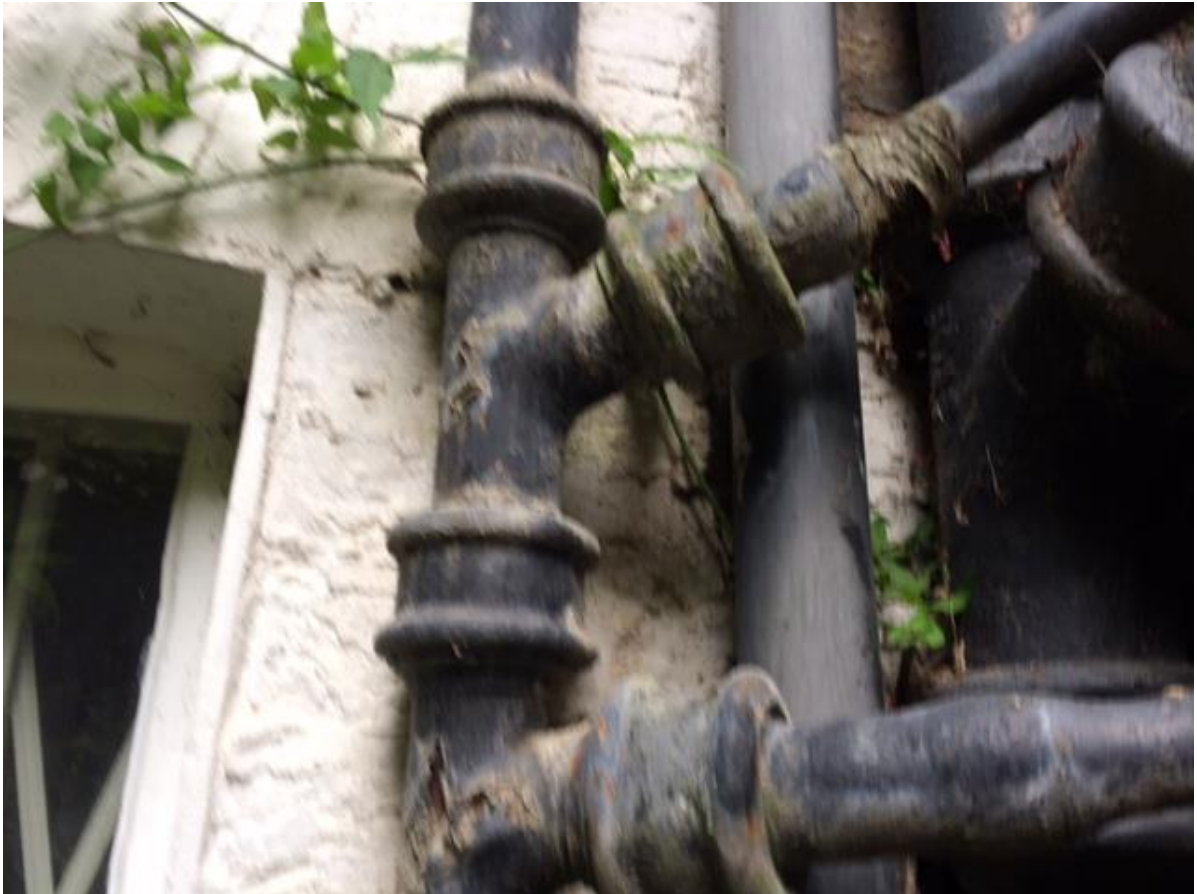
The majority of the external wastewater pipework is also positioned against the rear wall and is formed in the original lead and cast iron and with some later plastic connections. There are various leaks at collar joint connections and the lead wastepipe connection with the cast iron downpipe are leaking. The wastewater pipework will need to be upgraded and replaced which may have been deemed necessary in any event in conjunction with your proposed refurbishment and alterations to the property.

Leaking wastewater pipework
