Project Title: ATHLONE HOUSE			
Drawing Title: BOUNDARY WALL SURVEY			
Scale at A3: NTS	Drawn by: BSP	Date: 30.04.18	Checked: SHL

Drawing Status: FOR INFORMATION			
Project No: 1480	Drawing Type: SK	Drawing No: BW01	Revision: -

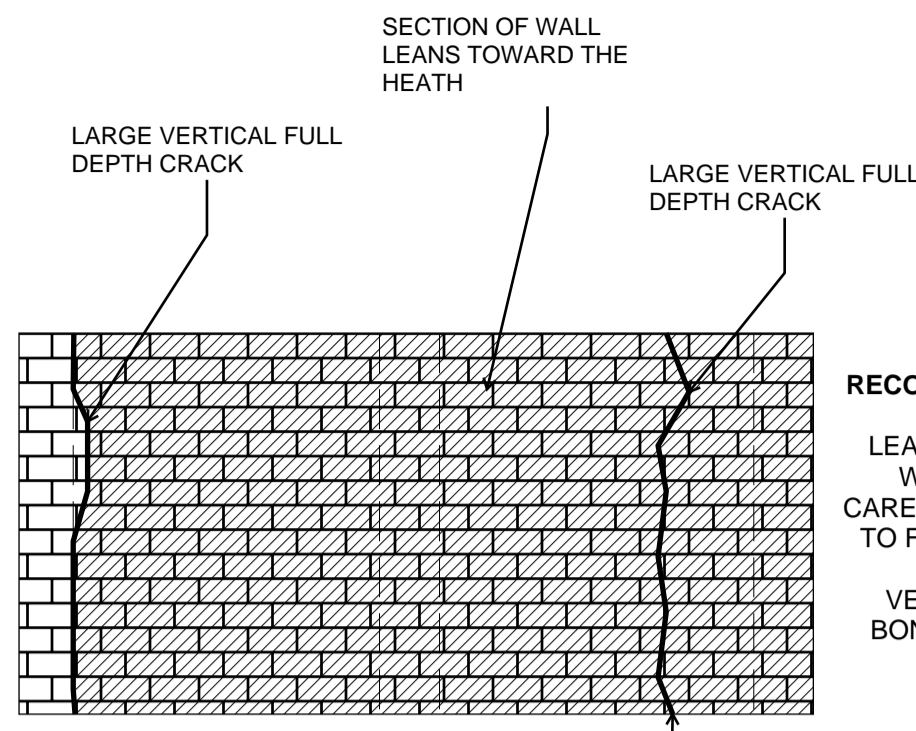
SECTION D
TREE DIRECTLY IN FRONT OF WALL. ROOTS LIKELY CAUSING CRACK

RECOMENDED REMEDIAL WORKS
LEANING SECTION OF WALL SHOULD BE CAREFULLY TAKEN DOWN TO FOUNDATION LEVEL AND REBUILT VERTICALLY, FULLY BONDED TO EXISTING PIER.

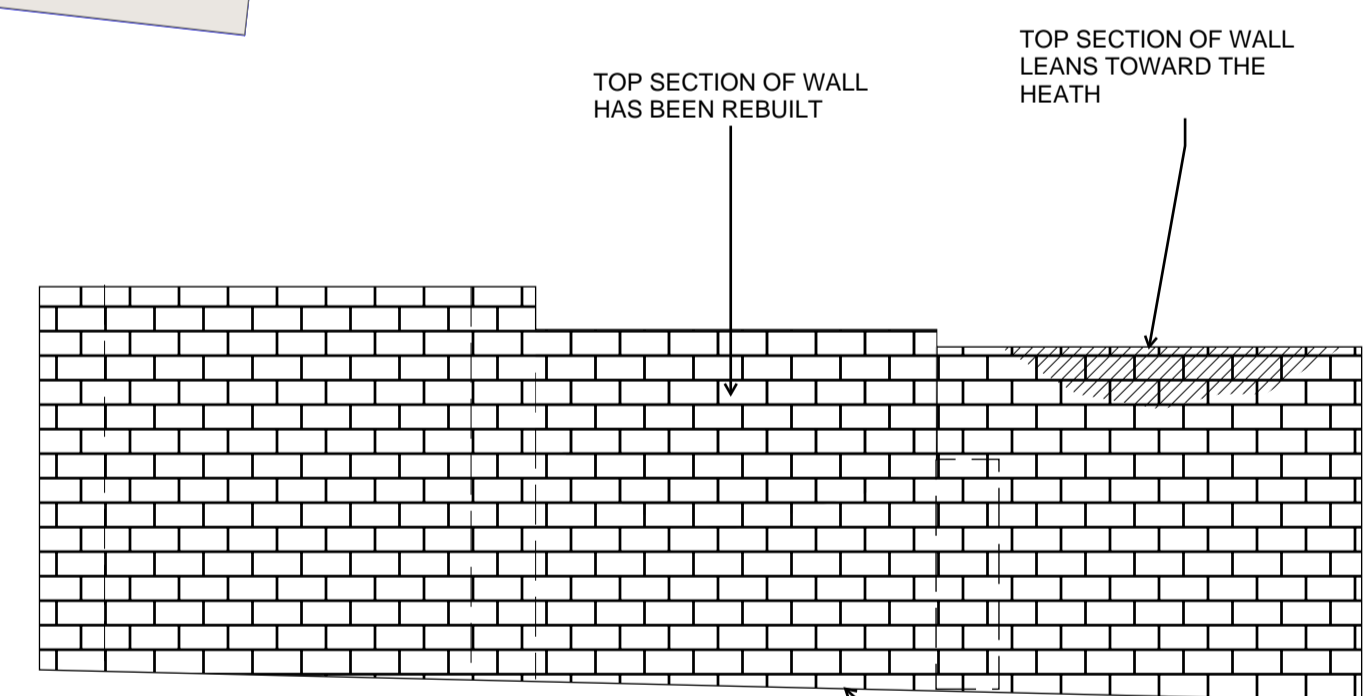
SECTION I

TRIAL PIT INVESTIGATION SHOWED TREE ROOTS HAD PENETRATED THE WALL FOUNDATIONS

RECOMENDED REMEDIAL WORKS
LEANING SECTION OF WALL SHOULD BE CAREFULLY TAKEN DOWN TO GROUND LEVEL AND REBUILT VERTICALLY, FULLY BONDED TO EXISTING WALL AND PIERS. TREE ROOT SHOULD BE EXPOSED AND CAREFULLY CUT AWAY AND BRICKWORK MADE GOOD

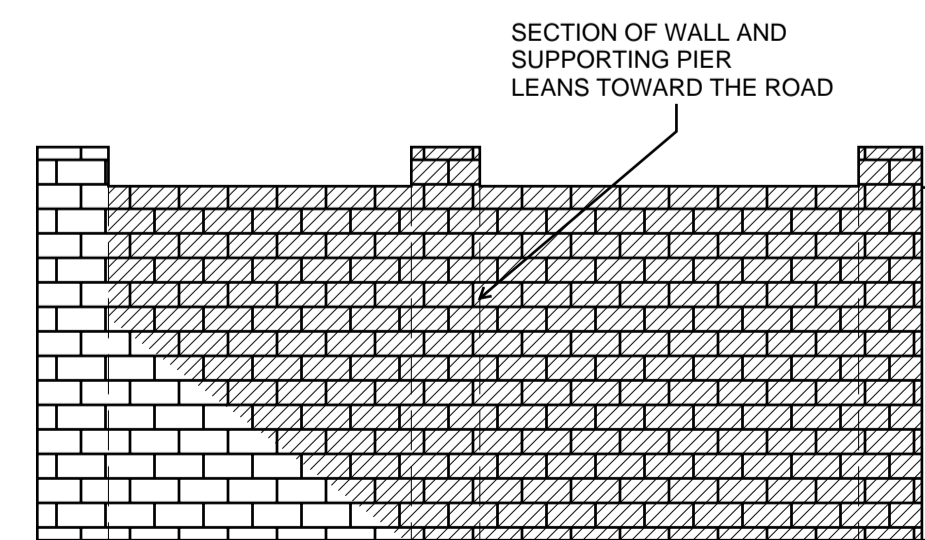
SECTION J

SECTION OF WALL TO BE REMOVED FOR SUBSTATION ENTANCE

RECOMENDED REMEDIAL WORKS
LEANING SECTION OF WALL SHOULD BE CAREFULLY TAKEN DOWN TO FOUNDATION LEVEL AND REBUILT VERTICALLY, FULLY BONDED TO EXISTING WALL AND PIERS.
