**TECHNICAL REPORT ON A SUBSIDENCE CLAIM**

**Crawford Reference: SU1604808**

**Gilling Court (Hampstead) Ltd  
Flat 2 Gilling Court  
Belsize Grove  
Hampstead  
London  
NW3 4UY**

**SUBSIDENCE CLAIM**

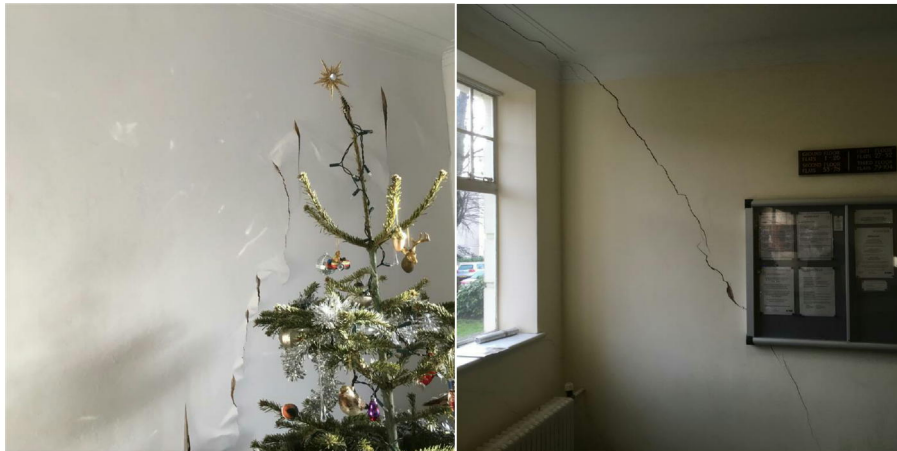
Crack in Flat 28 Living Room

Crack in the ground floor entrance lobby

Diagonal crack to right flank wall, possibly 15mm width with significant disturbance of plaster

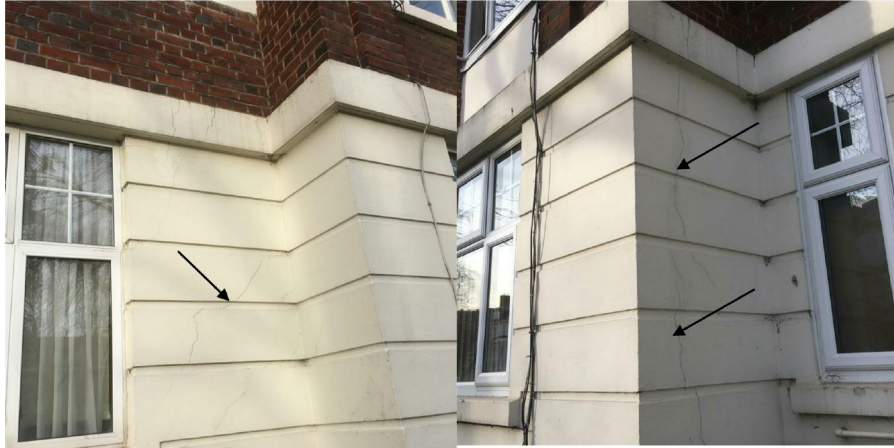
Cracks to front elevation

Series of short cracks, up to 3mm width to the rendered areas at first floor and below. These cracks are predominately to the left of the main entrance. Cracking and movement of the front steps.

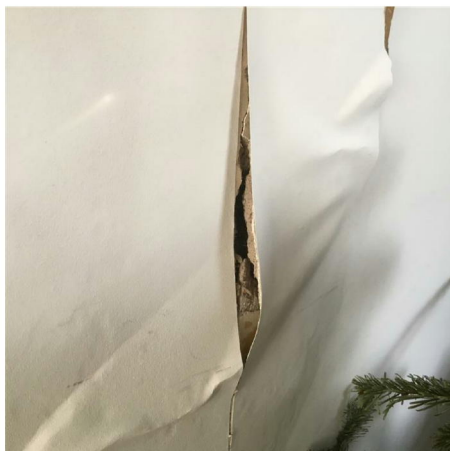
Crack in Flat 28 living Room

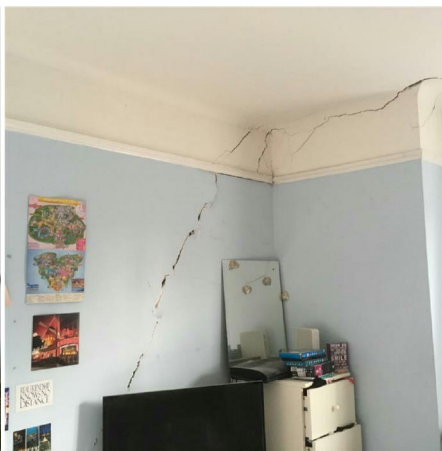
10mm diagonal crack to the right flank wall

Crack in Flat 2 Right hand end bedroom

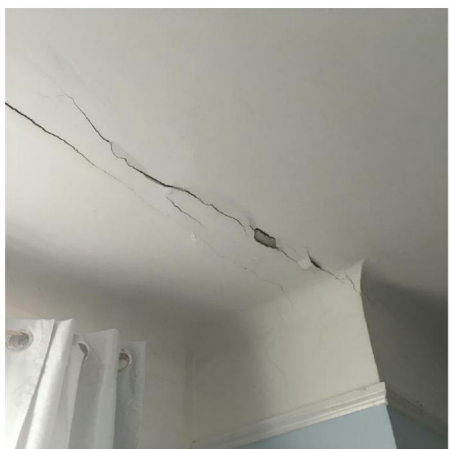
Crack in Fla2 Right hand end bedroom

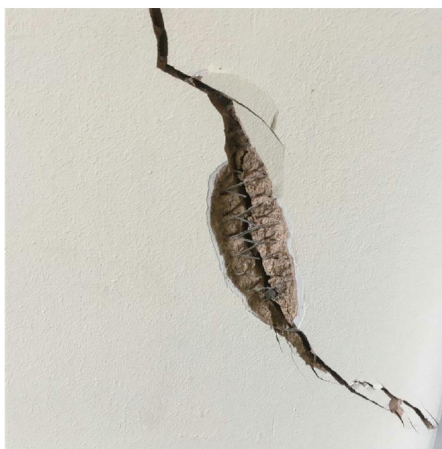
8mm diagonal crack to the wall to Flat 2, extends over front window

Close up of crack in the entrance lobby showing evidence of past repair

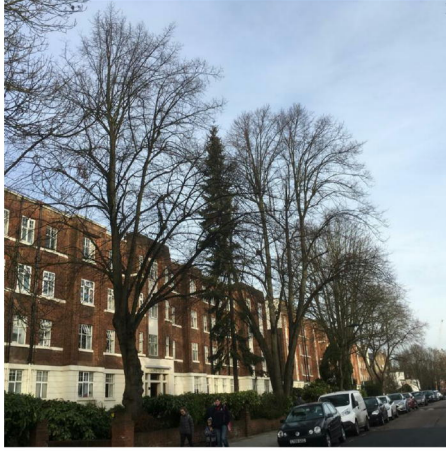
The timing of the event, the presence of shrinkable clay beneath the foundations and the proximity of vegetation where there is damage indicates the shrinkage to be root induced. This is a commonly encountered problem and probably accounts for around 70% of subsidence claims notified to insurers.

Trees in the front of the building.

Although the cause of the movement needs to be dealt with, we note the vegetation is in a Conservation Area and may be subject to Preservation Orders. Unfortunately, current legislation requires certain investigations to be carried out to support an application for the tree works.

Typically, these investigations would involve trial pits to determine the depth and type of footings, boreholes to determine the nature of the subsoil/influence of any roots and monitoring to establish the rate and pattern of movement. The monitoring data provided must be sufficient to show a pattern of movement consistent with the influence of the vegetation and therefore it may be necessary to carry out the monitoring for up to a 12 month period.

It will also be necessary to obtain a specialist Arboricultural Report.

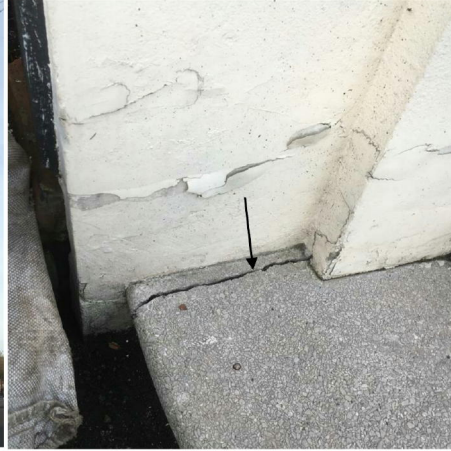
Damage to front steps at main entrance

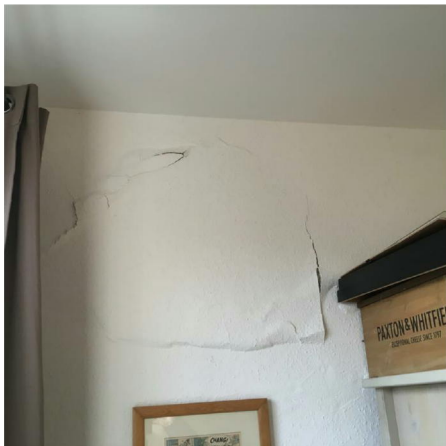
Crack behind wardrobe against left flank wall, possibly 10mm width

Cracking in Flat 28 Right hand end bedroom

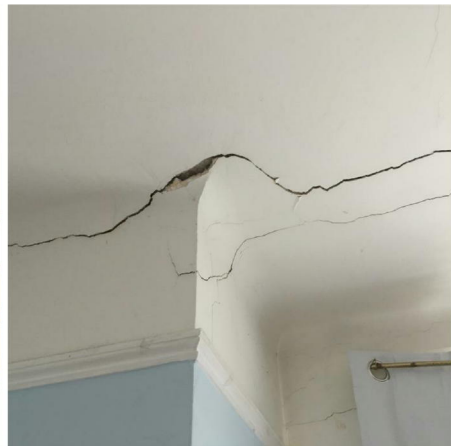
Cracking in Flat 2
