**ADDENDUM TECHNICAL REPORT**

**Gilling Court (Hampstead) Ltd  
Flat 2 Gilling Court  
Belsize Grove  
Hampstead  
London  
NW3 4UY**

**SUBSIDENCE CLAIM**

DATE 11 August 2017

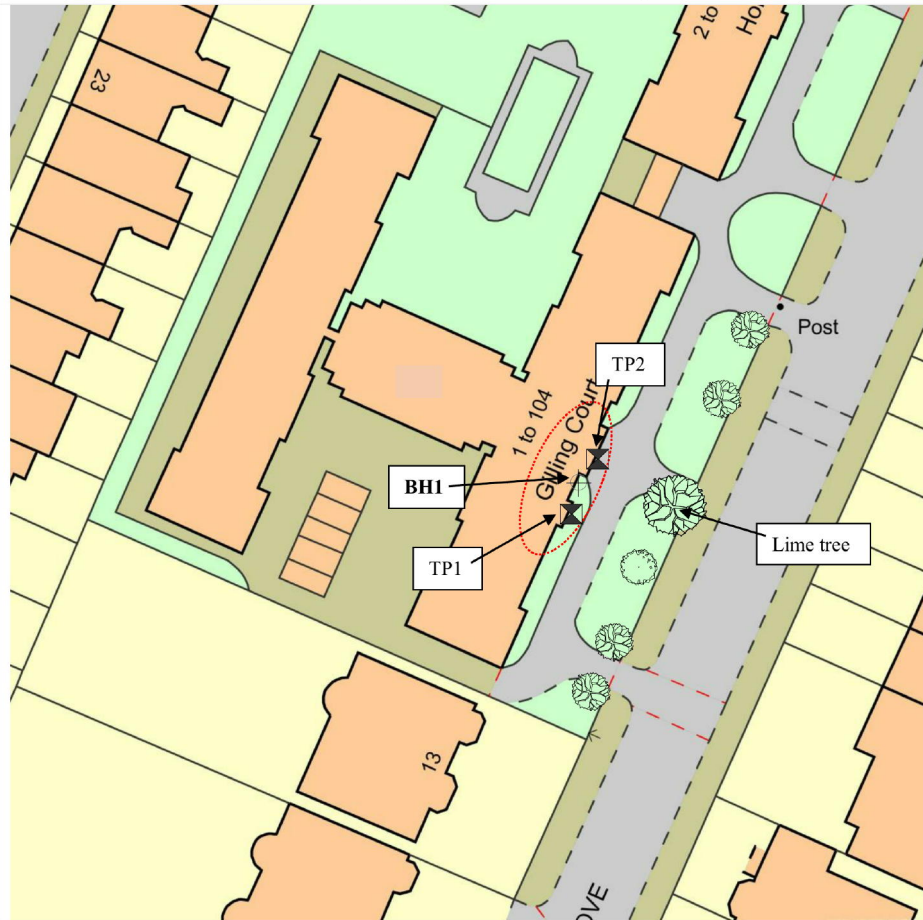
**Site Plan**

Area of Damage
