Arboricultural Appraisal Report

Subsidence Damage Investigation at:

Flat 2, Gilling Court
 Belsize Grove
 Hampstead
 London
 NW3 4UY

CLIENT:	Crawford & Company
CLIENT REF:	SU1604808
MWA REF:	SUB170818-1673
MWA CONSULTANT:	Andy Clark
REPORT DATE:	30-08-2017

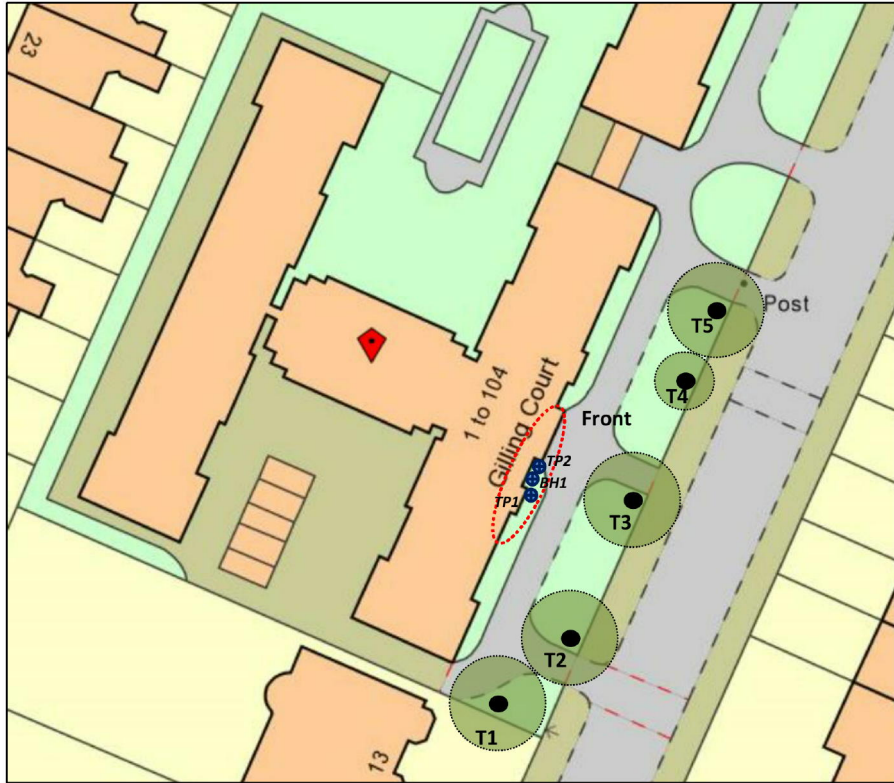
SITE PLAN

Approximate areas of damage

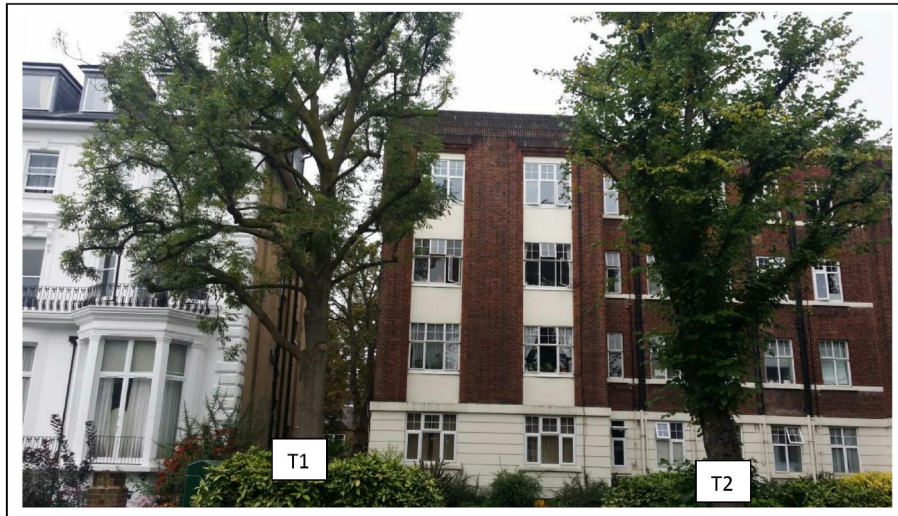
View of T1 Ash and T2 Lime

Tree No.	Species	Ht (m)	Dia (mm)	Crown Spread (m)	Dist. to building (m)	Age Classification	Ownership
T2	Lime	14.5	600	7.0	10.4	Younger than property	Policy Holder
Management history		Crown reduced in recent past – regrowth appears <1yr Moderate basal and epicormic growth					
Recommendation		Fell to ground level and treat stump to inhibit regrowth					
T3	Lime	20.5	Ms [x4] 400	14.0	11.1	Younger than property	Policy Holder
Management history		Pollarded in past @ approx. 15m – regrowth appears <10yrs Included unions @ main stem fork cluster					
Recommendation		Fell to ground level and treat stumps to inhibit re-growth

Tree No.	Species	Ht (m)	Dia (mm)	Crown Spread (m)	Dist. to building (m)	Age Classification	Ownership
T1	Ash	15.5	530	7.5	6.8	Younger than property	Policy Holder
Management history		Crown reduced in recent past – regrowth appears <1yr					
Recommendation		Fell to ground level and treat stumps to inhibit re-growth. The tree is too close and is an inappropriate species for its location.					
T4	Cherry	12.5	350	3.5	11.2	Younger than property	Policy Holder
Management history		Leaning stem and asymmetrical crown growth habit Crown reduced in recent past – regrowth appears <1yr					
Recommendation		Do not allow to exceed current dimensions through a programme of regular [triennial] pruning					
T5	Horse Chestnut	13.5	870	11.0	11.4	Younger than property	Policy Holder
Management history		Pollarded in past @ approx. 5.5m – regrowth appears 10> yrs Moderate stem decay at old pollard points					
Recommendation		Do not allow to exceed current dimensions through a programme of regular [triennial] pruning

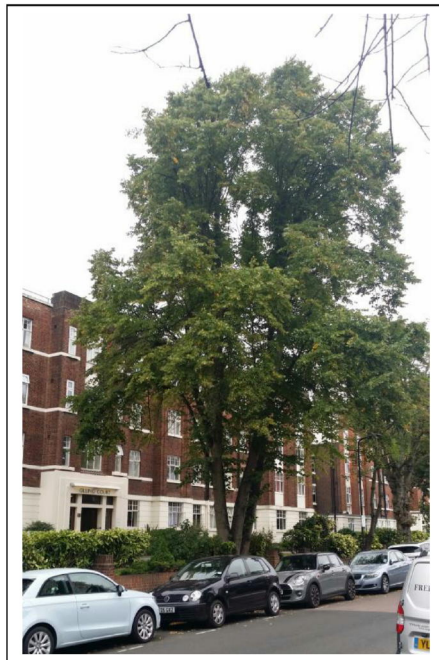
Roots were observed to a depth of 4.0m bgl in BH1 and recovered samples have been positively identified (using anatomical analysis) as *Tillia* spp. and *Berberis* or *Mahonia* spp., the origin of which, given their relative proximity to the property, will be T3 Lime, confirming the influence of this trees on the soils below the foundations. The recorded *Berberis* or *Mahonia* spp. roots will relate to small nearby shrubs which are not considered to be relevant. Irrespective of the root identification however, the roots of T1, T2, T4 and T5 are also likely to have a significant presence below the foundations of the property given their size and relative proximity to the structure.

View of T3 Lime

Based on the technical reports currently available, engineering opinion and our own site assessment we conclude the damage is consistent with shrinkage of the clay subsoil related to moisture abstraction by vegetation. Having considered the available information, it is our opinion that T3 Lime is the principal cause of the current subsidence damage with T2 Lime also being contributory. If an arboricultural solution is to be implemented to mitigate the current damage and allow the soils beneath the property to recover to a position such that an effective repair solution can be implemented we recommend that T2 and T3 are removed.
