ACLAND BURGHLEY SCHOOL
CONSERVATION & HERITAGE REPORT

INTRODUCTION

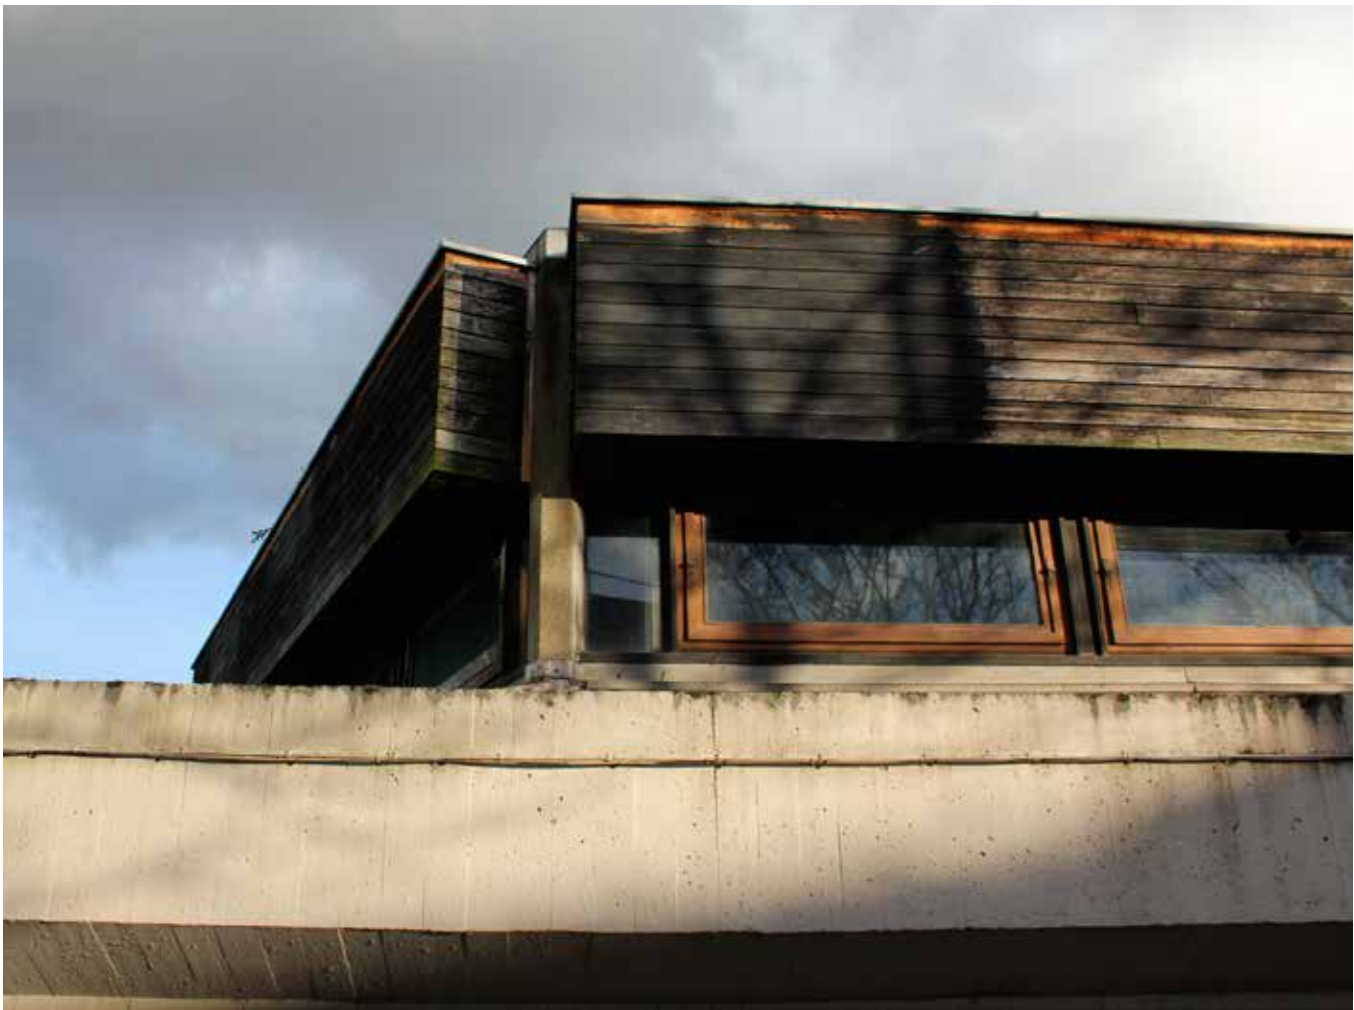
9.2 This photograph shows the timber cladding to the upper part of the assembly hall. The original boarding is heavily weathered and in need of refurbishment. The original timber windows with metal brackets are also in need of a careful restoration but do not appear in too bad a condition.

9. The timber cladding at roof level and fly tower of Assembly Hall - partial replacement of decayed timber and re-varnishing. Varnish to complement wooden surrounds of clerestory windows.

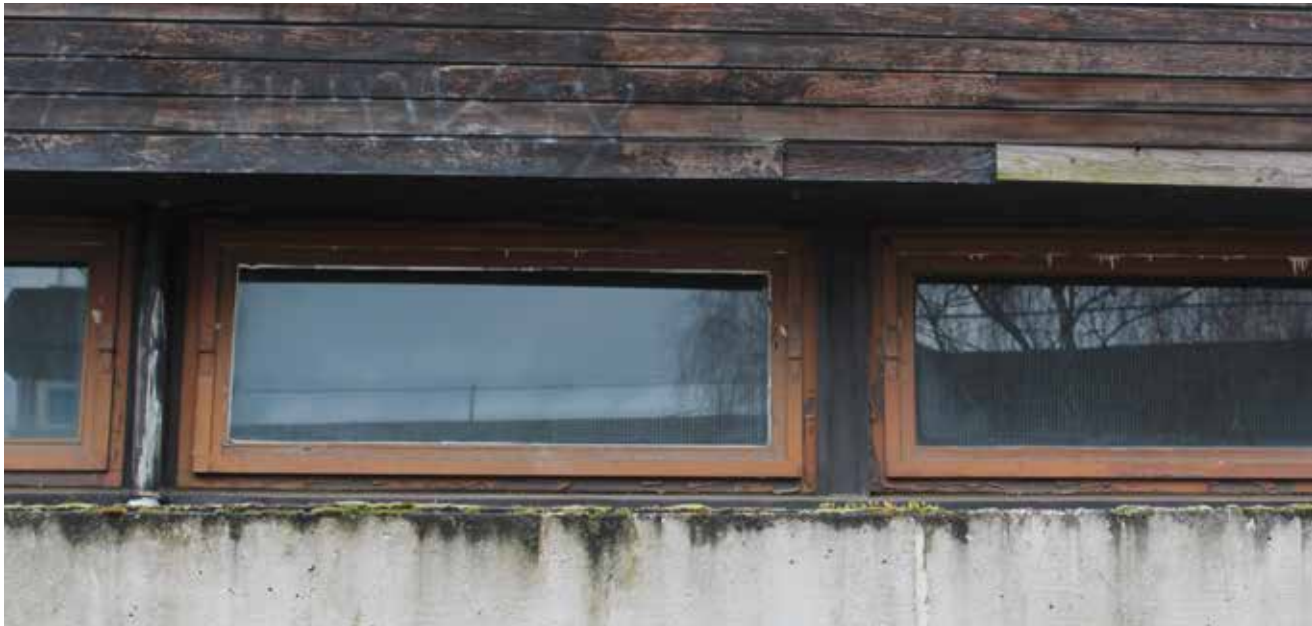
9.5 A close up view of the high level clerestory windows of the assembly hall.

3. Clerestory Windows to Assembly Hall - refurbish and add new blinds/opening mechanisms - retain the glazing units rather than replace, ensure new mechanisms complement the original building design.

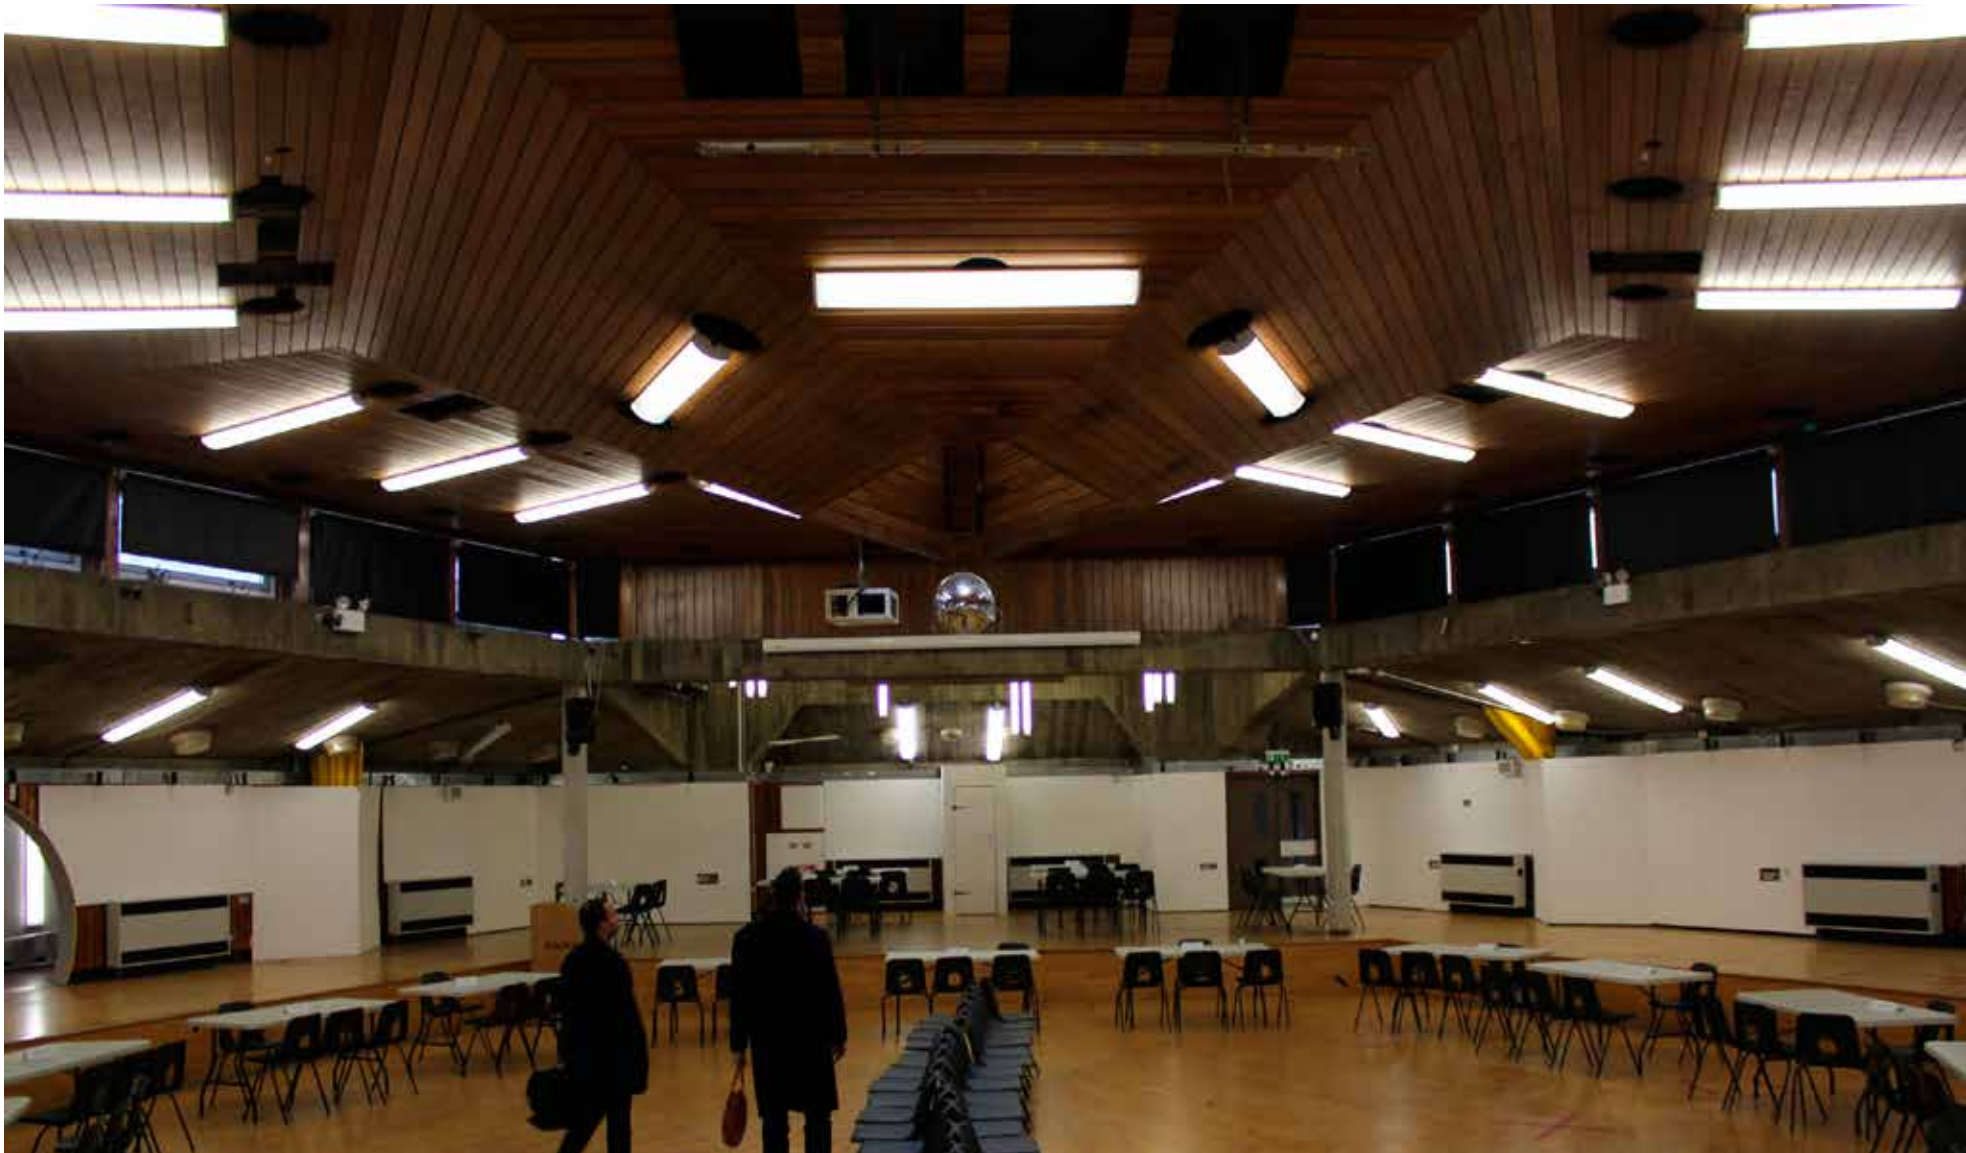
10.1 View of the main hall showing modern lighting and circular holes in the timber ceiling where the original light fittings have been removed. Note the clerestory glazing with modern blinds to the upper level and white boarding to the ground level, covering over the original timber cladding.

Whilst not included in the current proposed scope of works, we see huge potential for incremental enhancement of the heritage assets through the removal of insensitive accretions, such as the recent Assembly Hall lighting, and the repair of original features. These could include inset lighting, and the timber battens around the periphery, while deleterious alternations such as the wall view holes could be ameliorated through sensitive design.

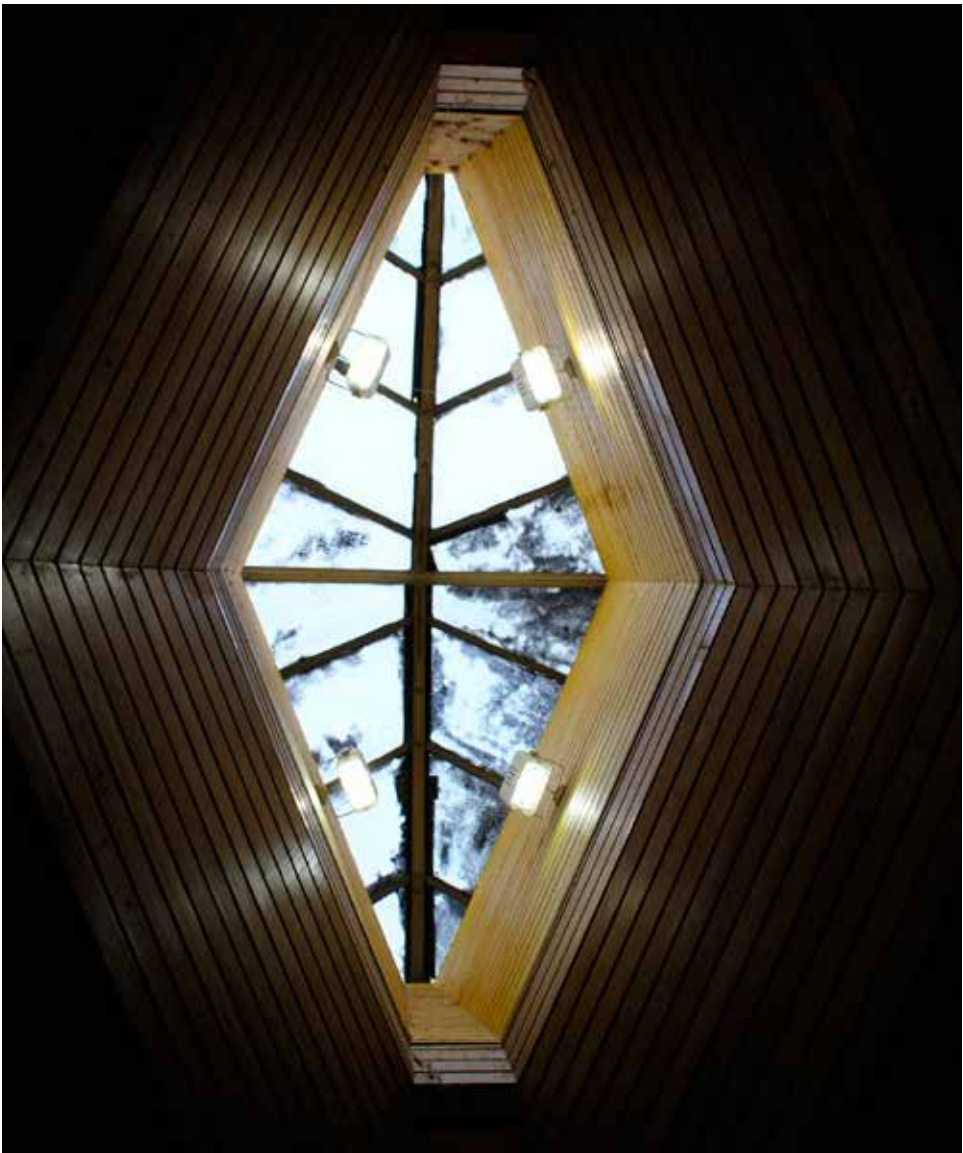
10.2 The central lantern to the assembly hall roof currently leaks and is in need of attention.

1. Replacement Lantern Light to Assembly Hall and skylight to T4 classroom - The original lantern is life expired and lets in rainwater - double glazed replacements are proposed to match original design with reference to original architectural drawings, and aluminium frames.

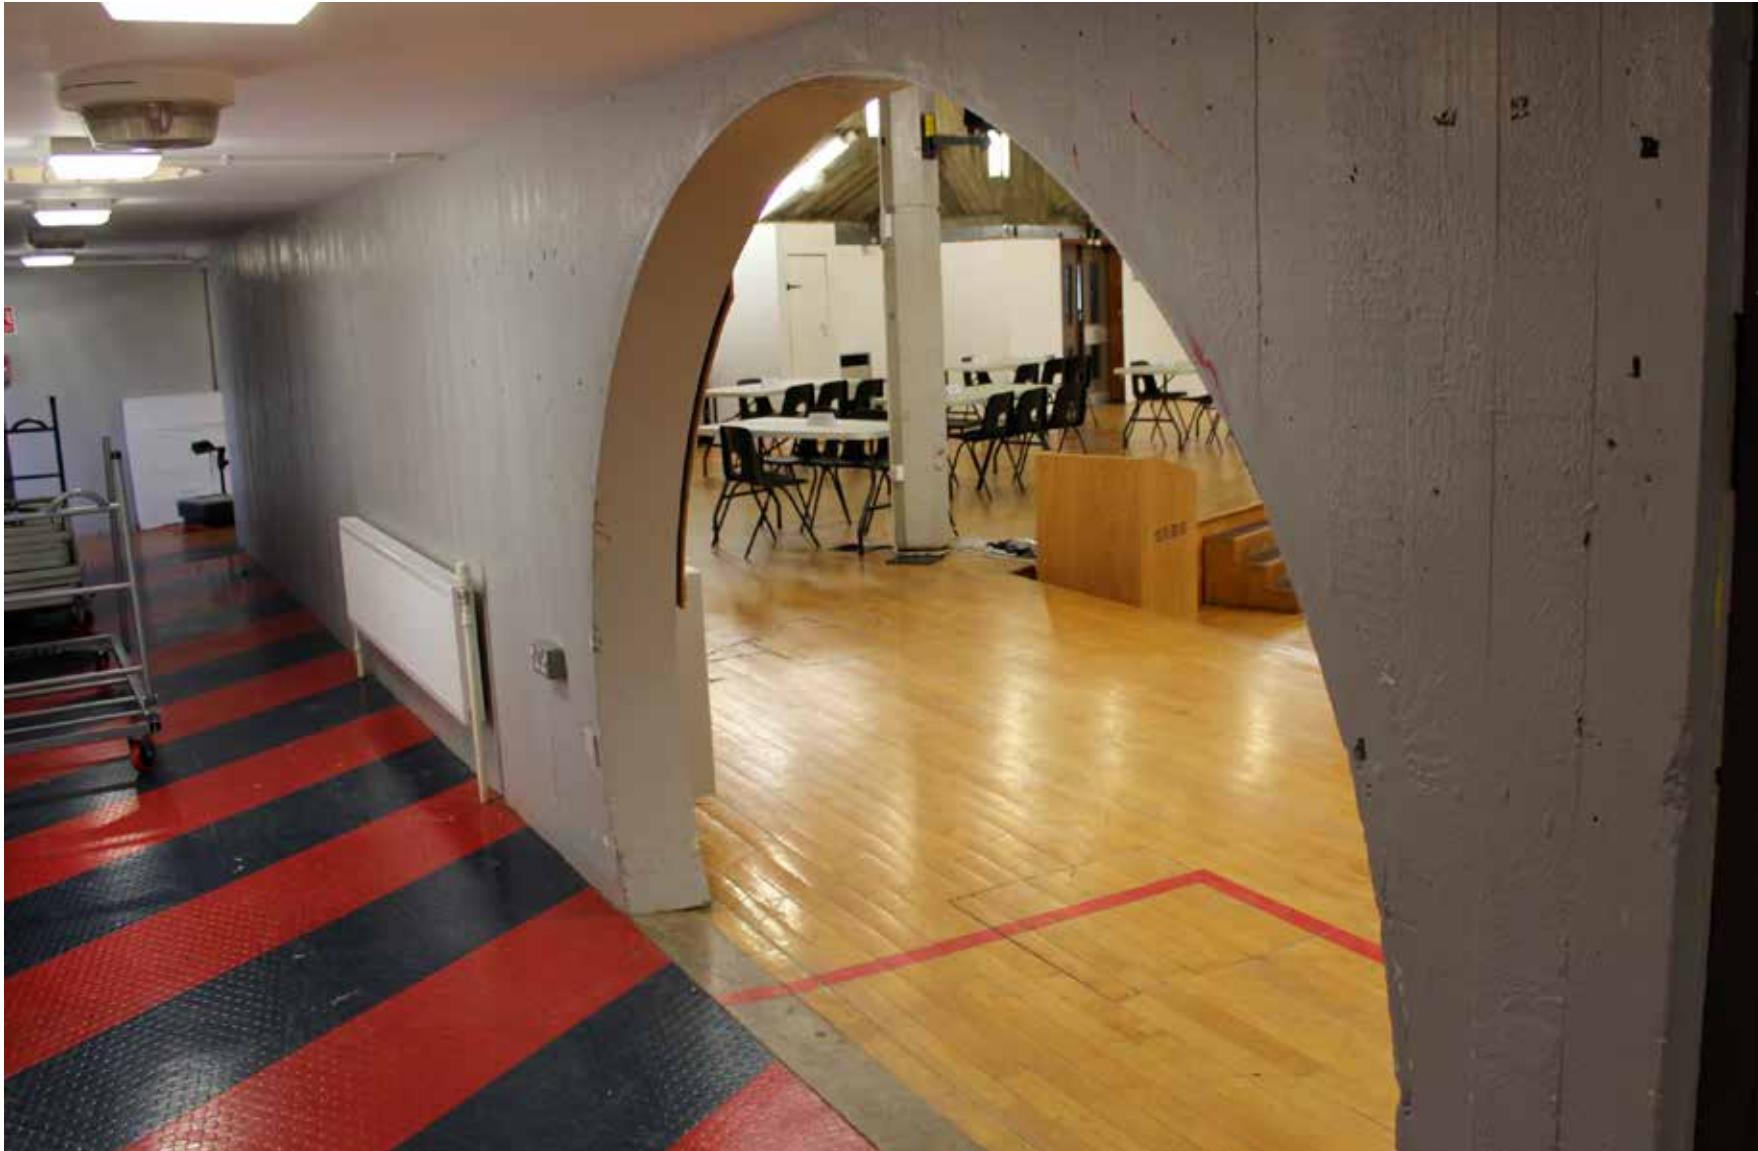
11.1 One of several circular apertures cut through the concrete wall of the assembly hall as part of the 'Schools for the future' pilot initiative.

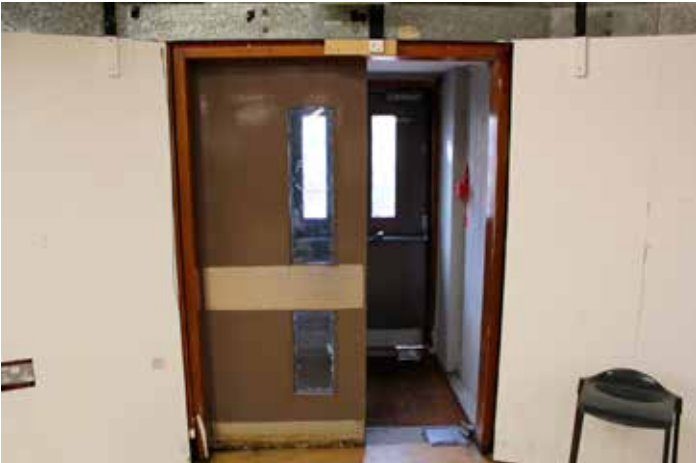
11.5 Original exit doors from the assembly hall.

4. Replacement rooflights to circulation corridors in Assembly Hall - replacements to duplicate polycarbonate originals.
5. External Fire Escape Doors to Assembly Hall - Overhaul 4 No. existing painted timber emergency exit double doorsets - reference drawings and pictures of originals, consider reinstating original external handrails (now lost). Research and duplicate the original paint finishes.

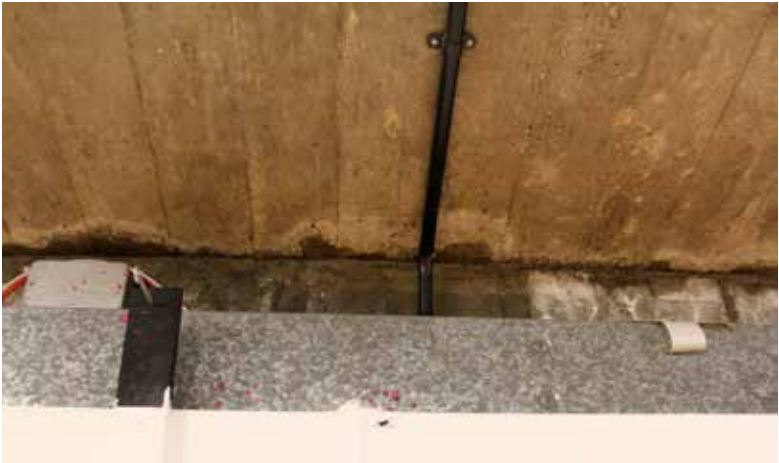
11.6 Signs of damp to the south-east side of the hall at ceiling level.

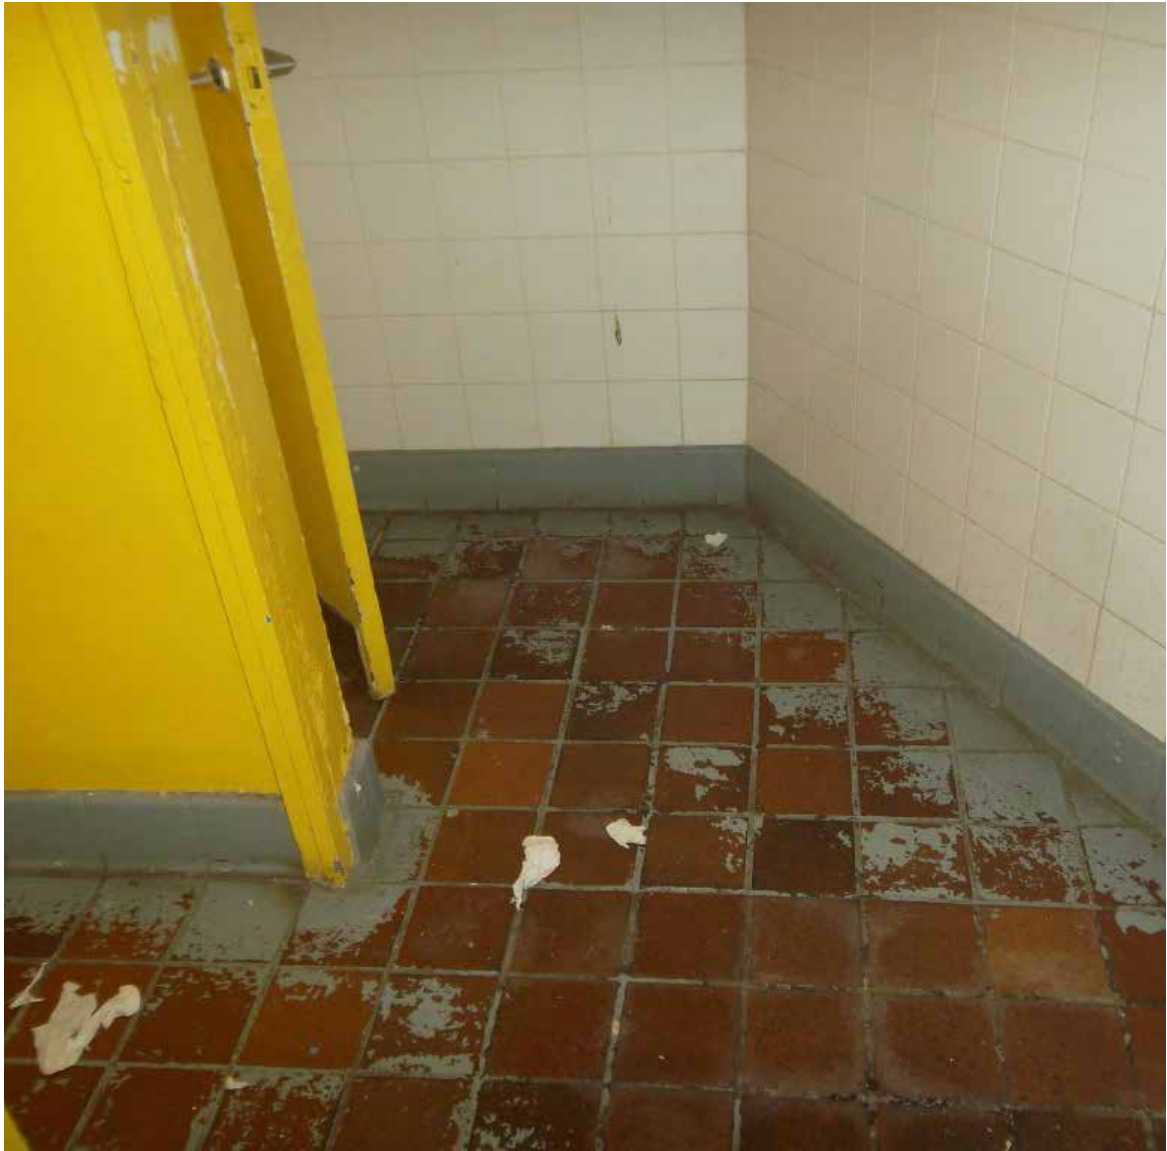
12.2 The original quarry tiled floor is intact to both toilets. These could be cleaned of paint and retained as a heritage feature.

7. Female Toilet (currently out of use) - refurbish to modern standard retaining original features where possible, including quarry floor tiles, wall tiles and signage. New sanitaryware and sinks to be sympathetic design to date of original building. Re-use the original sanitaryware if possible.

8. Male Toilet (currently out of use) - refurbish to modern standard - retaining original features where possible, including quarry floor tiles, wall tiles and signage. New sanitaryware and sinks to be sympathetic design to date of original building. Re-use the original sanitaryware if possible.

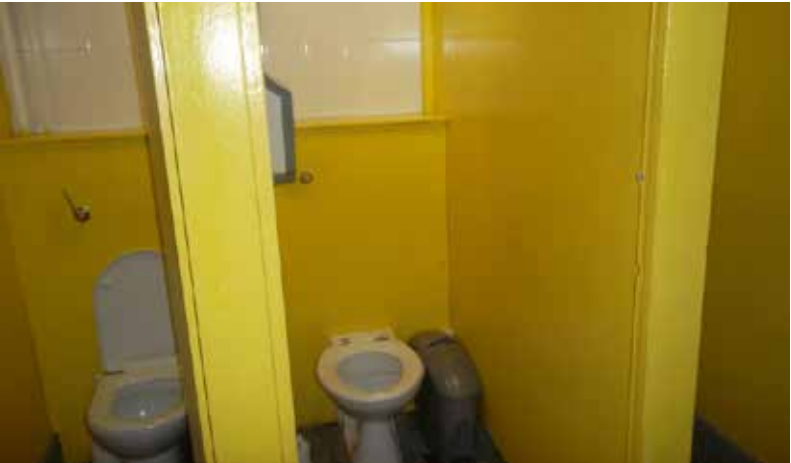
12.6 The original toilet cubicle partitions survive to both toilets. This photo shows an original style toilet to the right and a modern replacement to the left.

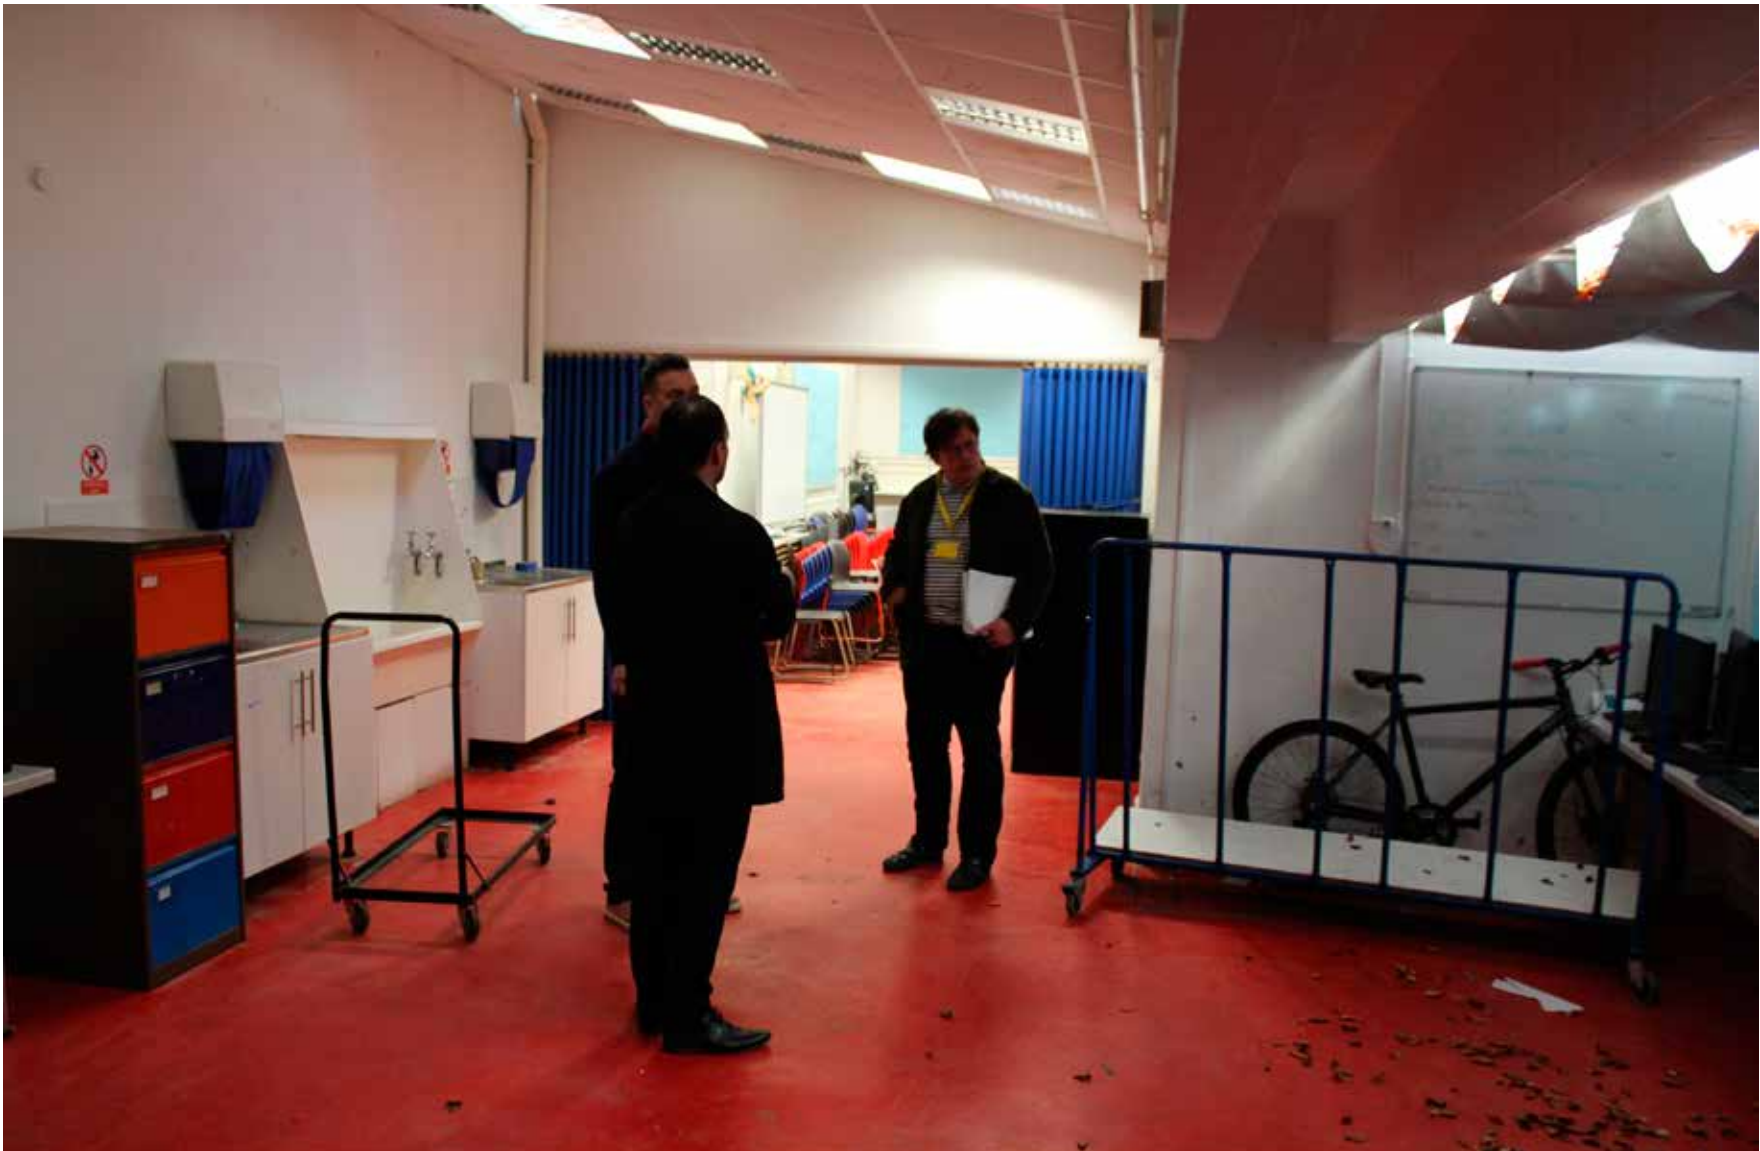
13.2 This photograph shows how the glazed roof is currently obscured by blinds, to the right of this image, and a suspended ceiling, to the left. The life expired glazed roof to this classroom is to be carefully replaced in its entirety.

2. Replacement Patent Glazed Roof and Valley Gutter Linings to Textile Classroom (former drama studio) - new double glazed roof to a design matching the original, with aluminium frames to match the original finish.

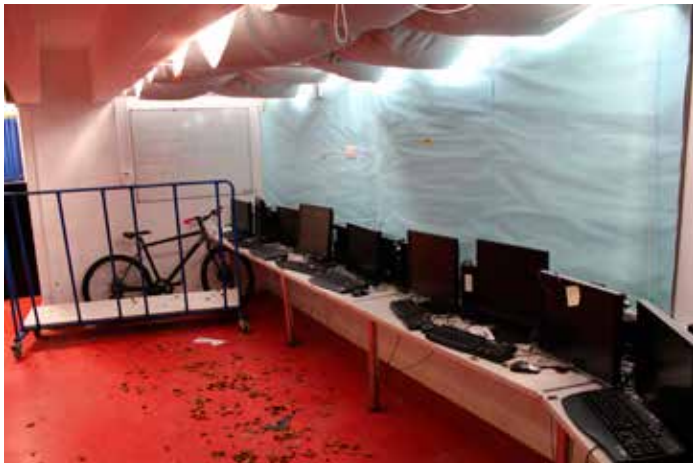
13.3 Leaves on the floor of the computer area caused by the damaged skylights above.

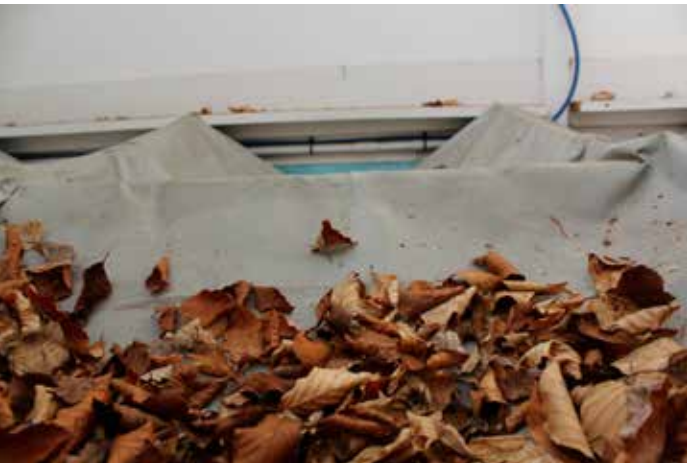
13.5 A collection of leaves on top of the sun blinds caused by damaged skylights.

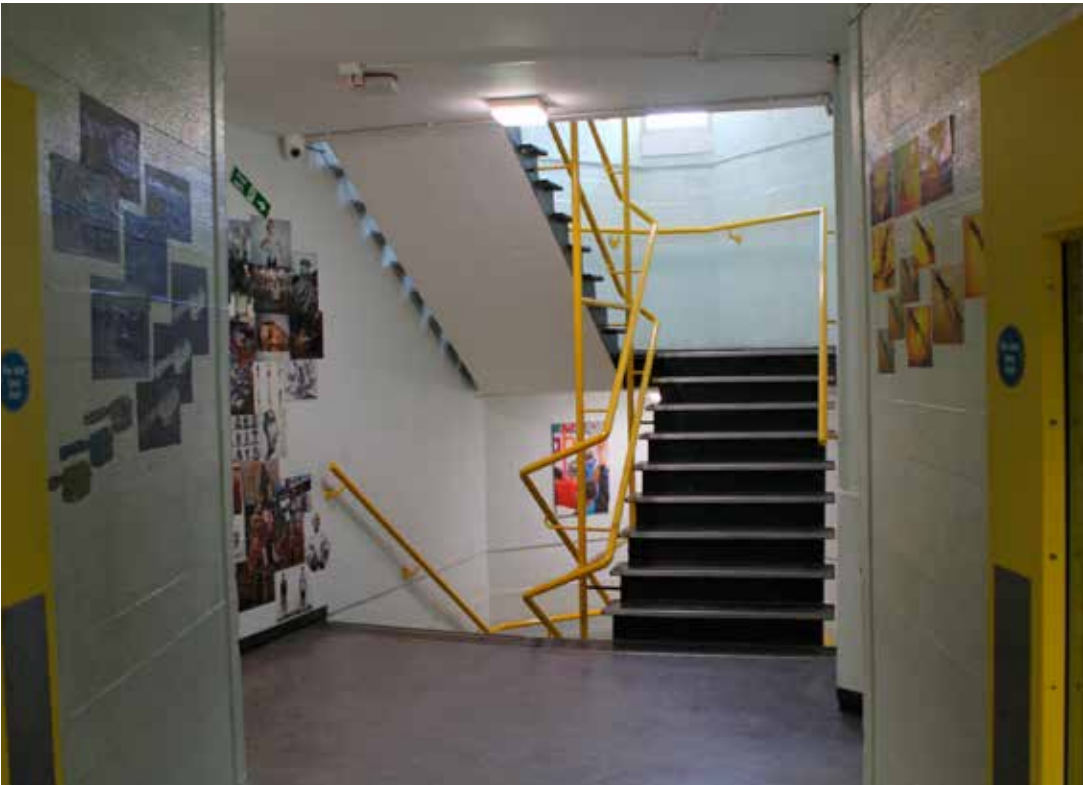
14.4 The painted steel balustrade and handrail to the stair cores is original to the building. These are to be retained and repainted where necessary.

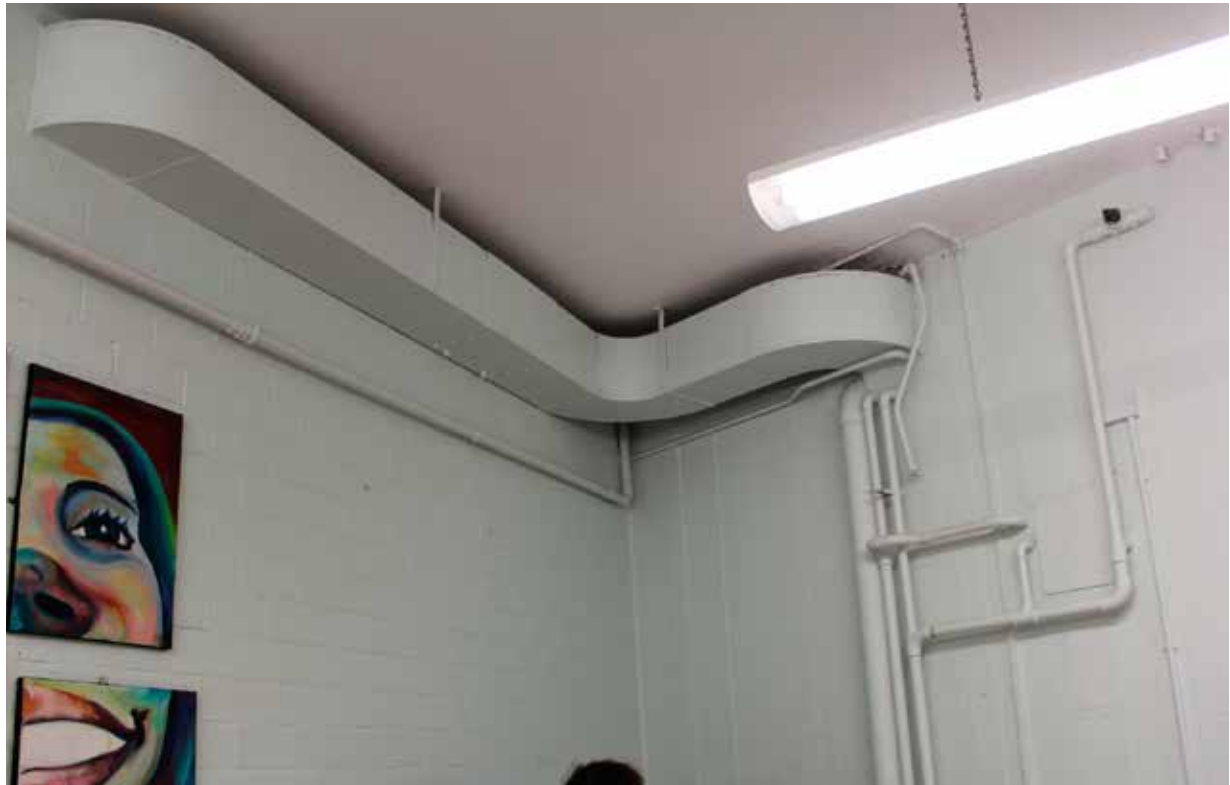
14.5 Existing surface mounted services conduits to a meeting room at ground level. Where new conduit / trunking is installed, these can be 'painted in' to match the wall finishes to minimise the visual intrusion.

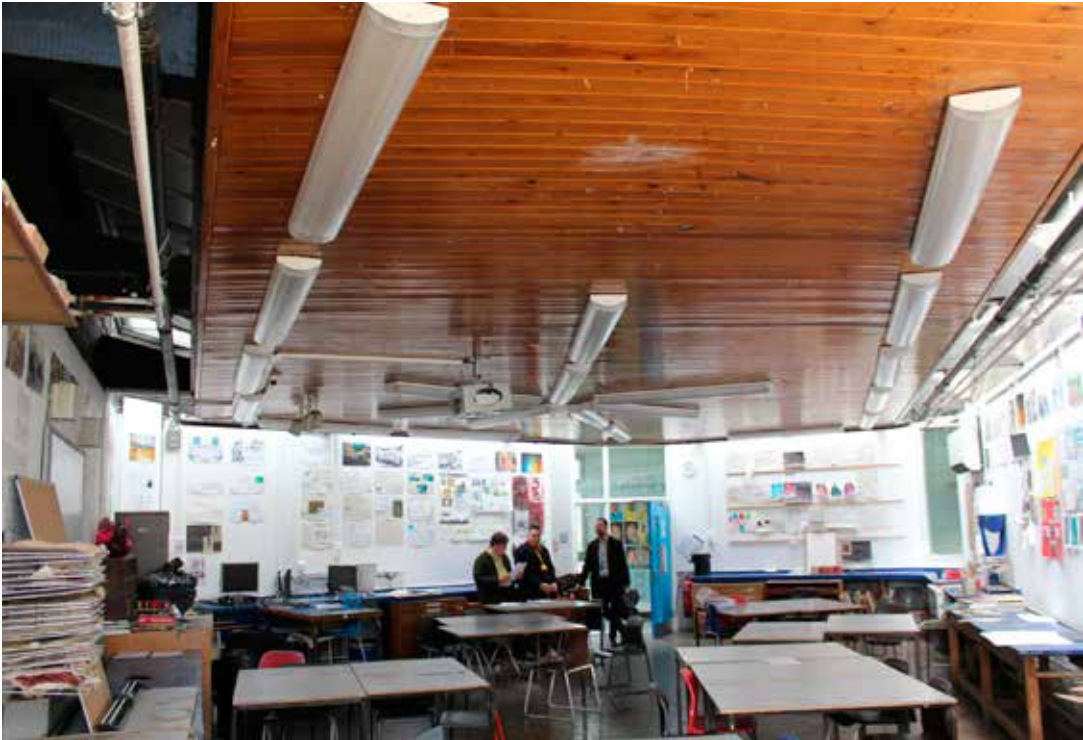
15.2 The original timber roof to the art room. Note the inappropriate modern strip lighting, also used in the assembly hall which detracts from the original design.

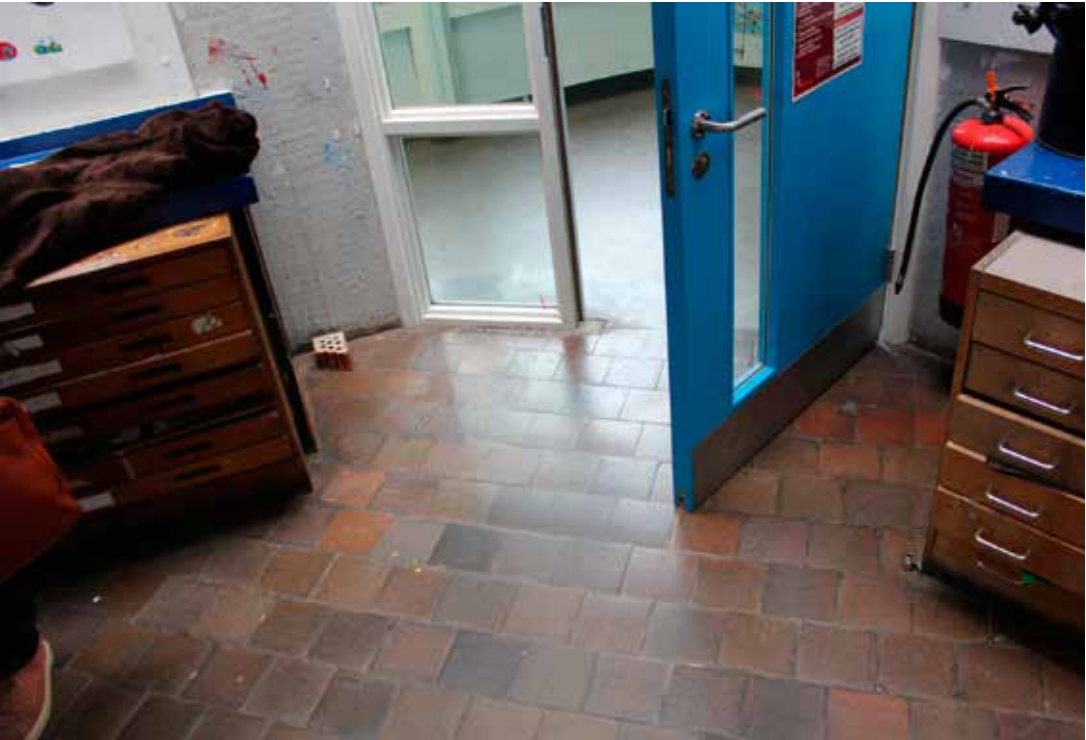
15.3 The original quarry tiled floor to the art room. These tiles are to be cleaned and retained where possible throughout the building and celebrated as an attractive heritage feature.

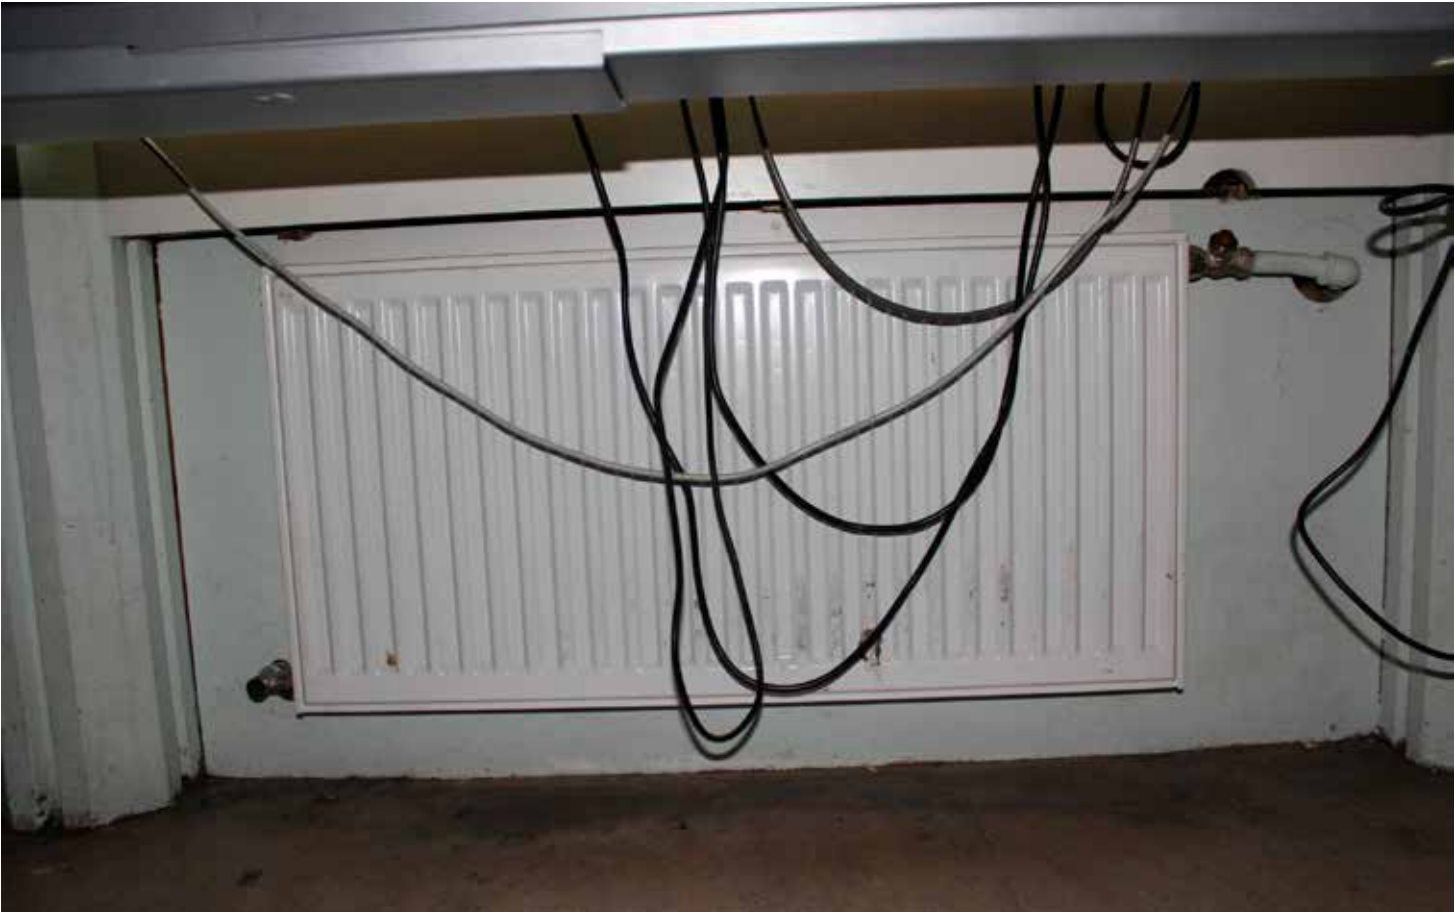
15.5 A typical classroom radiator with concealed pipework to the rear. The existing painted timber board is to be upgraded with a new fire rated Supalux cladding panel. The proposed improvements can help with cable management.

16. Replacement pipework within the classroom services voids, including replacing the panels that the radiators are fixed to below the windows.
17. Replacement of the sub-mains distribution boards and electrical rewires which will require new PVC tubular conduit and PVC dado trunking to classroom areas.
