ROYAL PARKS QUADRENNIAL SURVEY 2014

THE GOTHIC FOUNTAIN, REGENT'S PARK

ASSET NO: REP12

July 2014 (Revision 1 February 2015)

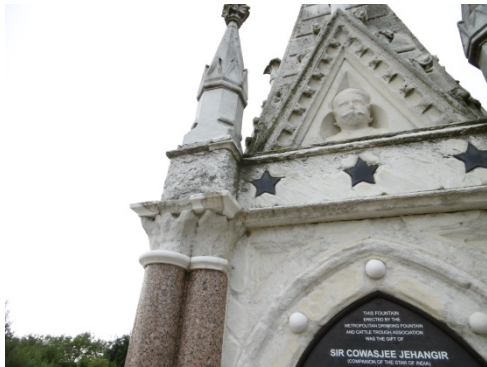
The marble spire and corner pinnacles have had new marble indents to various areas and some pinnacles and florettes have been replaced with new carved marble. There are however areas of marble to the spire and pinnacles that look to be open textured and may be friable. Areas of marble to the south especially are showing signs of spalling and small amounts of algae growth are visible around the spire. There are some quite small cracks to the marble base under the spire that may be traps for water. The finial to the western face of the spire is missing and moulded detail to original stonework is deteriorating. The glass pane to the clock on the northern face is cracked and requires replacing.

Fig. 1 - Friable original marble

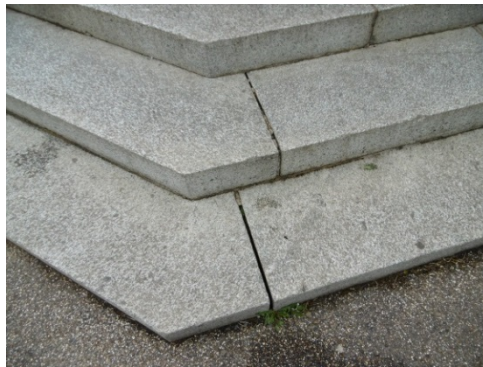
The stepped podium on which the monument stands has open joints to several areas. Granite stepping blocks are lightly worn, with chipped corners to some blocks.

Fig. 2 - Open joints to steps

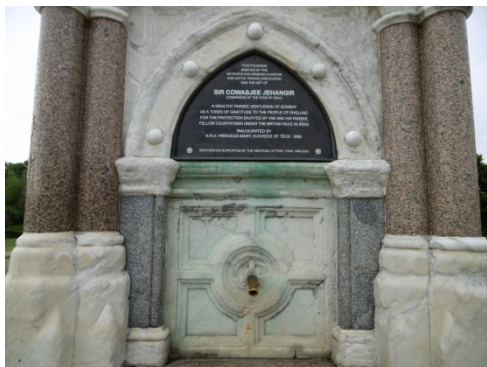
Fig. 3 - Green staining beneath plaque

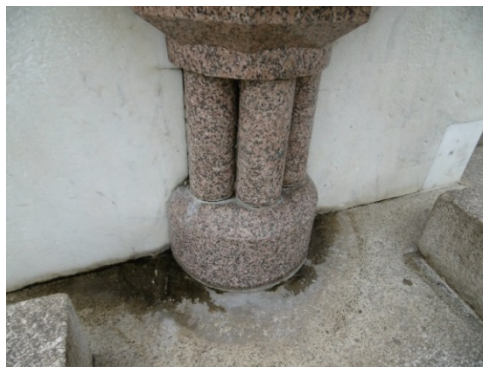
Fig. 4 - Limescale build up at the base of pedestals is in a better condition than previously reported and appears to have been cleaned

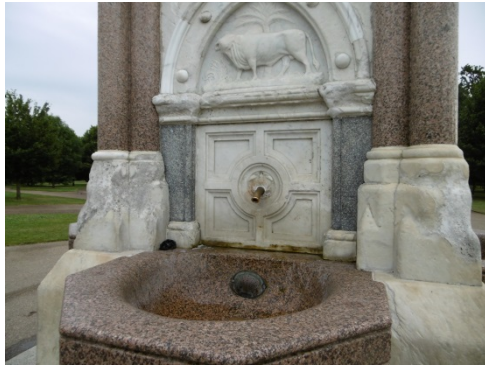
there is iron staining on the marble at the outlet position, possibly due to corrosion of internal iron or steel pipework.

Fig. 5 - Ferrous staining around pipes

All elevations	Bronze spouts	There is iron staining to the white marble around the spout pipes and at top of basins	Poultice clean marble.	Specialist Conservator	P3	Approx 1m2	£150.00		
All elevations	Drinking fountains	The drinking fountains were not functioning during the survey.	Fountain specialist to carry out maintenance inspection and servicing on water system and drainage	Fountain Specialist	P3	Item	£3,000.00		
All elevations	Steps	There are open joint to the steps.	Point open joints.	Stonemason	P3	Approx 8lin m	£350.00

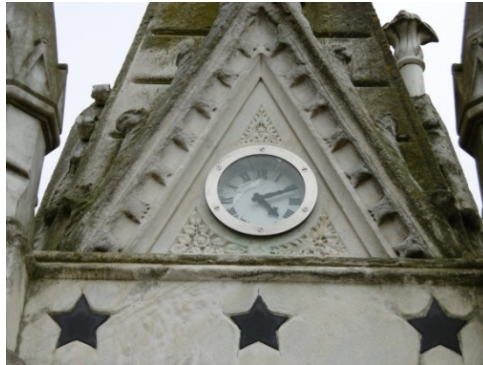
Fig. 6 - Cracked glass to clock

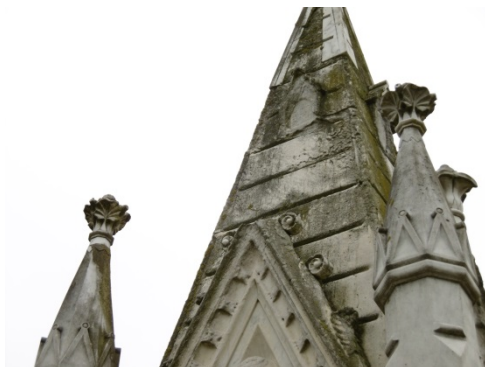
Fig. 7 - Missing finial to east elevation

East elevation	Final	Finial is missing	Replace Finial with new to match existing	Stonemason	P2	Item	£400.00		
East elevation	Spire base	There are several hairline cracks to the marble around the black inset stars.	Resin fill fine cracks with resin/marble repair to prevent ingress of water.	Specialist Conservator	P3	Approx 0.5lin m	£350.00		
East elevation	Plinth/base	There is black ghosting to the marble plinth where black graffiti has been removed.	Poultice clean affected areas to remove last remnants of graffiti.	Specialist Conservator	P3	Approx 0.5m2	£150.00		
South elevation	Spire pinnacles	The marble forming the base of 2 spire pinnacles looks to be very friable and there are several hairline cracks through the marble.	Conservator to inspect marble surface and carry out consolidation of marble surfaces.	Specialist Conservator	P3	Item	£350.00	£450.00	
South elevation	Granite bowl	The underside of the granite bowl has spalling to the edge of the bowl where it abuts the marble base.	Conservator to remove loose granite and consolidate edge with granite/resin compound.	Specialist Conservator	P3	Item	£600.00

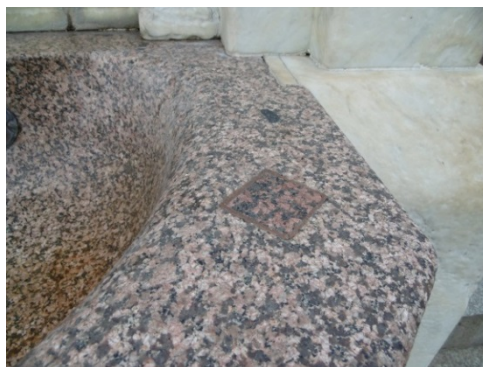
Fig. 8 - Joints to previous piecing in have recently been filled

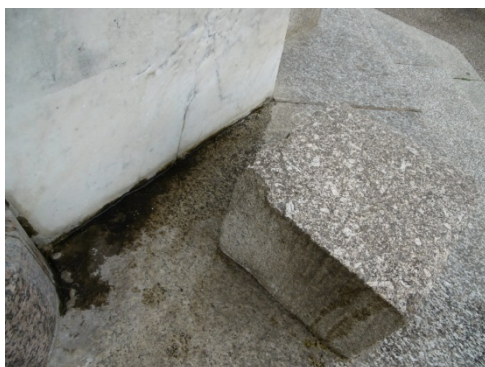
Fig. 9 - Chipped corners to stone stepping blocks
