Our Ref: 8334

FLAT 4, 46 CHALCOT CRESCENT, LONDON NW1: DAMP INGRESS & ASSOCIATED WORKS

FLAT 4, 46 CHALCOT CRESCENT, LONDON

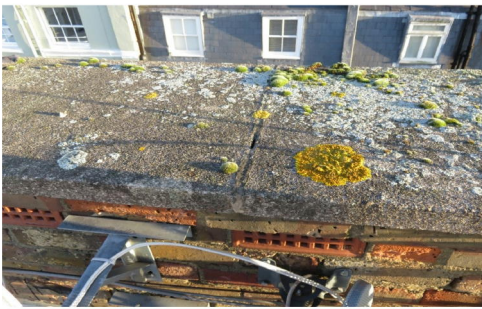
Open joint to coping stone

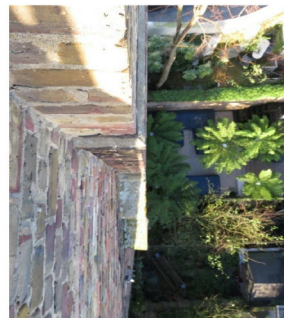
From the limited views available to us at the time, it appears that there are areas of significant dampness affecting the outside of the chimney flues. There is also some "bowing" of the flank wall and loose and missing pointing to the flank wall.

View of flank wall and adjacent garden from above

The wall would need to be inspected and all loose pointing removed and replaced. We would also recommend that Helifix bars be installed at 900mm centres at second and third floor levels and at roof level, to tie the brickwork back into the main building structure. This will need to be done

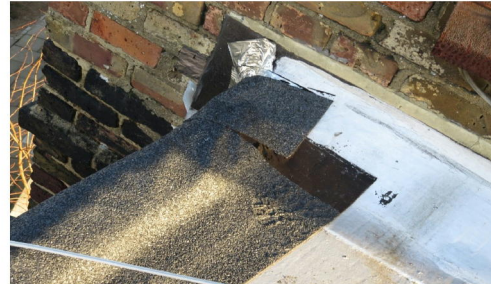
Main roof over no. 46.

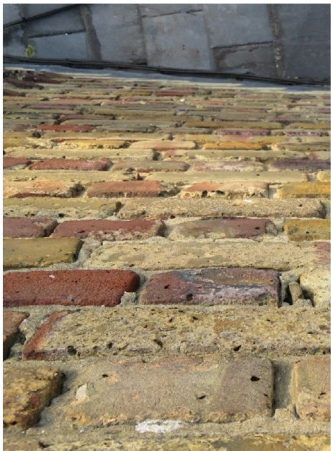
Defective

Defective flashing – note: no upstand at abutment

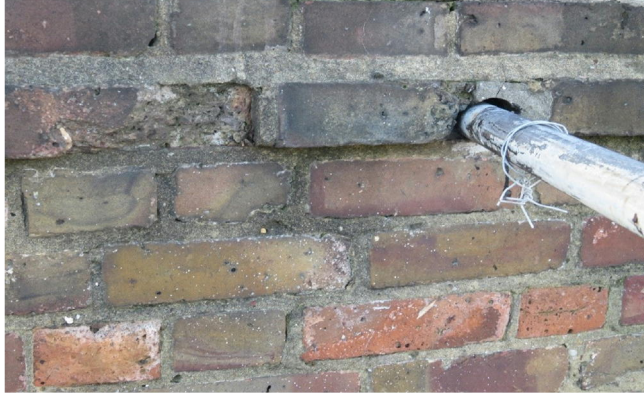
Poorly sealed fixing for handrail

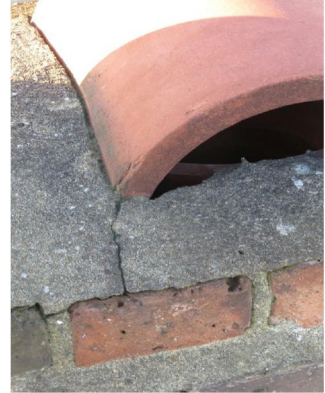
Cracked flue
