## Arboricultural Consultancy for Co-operative Insurance Society

### 1. Case Details

Insured	Mr David Blagbrough	Address	160 Camden Road, London, NW1 9HJ		
Client	Subsidence Management Services	Contact	Danielle Irving	Claim No.	IFS-CIS-SUB-11-0031154
ES Ref	SA-19426	Consultant	Giles Mercer	Contact No.	0330 380 1036
Report Date	18/06/2018 Revised: 18/06/2018

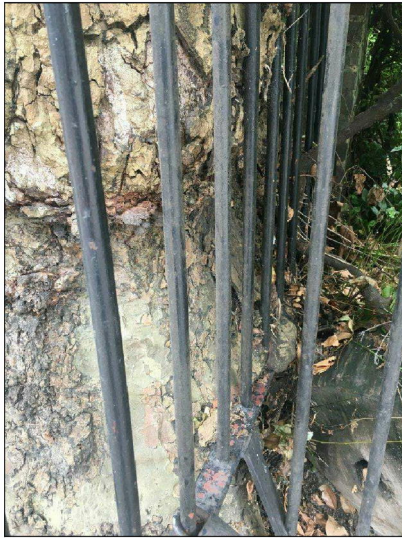
Fence embedded in trunk of T1

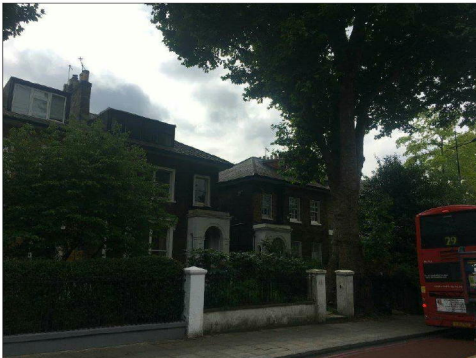
Our survey of the site identified T1 (Plane (London)), given its position relative to the damage it is our opinion that the roots identified within TP/BH1 will emanate from this tree.

In terms of species profile, size and proximity to the damaged structure T1 is therefore, in our opinion the dominant vegetation, the source of the roots identified and accordingly the principal cause of the ongoing damage.

In order to mitigate the current damage and allow soils beneath the property to recover to a position such that an effective engineering repair solution can be implemented, we recommend T1 be removed.

Tree No.	Species	Age Cat	Approx. Height (m)	Distance to Building (m) *	Ownership	Action	Requirement
T1	Plane (London)	2	26	6.4	C - Insured	Remove	Remove close to ground level and treat stump to inhibit regrowth.
Age Cat: 1 = Younger than property; 2 = Similar age to the property; 3 = Significantly older than property
