160 Camden Road, London, NW1 9HJ
Subsidence Management Services

GEOTECHNICAL

Client: Subsidence Management Services
Client Contact: Peter Moore
Client Ref: IFS-CIS-SUB-11-0031154
Policy Holder: Mr David Blagbrough
Report Date: 20 January 2016
Our Ref: C6598G10848

Drainage Investigation Report

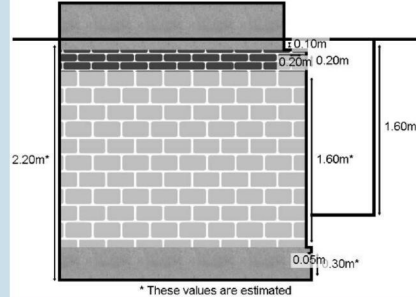
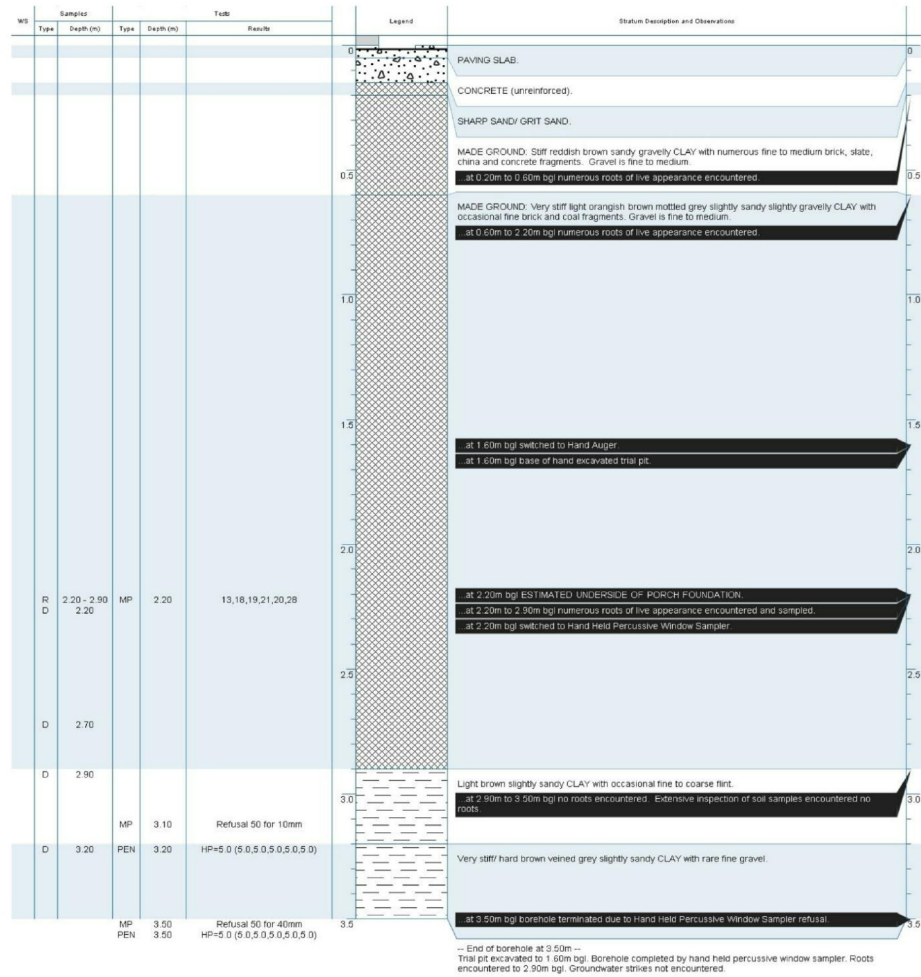
TP/BH1 Foundation Detail and Borehole Log

Porch/ Steps foundation comprised of concrete to 100mm bgl, bearing on brickwork to 300mm bgl with a total projection of 200mm from the elevation. In turn, bearing on concrete blockwork to 1900mm bgl, with a total projection of 200mm from the elevation. In turn, bearing on concrete to an estimated depth of 2200mm bgl, with a total projection of 250mm from the elevation.

Underside of foundation (USF) was estimated by pushing a probe, approximately 200mm back from the face of the foundation, at an angle with no apparent contact with the face of the foundation beyond the estimated depth.

Excavation did not expose the underside of the Porch/ Steps foundation. The underside of foundation (USF) was estimated to be 2.20m bgl in TP/BH1. The underside of the foundation was not exposed or confirmed due to being unable to safely extend trial pit to the underside of foundation (USF).

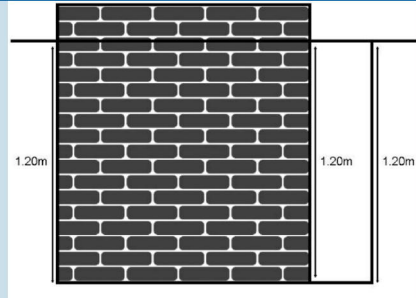
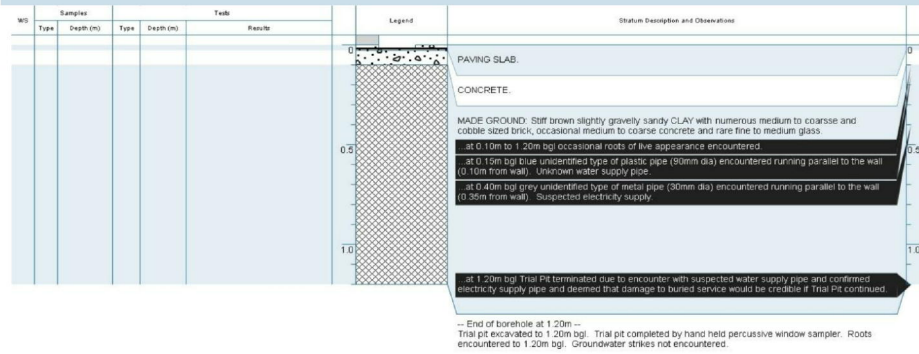
TP2 Foundation Detail and Borehole Log

Addition foundation was partially exposed and comprised of brick wall to a depth of at least 1200mm bgl.

Addition foundation was not exposed or underside confirmed due to buried services within the trial pit.

Addition foundation was partially exposed to 1.20m bgl but the underside of foundation (USF) was unable to be confirmed or checked in TP/2. The foundation was not exposed or underside confirmed due to buried services within the trial pit.

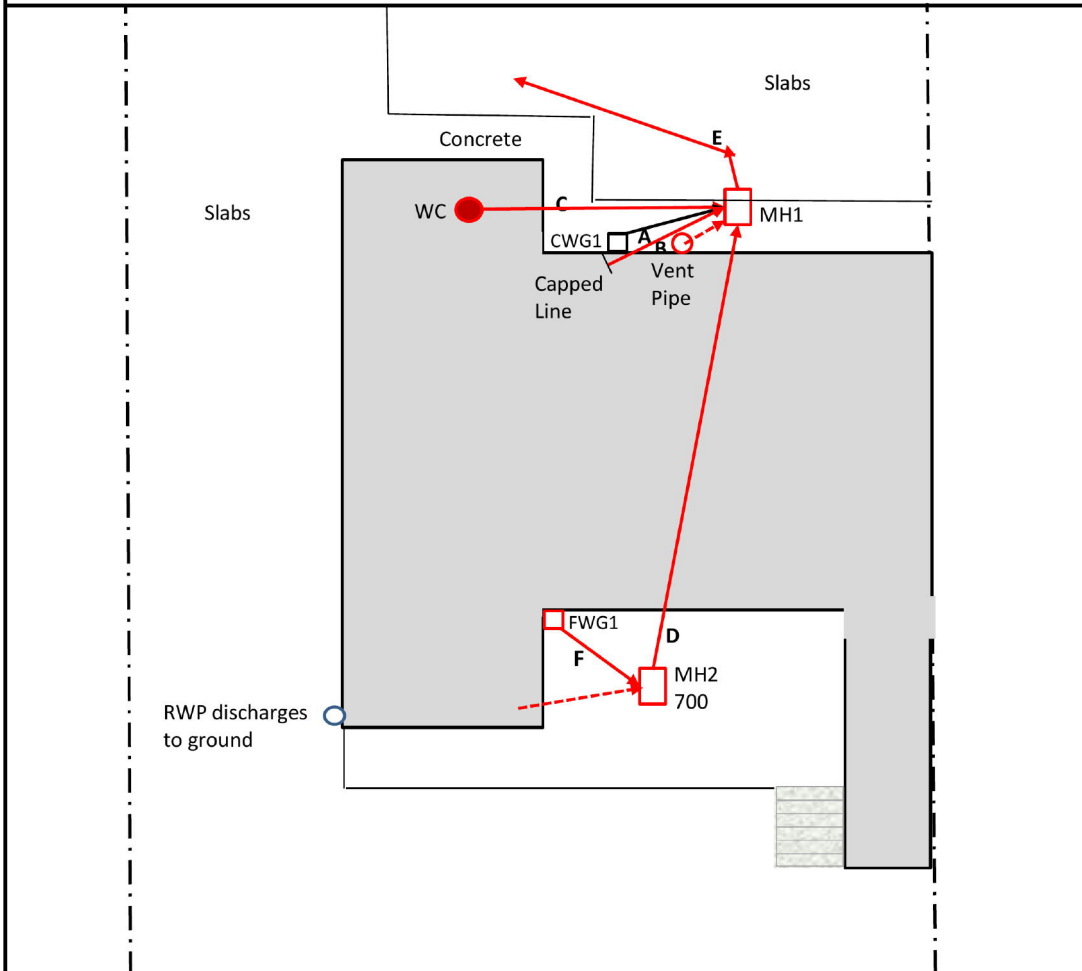
CCTV Survey Result: Structural Damage

Recommended Repair: Cap off line within MH1 using C20P concrete

Recommended Repair: Clean and survey in preparation of lining. Reline from MH1 U/S for a distance of 4.2m. Insert a patch liner on U/S section of liner to seal

Recommended Repair: Remove all encrustation from line. Clean and survey in preparation of lining. Reline from MH1 D/S MH2 a distance of up to 10m

Recommended Repair: Clean and survey in preparation of lining. Insert a patch liner at 2.9m D/S of MH1
