ADDENDUM ENGINEERING REPORT

Our Reference IFS-CIS-SUB-11-0031154
Claim Reference [REDACTED]
Prepared for Co-op Insurance

Report Date 10 May 2018
Policyholder Mr. D. Blagbrough
Claim address 160 Camden Road
London
NW1 9HJ

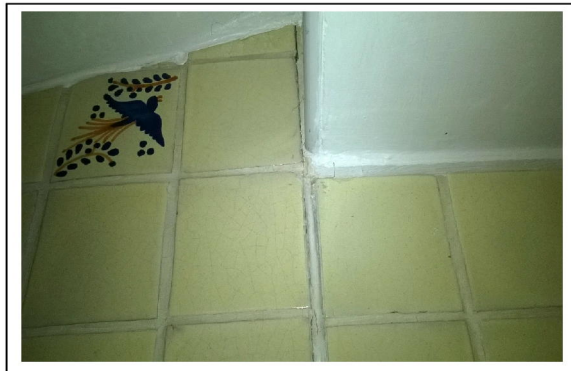
Cracking to Left Hand Wall in Bathroom

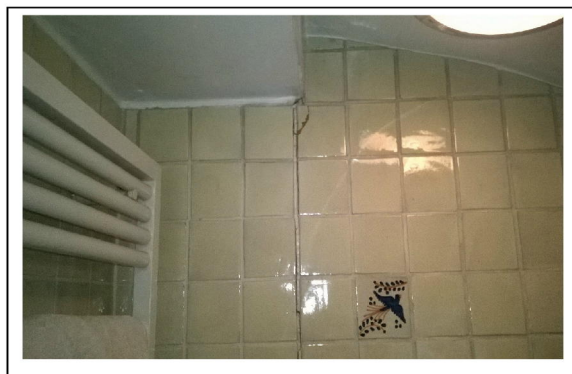
Cracking to Right Hand Wall in Shower Room

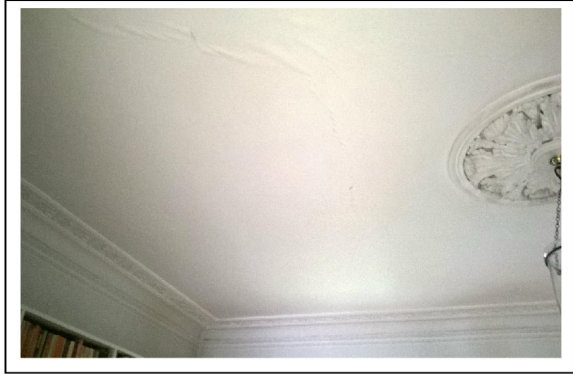
Pulling and Cracking of Kitchen Ceiling

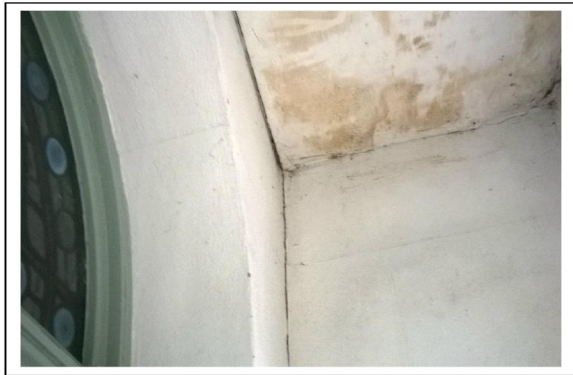
Movement Between House and Porch

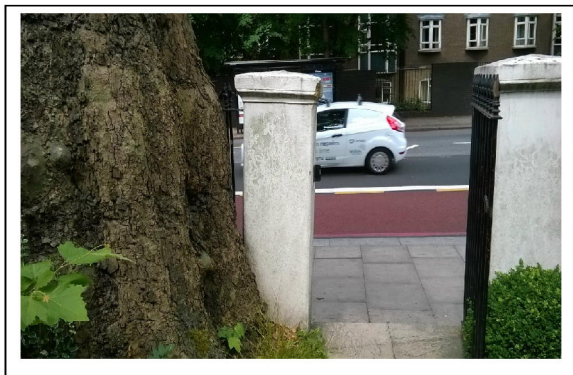
Leaning Gate Pillar | Gate Unable to Close

Given the size and location of the tree it is recommended that it is removed. If it is not removed then the gate pillar will need to be demolished to prevent it from collapsing into the public footpath and the paving will continue to be uneven, representing a trip hazard to anyone visiting the property. The base of the tree is already protruding into the public footpath creating a trip hazard. Further pruning or pollarding may be effective in the short term but in the medium term it will fail as the root system of the

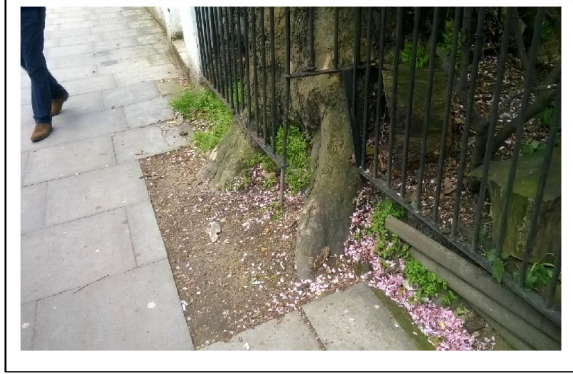
Tree Protruding into Public Footpath

It is strongly recommended that the Plane tree is removed to allow the property to stabilise. Whilst the degree of cracking and movement is not severe, it will continue to recur periodically whilst the tree remains in place, regardless of any pruning regime. In addition the damage to the external landscape will continue whilst the tree is in-situ and the risk of tripping on the public footpath will increase.

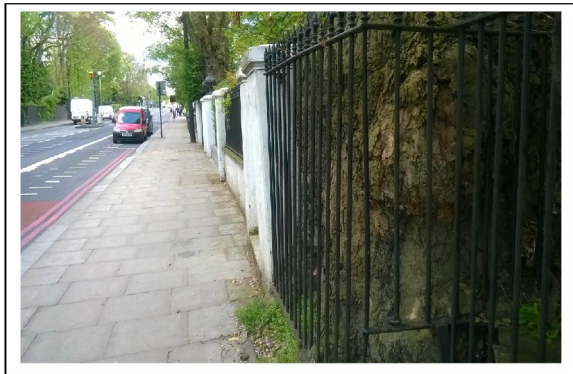
Gate Pillar Leaning into Public Footpath

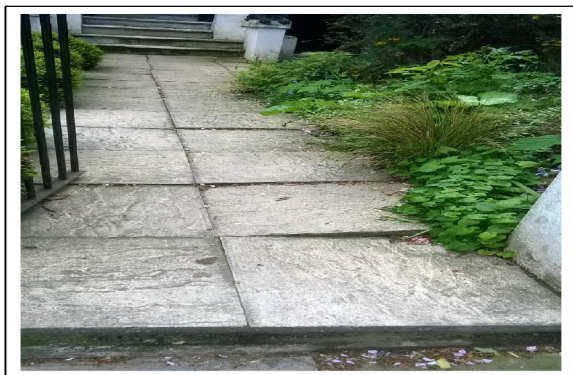
Uneven Paving to Front Path
