Engineer's Report

Our Reference	IFS-CIS-SUB-11-0031154
Claim Reference	[REDACTED]
Prepared for	The Co-operative Insurance

Report Date	30 October 2011
Policyholder	Mr Blagbrough
Address	160 Camden Road, London, NW1 9HJ

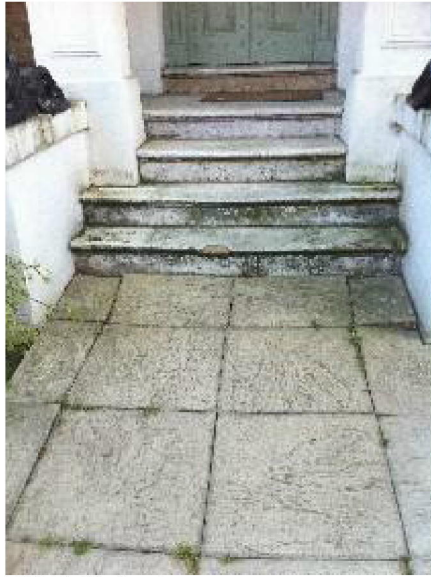
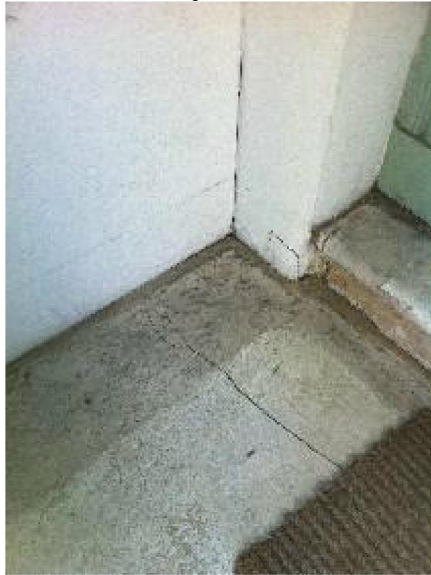
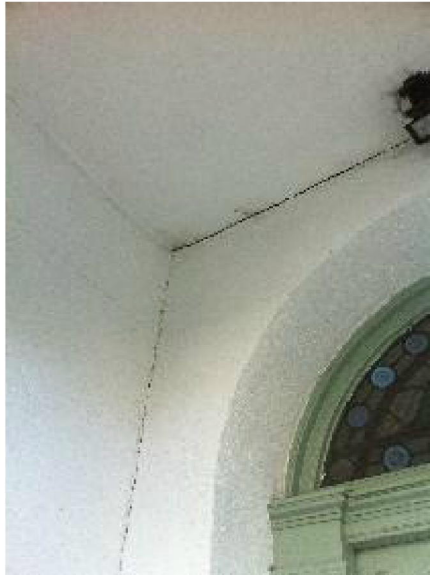
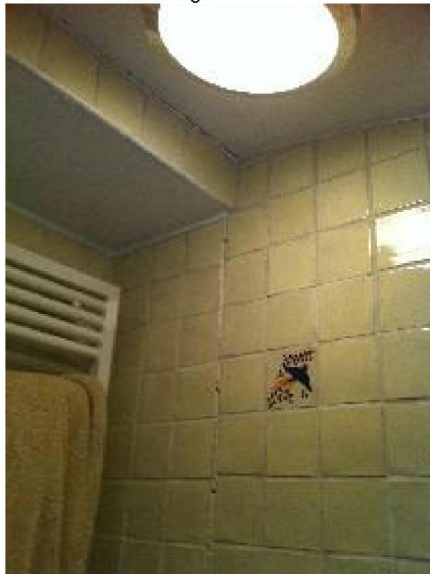
The damage internally consists of cracking to the ground floor bathroom within the basement. There is an existing movement joint between the section under the porch and the remainder of the property. This has now moved beyond the maximum scope that it was designed for. Within the two reception rooms there is minor cracking (1-2mm) above the entrance doors and into the cornice work.

Externally, the main damage to the property is at the junction between the porch and the main house. The maximum separation is between 3-4mm. There is significant cracking on the floor of the porch at the junction of where the porch and threshold of the house meet. There is also some cracking to the front elevation at low level with a maximum crack width of 2mm.

It is common practice to categorise the structural significance of the damage in accordance with the classification given in Table 1 of Digest 251 produced by the Building Research Establishment. In this instance, the damage falls into Category 2 (Slight).

The diagonal aspect of the cracks, together with the fact that they increase in width with height is indicative of subsidence as a result of shrinkage of the clay subsoil due to the moisture extracting influence of the London Plane within the front garden.

Provided the property stabilises as expected, no foundation stabilisation works are considered necessary, with structural repairs of the superstructure being required only, together with internal redecoration of the damaged rooms.

Generally cracks 1mm wide or less will be filled (internal) or re-pointed (external). Internally, where the cracks are wider than 1mm, but less than 5mm the underlying brickwork or blockwork will be exposed and prior to making good the plaster finishes the cracking will be covered with expanded metal lath. Where cracks are 5mm across or wider, some form of bed joint reinforcement will be introduced.
