**32 FERNCROFT AVENUE
LONDON
NW3 7PE**

**DEMOLITION/REFURBISHMENT
SURVEY FOR ASBESTOS**

Report No: JE/161206/1	Name	Signature	Date
Report by:	David Mosapoor Surveyor

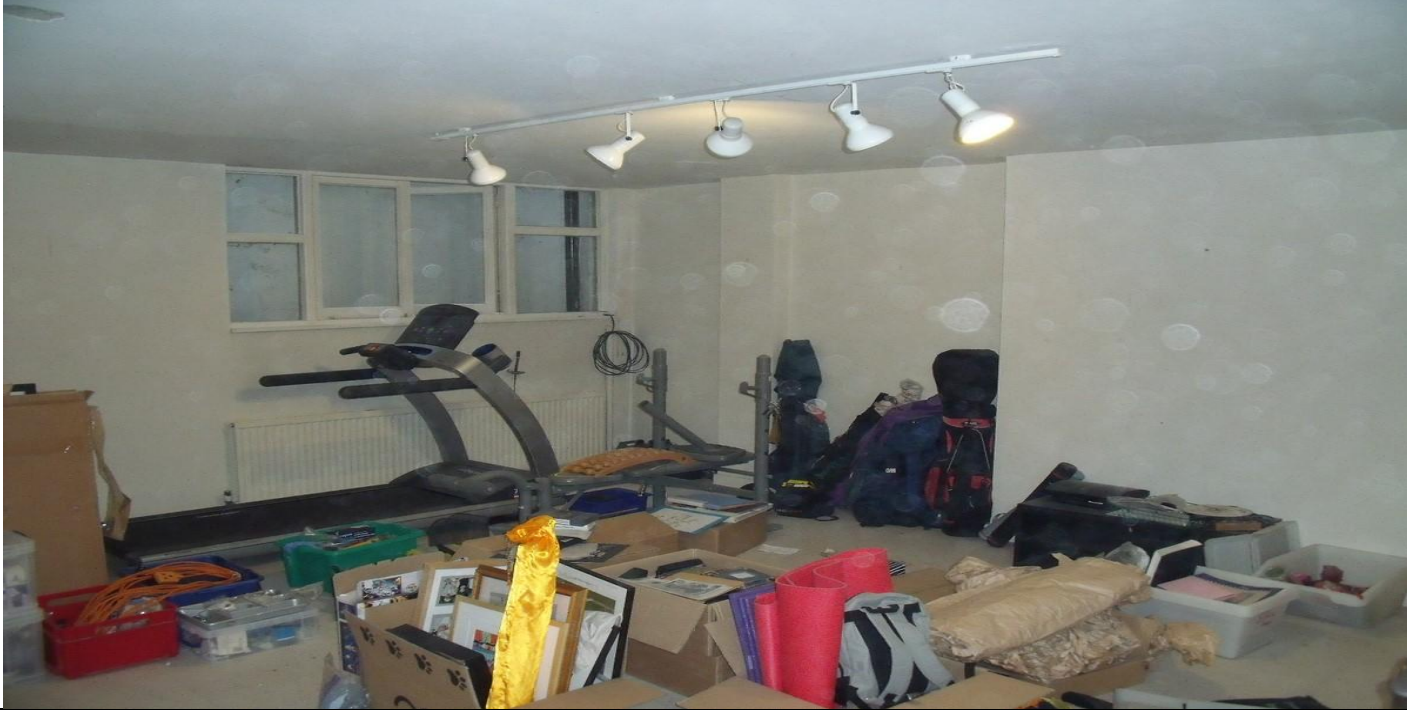
<i>Environmental Inspection Record</i>				32 FERNCROFT AVENUE LONDON NW3 7PE	
<i>Location</i>		<i>Component</i>		<i>Inspection Ref</i>	
BASEMENT B.01		PAINTED LATH & PLASTER CEILING PAINTED PLASTERED BRICK WALLS MODERN VINYL FLOOR TILES ONTO SCREED CONCRETE FLOOR		<i>Surveyor:</i>	D. MOSAPOOR
				PICTURE 1	
				<i>Date:</i>	06/12/16
				<i>Survey Type:</i>	DEMOLITION/ REFURBISHMENT SURVEY
<i>Condition:</i>	N/A	<i>Access:</i>	N/A	<i>Asbestos?</i>	NO
				<i>Re Inspection Date:</i>	N/A
<i>Friability:</i>	N/A	<i>Amount:</i>	NOT MEASURED	<i>Type:</i>	NON ASBESTOS
<i>Damage:</i>	N/A	<i>Exposure:</i>	OCCUPANTS	<i>Analysis:</i>	N/A
<i>Position:</i>	B.01	<i>Risk Factor</i>	0	<i>Priority Assessment:</i>	NO RISK
		<i>Risk Band</i>	E

<i>Recommended Action</i>		NO ASBESTOS MATERIALS IDENTIFIED

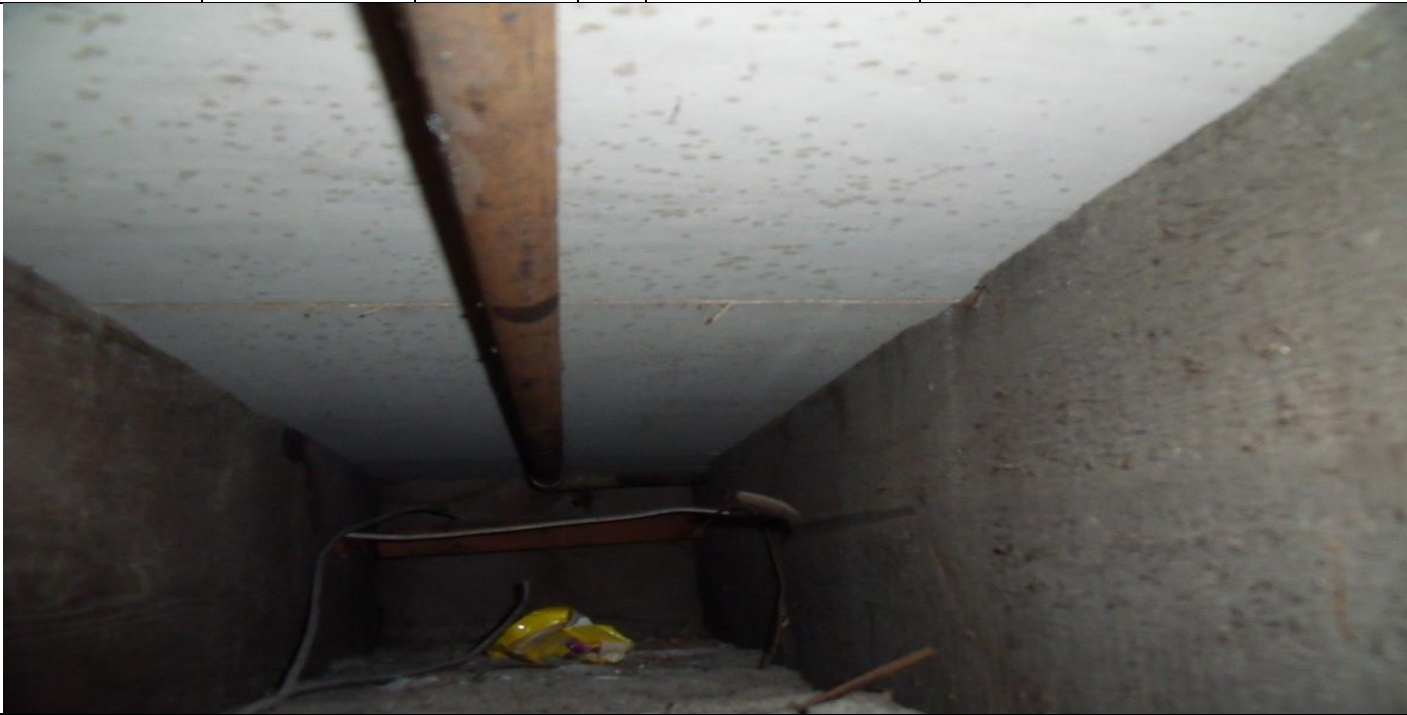
<i>Environmental Inspection Record</i>				32 FERNCROFT AVENUE LONDON NW3 7PE	
<i>Location</i>		<i>Component</i>		<i>Inspection Ref</i>	
BASEMENT B.01		TIMBER FLOORING ABOVE TIMBER FLOOR JOISTS UN-LAGGED METAL PIPES ELECTRICAL CABLES GENERAL BUILDING DEBRIS		<i>Surveyor:</i>	D. MOSAPOOR
				PICTURE 2	
				<i>Date:</i>	06/12/16
				<i>Survey Type:</i>	DEMOLITION/ REFURBISHMENT SURVEY
<i>Condition:</i>	N/A	<i>Access:</i>	N/A	<i>Asbestos?</i>	NO
				<i>Re Inspection Date:</i>	N/A
<i>Friability:</i>	N/A	<i>Amount:</i>	NOT MEASURED	<i>Type:</i>	NON ASBESTOS
<i>Damage:</i>	N/A	<i>Exposure:</i>	OCCUPANTS	<i>Analysis:</i>	N/A
<i>Position:</i>	CEILING VOID	<i>Risk Factor</i>	0	<i>Priority Assessment:</i>	NO RISK
		<i>Risk Band</i>	E

<i>Recommended Action</i>		NO ASBESTOS MATERIALS IDENTIFIED

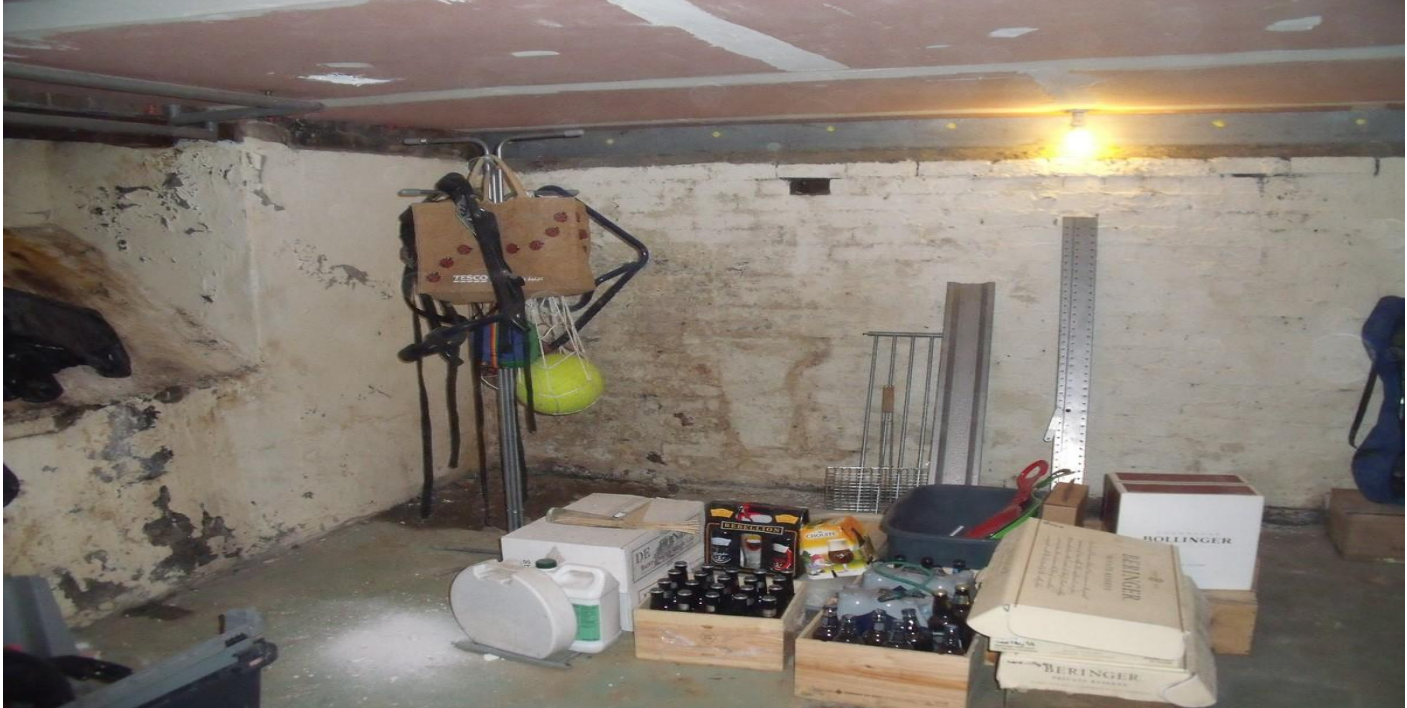
Environmental Inspection Record				32 FERNCROFT AVENUE LONDON NW3 7PE	
Location		Component		Inspection Ref	
BASEMENT B.02		PLASTERBOARD CEILING PAINTED PLASTERED & EXPOSED BRICK WALLS SCREED CONCRETE FLOOR		Surveyor:	D. MOSAPOOR
				PICTURE 3	
				Date:	06/12/16
				Survey Type:	DEMOLITION/ REFURBISHMENT SURVEY
Condition:	N/A	Access:	N/A	Asbestos?	NO
				Re Inspection Date:	N/A
Friability:	N/A	Amount:	NOT MEASURED	Type:	NON ASBESTOS
Damage:	N/A	Exposure:	OCCUPANTS	Analysis:	N/A
Position:	B.02	Risk Factor	0	Priority Assessment:	NO RISK
		Risk Band	E

Recommended Action		NO ASBESTOS MATERIALS IDENTIFIED

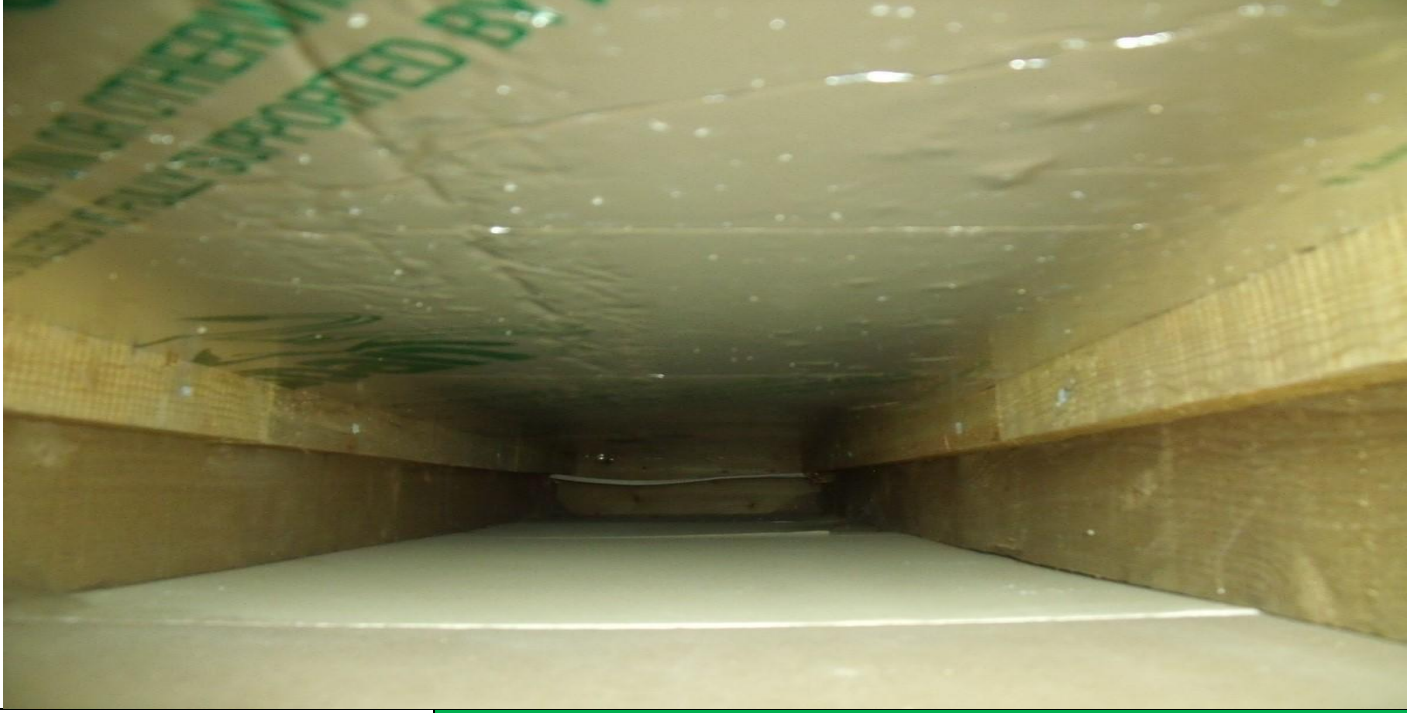
Environmental Inspection Record				32 FERNCROFT AVENUE LONDON NW3 7PE	
Location		Component		Inspection Ref	
BASEMENT B.02		PIR INSULATION TO TIMBER ABOVE TIMBER FLOOR JOISTS		Surveyor:	D. MOSAPOOR
				PICTURE 4	
				Date:	06/12/16
				Survey Type:	DEMOLITION/ REFURBISHMENT SURVEY
Condition:	N/A	Access:	N/A	Asbestos?	NO
				Re Inspection Date:	N/A
Friability:	N/A	Amount:	NOT MEASURED	Type:	NON ASBESTOS
Damage:	N/A	Exposure:	OCCUPANTS	Analysis:	N/A
Position:	CEILING VOID	Risk Factor	0	Priority Assessment:	NO RISK
		Risk Band	E

Recommended Action		NO ASBESTOS MATERIALS IDENTIFIED

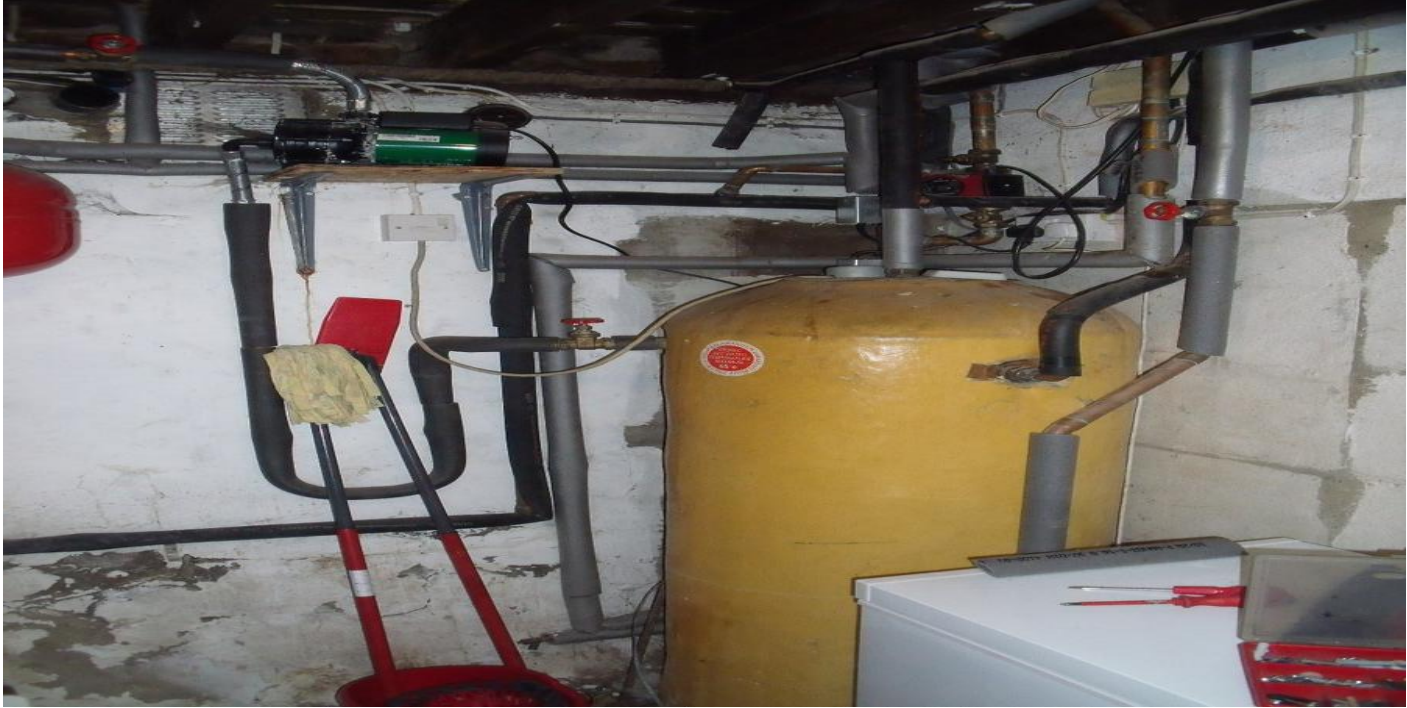
Environmental Inspection Record				32 FERNCROFT AVENUE LONDON NW3 7PE	
Location		Component		Inspection Ref	
BASEMENT B.03		EXPOSED TIMBER JOISTS PLASTERED BRICK WALLS FOAM LAGGED COPPERS PIPES FOAM LAGGED COPPER WATER CYLINDER CONCRETE FLOOR		Surveyor:	D. MOSAPOOR
				PICTURE 5	
				Date:	06/12/16
				Survey Type:	DEMOLITION/ REFURBISHMENT SURVEY
Condition:	N/A	Access:	N/A	Asbestos? NO	
				Re Inspection Date: N/A	
Friability:	N/A	Amount:	NOT MEASURED	Type:	NON ASBESTOS
Damage:	N/A	Exposure:	OCCUPANTS	Analysis:	N/A
Position:	B.03	Risk Factor	0	Priority Assessment:	NO RISK
		Risk Band	E

Recommended Action		NO ASBESTOS MATERIALS IDENTIFIED

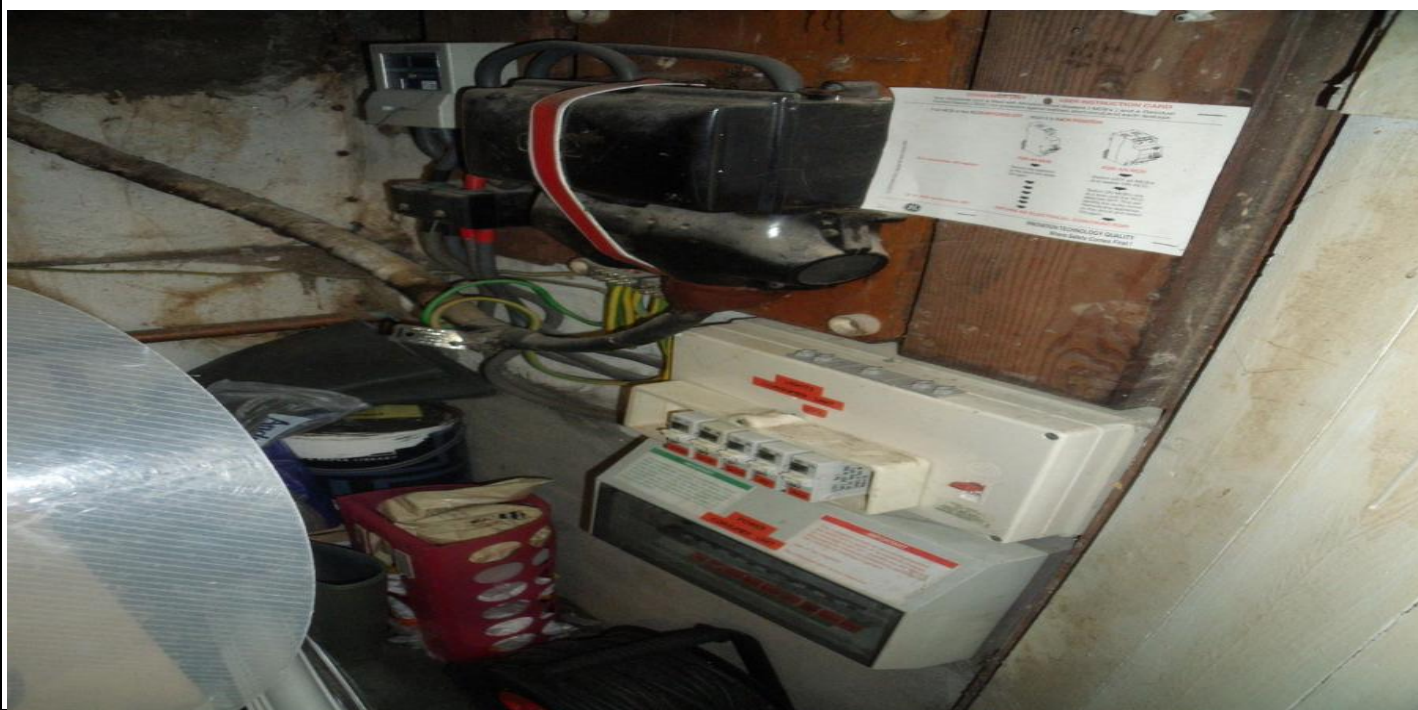
Environmental Inspection Record				32 FERNCROFT AVENUE LONDON NW3 7PE	
Location		Component		Inspection Ref	
BASEMENT B.04		TIMBER STAIR CONSTRUCTIONS MODERN ELECTRICAL FUSE BOARD & METER		Surveyor:	D. MOSAPOOR
				PICTURE 6	
				Date:	06/12/16
				Survey Type:	DEMOLITION/ REFURBISHMENT SURVEY
Condition:	N/A	Access:	N/A	Asbestos?	NO
				Re Inspection Date:	N/A
Friability:	N/A	Amount:	NOT MEASURED	Type:	NON ASBESTOS
Damage:	N/A	Exposure:	OCCUPANTS	Analysis:	N/A
Position:	UNDERNEATH STAIRS	Risk Factor	0	Priority Assessment:	NO RISK
		Risk Band	E

Recommended Action	NO ASBESTOS MATERIALS IDENTIFIED
---------------------------	---

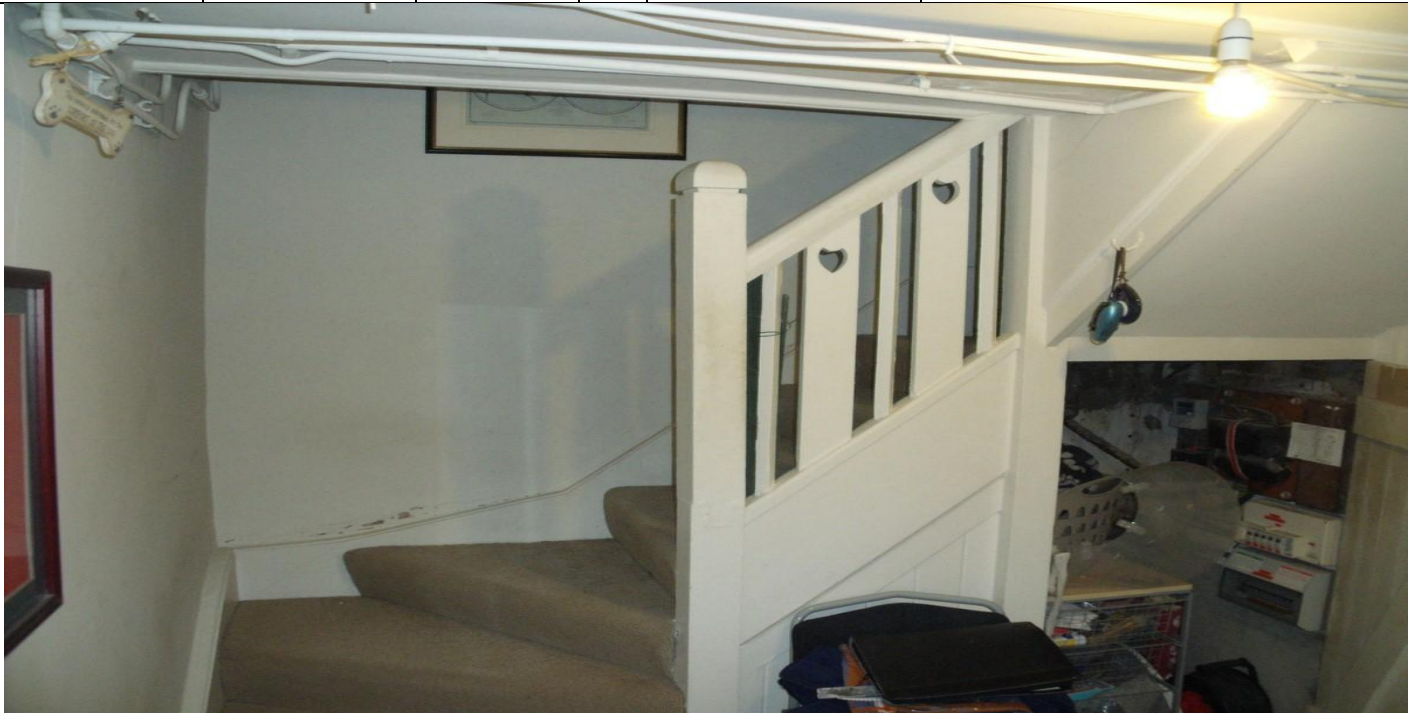
Environmental Inspection Record				32 FERNCROFT AVENUE LONDON NW3 7PE	
Location		Component		Inspection Ref	
BASEMENT B.05		PAINTED LATH & PLASTER CEILING PAINTED PLASTERED BRICK WALLS CARPETED TIMBER STAIR CASE		Surveyor:	D. MOSAPOOR
				PICTURE 7	
				Date:	06/12/16
				Survey Type:	DEMOLITION/ REFURBISHMENT SURVEY
Condition:	N/A	Access:	N/A	Asbestos? NO	
				Re Inspection Date: N/A	
Friability:	N/A	Amount:	NOT MEASURED	Type:	NON ASBESTOS
Damage:	N/A	Exposure:	OCCUPANTS	Analysis:	N/A
Position:	STAIRS	Risk Factor	0	Priority Assessment:	NO RISK
		Risk Band	E

Recommended Action		NO ASBESTOS MATERIALS IDENTIFIED
