## Summary Report: Property Flat 2 84 Albert St NW1 7NR

# London Damp Specialists Report & Quotation

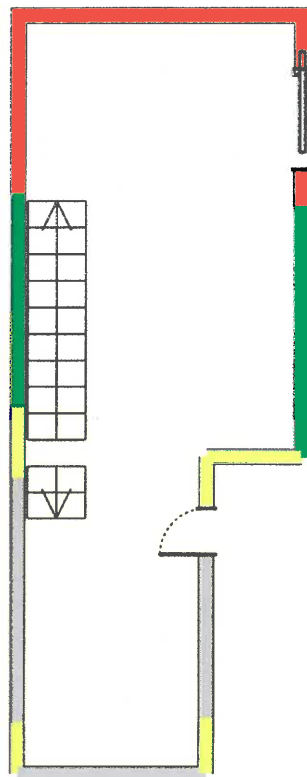
Areas marked in yellow would be treated to 1.2 meters high

Exterior walls marked in red will be treated to full height

Walls marked in green will be treated to the ceiling of the ground floor or up to the underside of the stairs
