## Arboricultural Appraisal Report

### Subsidence Damage Investigation at:

Flat 2, Gilling Court  
Belsize Grove  
Hampstead  
London  
NW3 4UY

CLIENT:	Crawford & Company
CLIENT REF:	SU1604808
MWA REF:	SUB170818-1673
MWA CONSULTANT:	Andy Clark
REPORT DATE:	30-08-2017

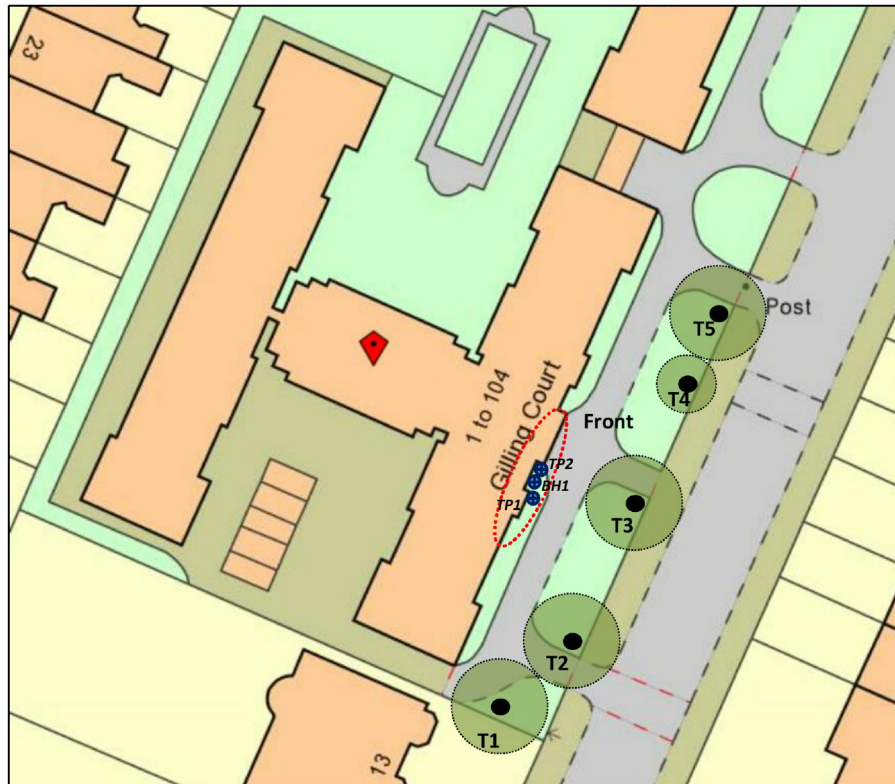
# SITE PLAN

Approximate areas of damage

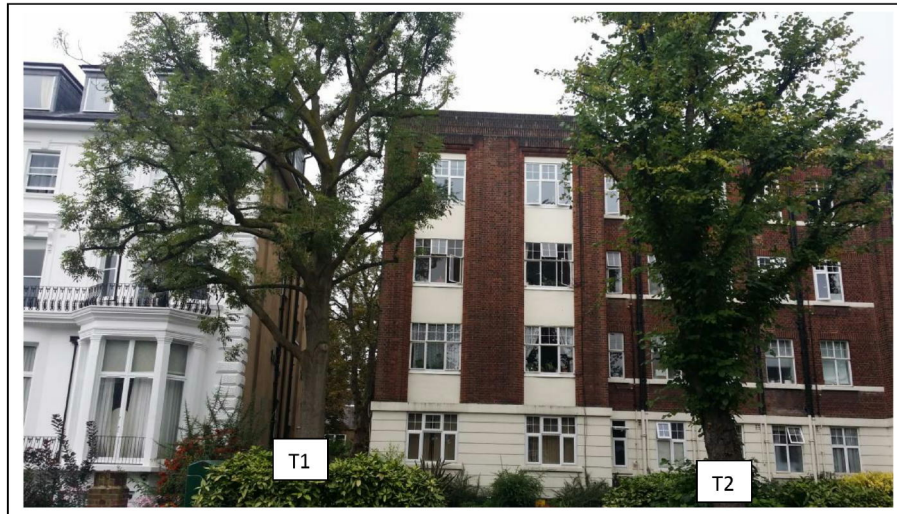
Tree No.	Species	Ht (m)	Dia (mm)	Crown Spread (m)	Dist. to building (m)	Age Classification	Ownership
T2	Lime	14.5	600	7.0	10.4	Younger than property	Policy Holder
Management history		Crown reduced in recent past – regrowth appears <1yr Moderate basal and epicormic growth					
Recommendation		Fell to ground level and treat stump to inhibit regrowth					
T3	Lime	20.5	Ms [x4] 400	14.0	11.1	Younger than property	Policy Holder
Management history		Pollarded in past @ approx. 15m – regrowth appears <10yrs Included unions @ main stem fork cluster					
Recommendation		Fell to ground level and treat stumps to inhibit re-growth

Tree No.	Species	Ht (m)	Dia (mm)	Crown Spread (m)	Dist. to building (m)	Age Classification	Ownership
T1	Ash	15.5	530	7.5	6.8	Younger than property	Policy Holder
Management history		Crown reduced in recent past – regrowth appears <1yr					
Recommendation		Fell to ground level and treat stumps to inhibit re-growth. The tree is too close and is an inappropriate species for its location.					
T4	Cherry	12.5	350	3.5	11.2	Younger than property	Policy Holder
Management history		Leaning stem and asymmetrical crown growth habit Crown reduced in recent past – regrowth appears <1yr					
Recommendation		Do not allow to exceed current dimensions through a programme of regular [triennial] pruning					
T5	Horse Chestnut	13.5	870	11.0	11.4	Younger than property	Policy Holder
Management history		Pollarded in past @ approx. 5.5m – regrowth appears 10> yrs Moderate stem decay at old pollard points					
Recommendation		Do not allow to exceed current dimensions through a programme of regular [triennial] pruning

View of T1 Ash and T2 Lime

Based on the technical reports currently available, engineering opinion and our own site assessment we conclude the damage is consistent with shrinkage of the clay subsoil related to moisture abstraction by vegetation. Having considered the available information, it is our opinion that T3 Lime is the principal cause of the current subsidence damage with T2 Lime also being contributory. If an arboricultural solution is to be implemented to mitigate the current damage and allow the soils beneath the property to recover to a position such that an effective repair solution can be implemented we recommend that T2 and T3 are removed.

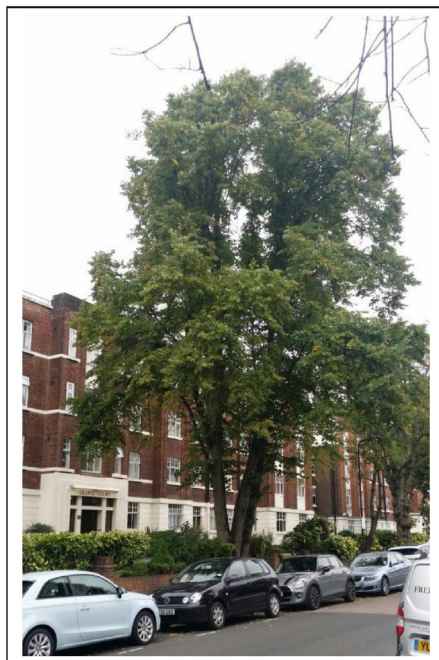
Roots were observed to a depth of 4.0m bgl in BH1 and recovered samples have been positively identified (using anatomical analysis) as *Tillia* spp. and *Berberis* or *Mahonia* spp., the origin of which, given their relative proximity to the property, will be T3 Lime, confirming the influence of this trees on the soils below the foundations. The recorded *Berberis* or *Mahonia* spp. roots will relate to small nearby shrubs which are not considered to be relevant. Irrespective of the root identification however, the roots of T1, T2, T4 and T5 are also likely to have a significant presence below the foundations of the property given their size and relative proximity to the structure.

View of T3 Lime

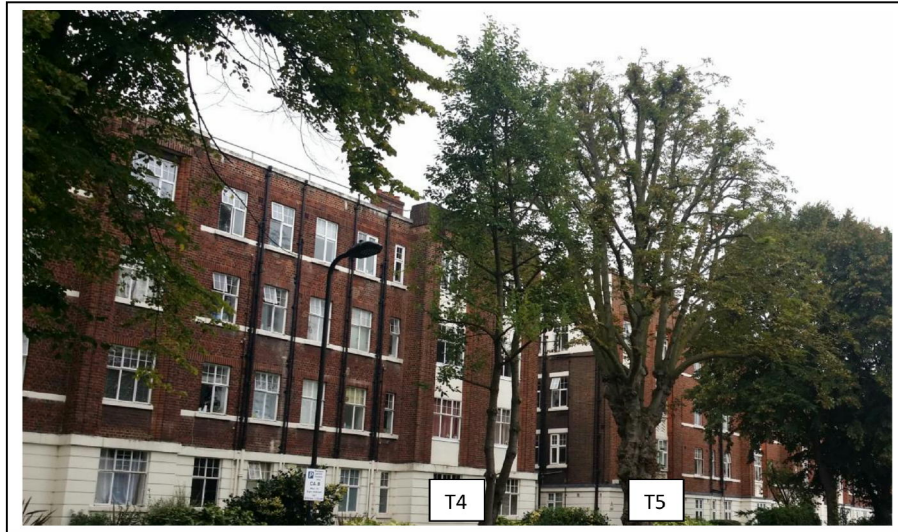
View of T4 Cherry and T5 Horse Chestnut
