TECHNICAL REPORT ON A SUBSIDENCE CLAIM

Crawford Reference: SU1604808

Gilling Court (Hampstead) Ltd
Flat 2 Gilling Court
Belsize Grove
Hampstead
London
NW3 4UY

SUBSIDENCE CLAIM

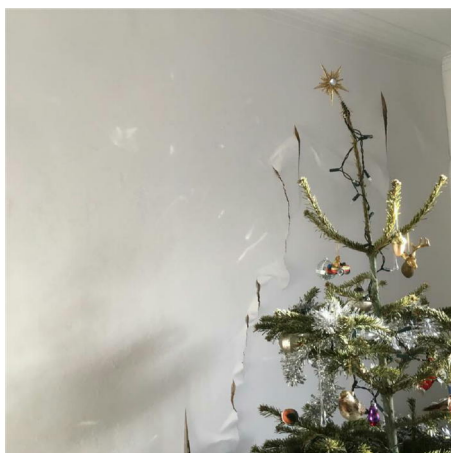
Crack in Flat 28 Living Room

Diagonal crack to right flank wall, possibly 15mm width with significant disturbance of plaster

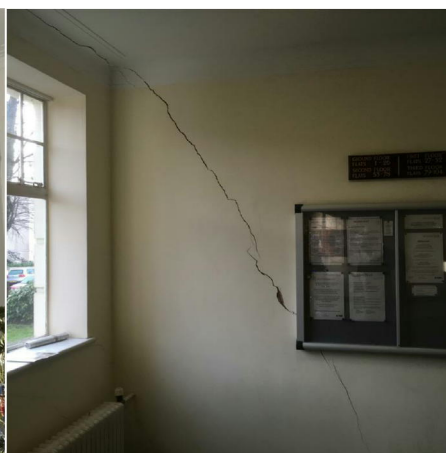
Crack in the ground floor entrance lobby

8mm diagonal crack to the wall to Flat 2, extends over front window

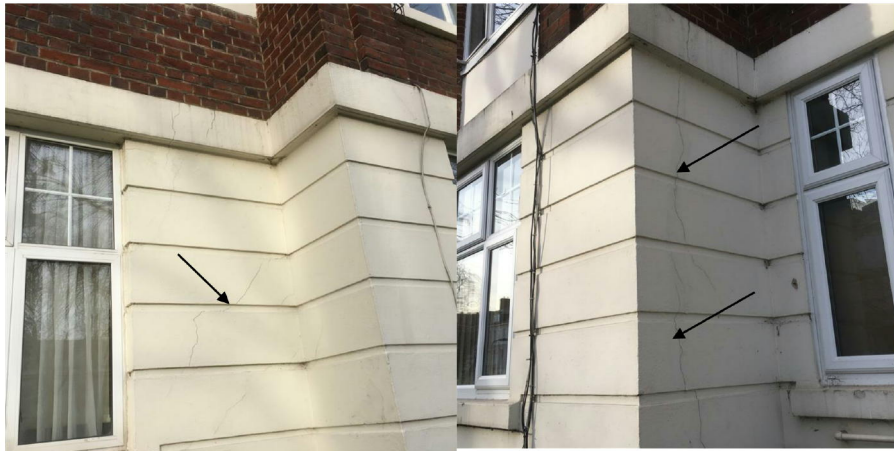
Cracks to front elevation

Series of short cracks, up to 3mm width to the rendered areas at first floor and below. These cracks are predominately to the left of the main entrance.

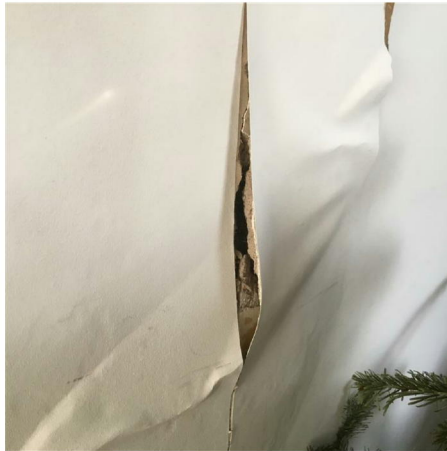
Crack in Flat 28 living Room

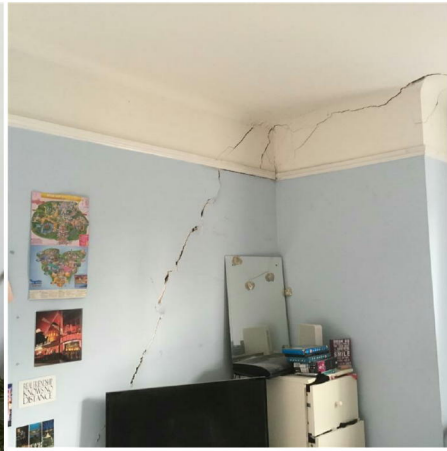
10mm diagonal crack to the right flank wall

Crack in Flat 2 Right hand end bedroom

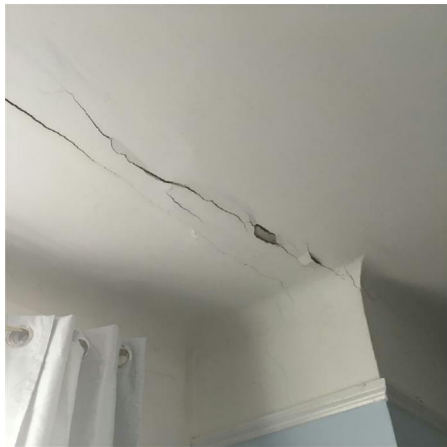
Crack in Flat 2 Right hand end bedroom

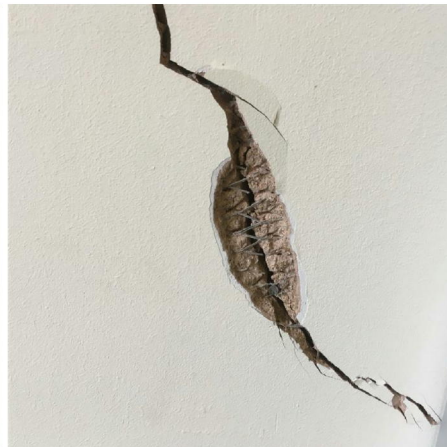
Close up of crack in the entrance lobby
showing evidence of past repair

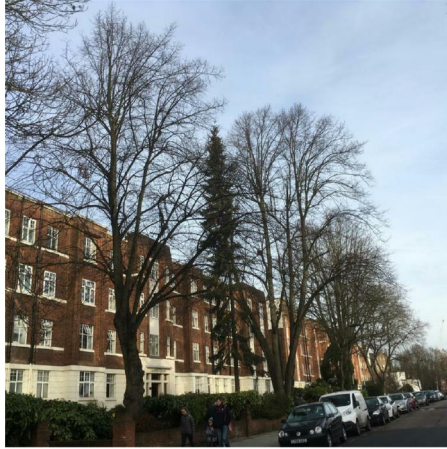
There are several trees and shrubs nearby, some with roots that may extend beneath the house foundations. The following are of particular interest:-

Type	Height	Distance	Ownership
Deciduous x5	20 m	12 m	Owners

The timing of the event, the presence of shrinkable clay beneath the foundations and the proximity of vegetation where there is damage indicates the shrinkage to be root induced. This is a commonly encountered problem and probably accounts for around 70% of subsidence claims notified to insurers.

Trees to the front of the building.

Although the cause of the movement needs to be dealt with, we note the vegetation is in a Conservation Area and may be subject to Preservation Orders. Unfortunately, current legislation requires certain investigations to be carried out to support an application for the tree works.

Typically, these investigations would involve trial pits to determine the depth and type of footings, boreholes to determine the nature of the subsoil/influence of any roots and monitoring to establish the rate and pattern of movement. The monitoring data provided must be sufficient to show a pattern of movement consistent with the influence of the vegetation and therefore it may be necessary to carry out the monitoring for up to a 12 month period.

It will also be necessary to obtain a specialist Arboricultural Report.

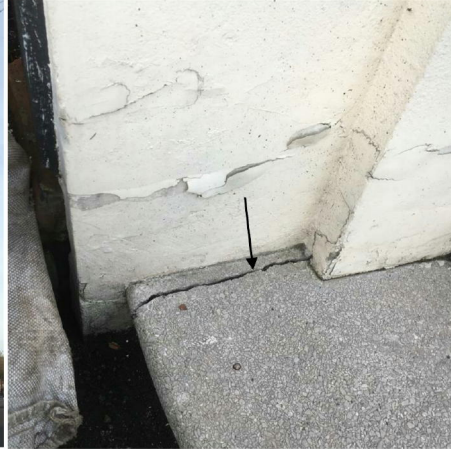
Cracking and movement of the front steps.

Damage to front steps at main entrance

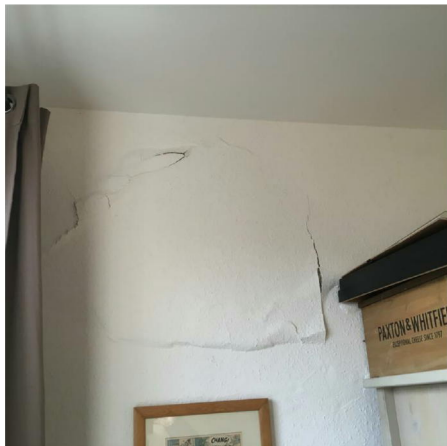
Crack behind wardrobe against left flank wall, possibly 10mm width

Cracking in Flat 28 Right hand end
bedroom
