SITE INVESTIGATION FACTUAL REPORT

Report No: 403958
Client: Crawford Claims Management
Site: Flat 2 , Gilling Court
Hampstead

Date of Visit: 23/02/17

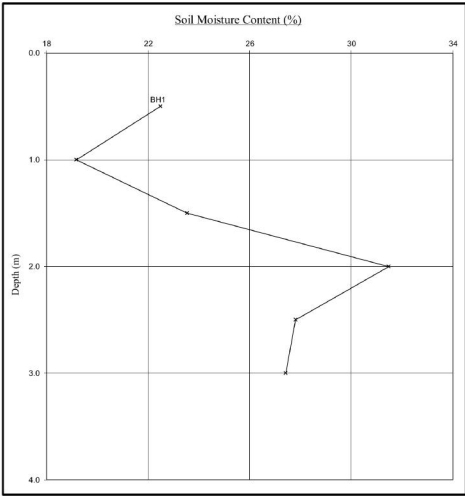
Moisture Content Profiles

Notes
1. If plotted, 0.4 LL and PL/2 (after Driscoll, 1983) should only be applied to London Clay (and similarly overconsolidated clay) at shallow depths.
2. Unless specifically noted the profiles have not been related to a site datum.

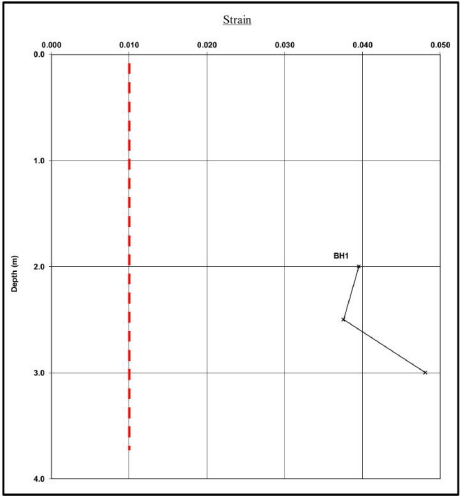
Oedometer Strain Profiles

TP/BH No	Depth (m)	Type	Moisture Content (%) [1]	Soil Fraction > 0.425mm (%) [2]	Liquid Limit (%) [3]	Plastic Limit (%) [4]	Plasticity Index (%) [5]	Liquidity Index [5]	Modified Plasticity Index (%) [6]	Soil Class [7]	Filter Paper Contact Time (h) [8]	Soil Sample Suction (kPa) [8]	Oedometer Strain [9]	Estimated Heave Potential (Dd) (mm) [10]	In situ Shear Vane Strength (kPa) [11]	Organic Content (%) [12]	pH Value [13]	Sulphate Content (g/l)		Class [16]
																		SO ₃ [14]	SO ₄ [15]	
BH1	0.5	D	22	28																
	1.0	D	19	36																
	1.5	D	24	19																
	2.0	D	31	<5	92	26	66	0.08	66	CE			0.0395	30.3	89					
	2.5	D	28	<5									0.0375	6.9	116					
	3.0	D	27	<5	83	29	54	-0.03	54	CV			0.0481	4.8	> 140					
free surface heave potential over the borehole depth is about 3cm to 6cm

--- Remoulding Disturbance
Assumptions
1. Soil Bulk Density (moist unit weight) is equal to 2098kg/m³
2. The water table is assumed as 1.0m below ground level.
3. Shrinkage Factor (sf) of 2 has been applied to the predicted heave, where applicable
4. Any possible surcharge stresses due to construction are not considered
Notes
1. Sample prepared in accordance with BS1377: Part 1: 1990 clause 7.7 at Natural (as received) Moisture
2. Unless specifically noted the profiles have not been related to a site datum.

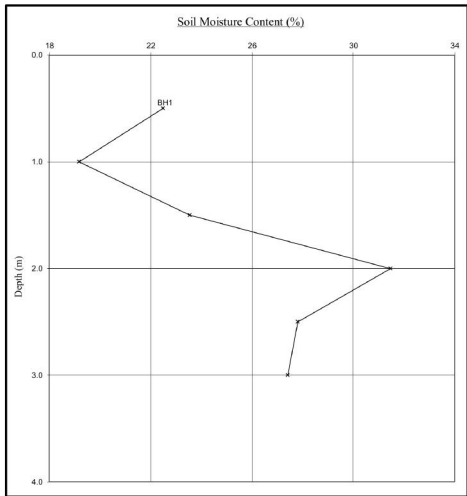
Moisture Content Profiles

Notes
1. If plotted, 0.4 LL and PL+2 (after Driscoll, 1983) should only be applied to London Clay (and similarly overconsolidated clay) at shallow depths.
2. Unless specifically noted the profiles have not been related to a site datum.

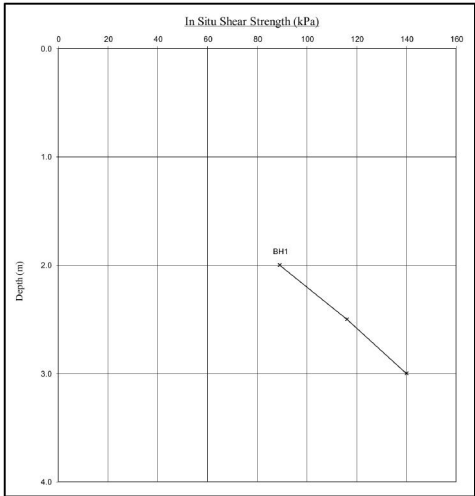
Shear Strength Profiles

Note
1. Unless otherwise stated, values of Shear Strength were determined in situ by CET using a Picon Hand Vane the calibration of which is limited to a maximum reading of 140 kPa.
2. Unless specifically noted the profiles have not been related to a site datum.
