**Asbestos Refurbishment/Demolition Survey for**  
Circle East Ltd  
**at**  
35A Broadhurst Gardens  
London  
NW6 3QT

Project Number: 20180525-AR01-REFURB

This survey was carried out by Andy Robson on the 25th May 2018.

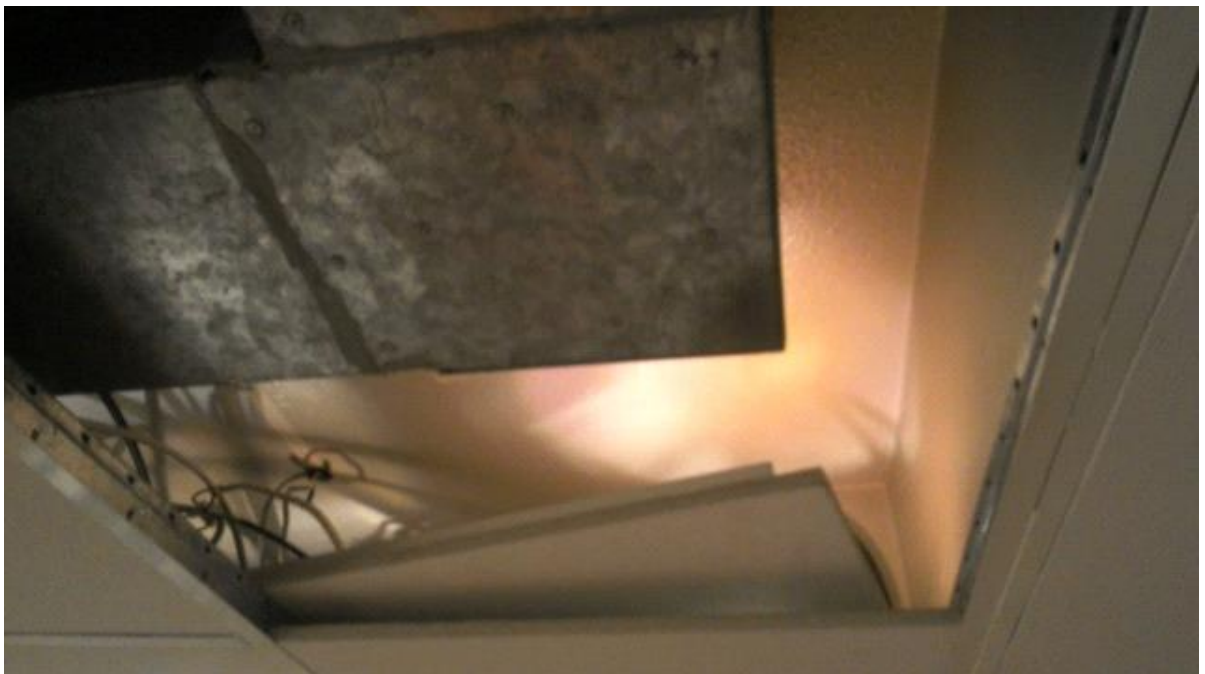
Material Risk Score:	N/A	<b>No Action Required</b>
Material Risk Band:	Not Applicable	
Priority Risk Score:	N/A	
Priority Risk Band:	N/A

Material Comments: Non Asbestos Textured Coating (ceiling - above ceiling tiles)

Action: No Further Action Required
