The Hope Project: Investigation of the 'Fly Tower' roof for condition, strength classes and construction

Site note 2 for 8 March 2018, job no. 146.89

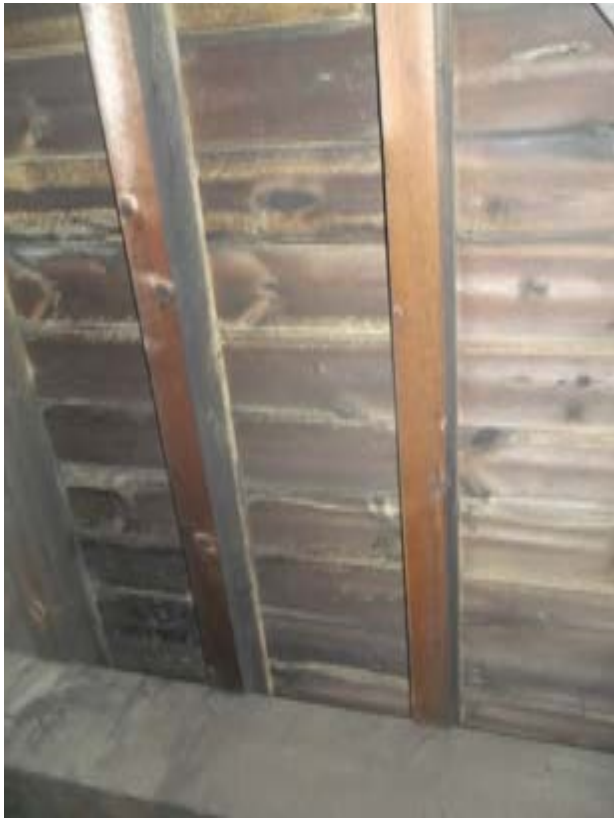
Fig 1:

Timber roof elements between TR2 truss and south-east corner of the roof: showing general view of the roof structure. Rafters and purlins were in good condition in this area. Notice that sarking timber boards were slightly degraded, however this was not considered to be structurally significant

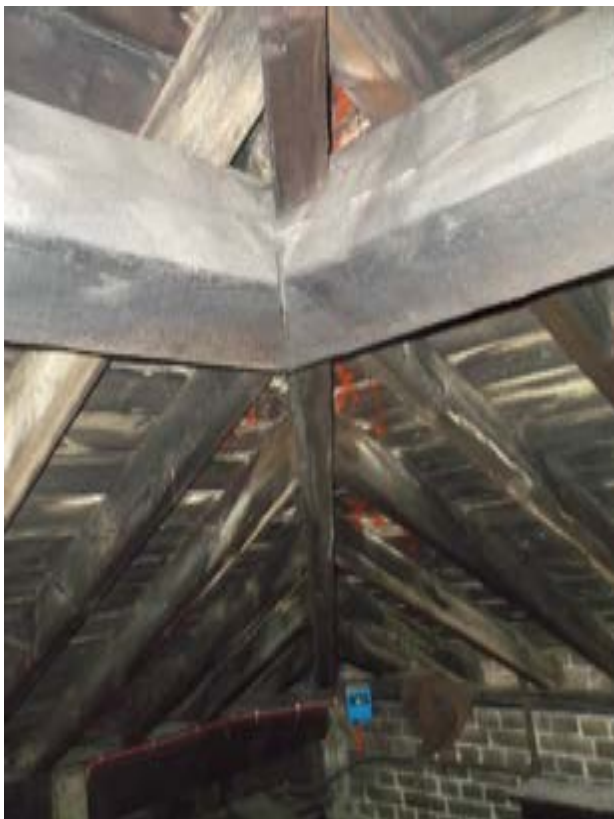
Fig 2:

South-east hip rafter: showing general view of south-east hip rafter and jack rafters. Approximately 12 no. jack rafters along the hip rafter span were structurally decayed at their bearing ends. Additionally, the sarking boards around the hip rafter were decayed, where decay extended between 100mm and 300mm on each side of the hip rafter

Further and future water ingress in the hip rafter areas should be stopped. Decayed bearing ends of the rafters should be cut back to sound timber for approximately 200mm and partnered with new structural timber. No chemical remedial treatments for fungal decay and wood boring insect are either necessary or recommended

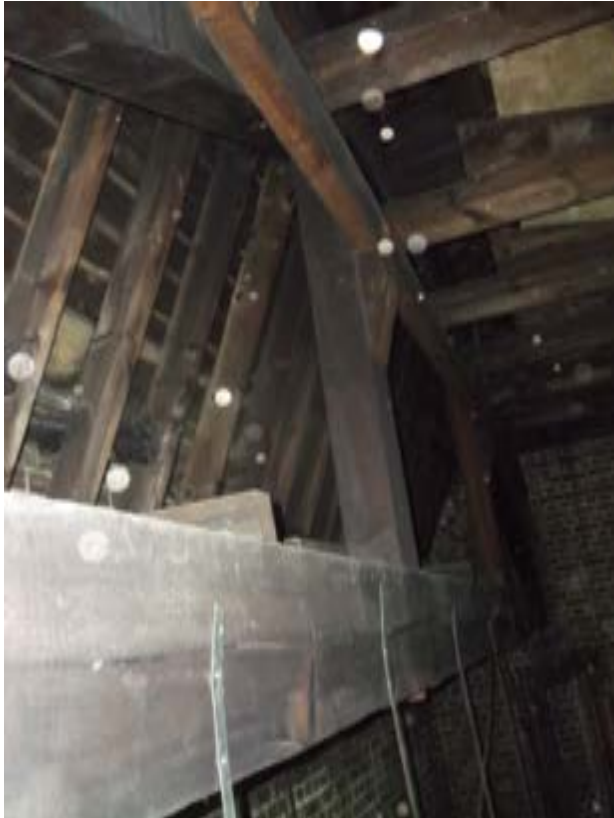
Fig 3:

South-east corner looking to the west: showing timber truss system which spanned parallel to the south eave. Timber truss was supporting floor joists and half timber truss (TR1). No structural issues nor fungal decay was observed visually

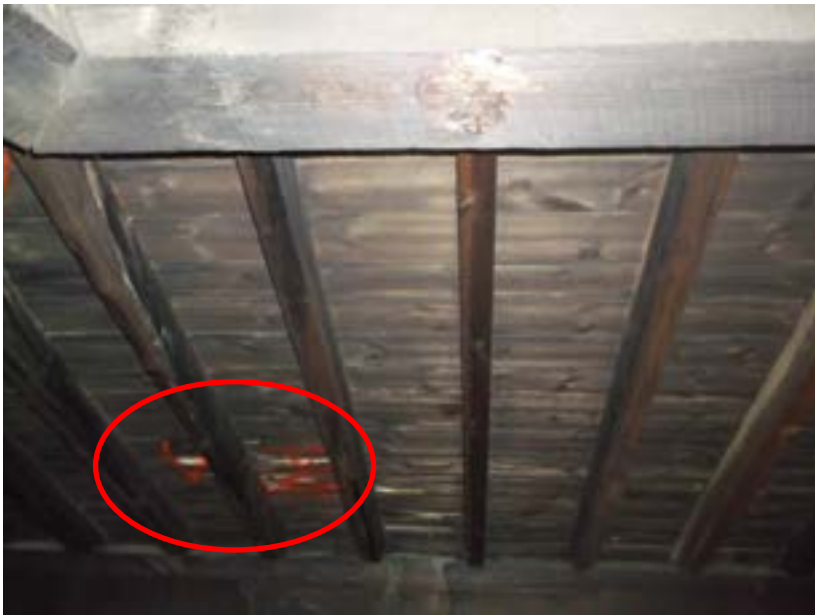
Fig 4:

Timber elements between south-east hip rafter and half truss (TR1): showing general view of timber rafters and underlying plate, which were in good condition. Noticed localised decay to the sarking boards which had been degrading due to failed roof finishes

All of the structurally affected sarking boards by wet rot should be cut back to sound timber and should be replaced with new softwood boards. All failed roof coverings should be replaced accordingly

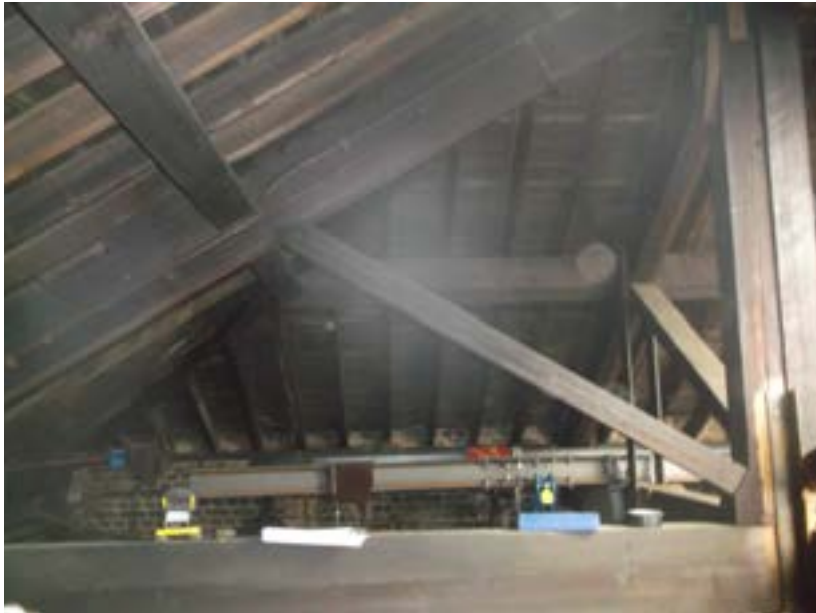
Fig 5:

East plane of the half truss (TR1): showing general view of the half truss system. All of the structural elements of the truss system were strength graded to the strength class C24

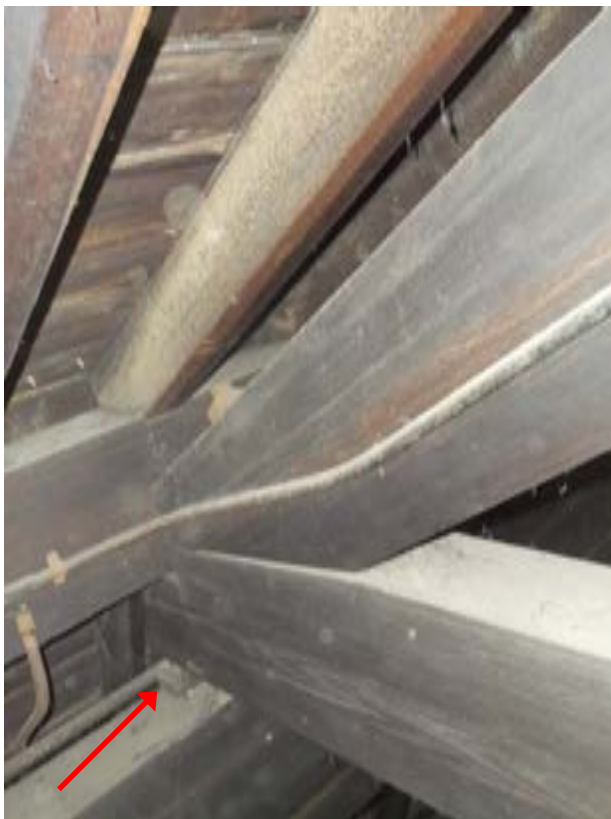
Fig 6:

- 1 Bearing end of the TR 1: The south bearing end of the half truss was bearing on a minimum effective bearing plane. This was considered to be structurally inadequate

South bearing end of the half truss (TR1): showing general structural configuration of the south bearing end of the half truss. Note that the tie beam was bearing onto a small piece of timber element which was providing minimum bearing length, no more than 15mm

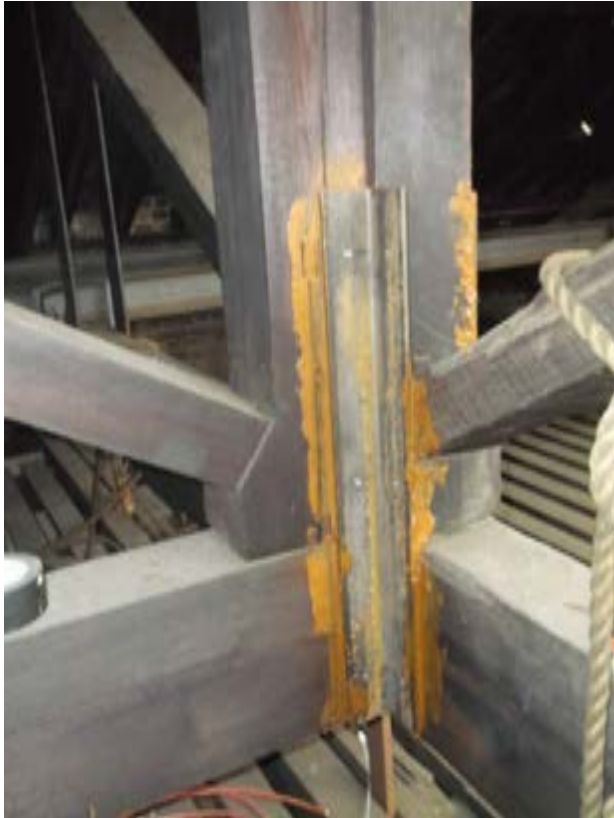
Fig 7:

Intersection between timber half truss (TR1) and king post truss (TR2): showing strengthened timber joint between the king posts and tie beams with epoxy based adhesive and steel angle section. Note that the screw fasteners should not be considered in structural verification of the joint, as they were only holding steel element in place until the solidification of the adhesive from the liquid state

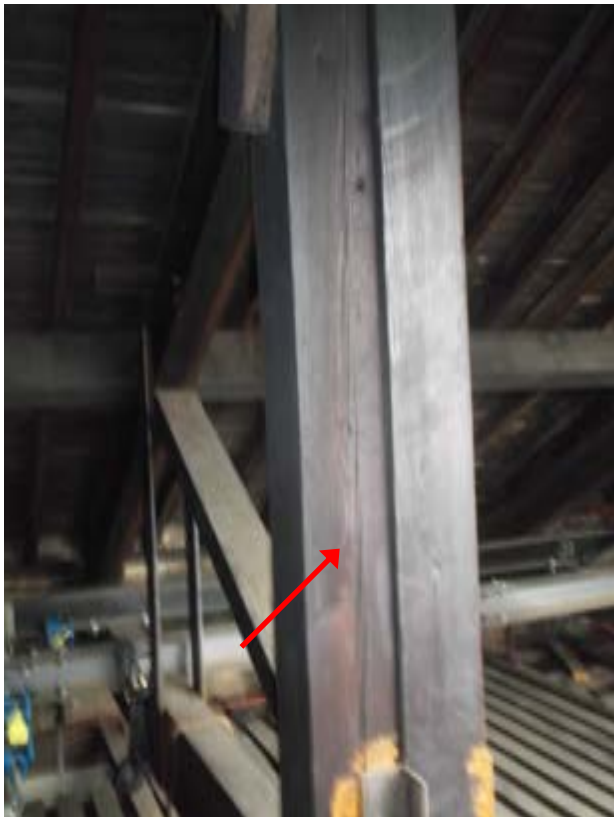
Fig 8:

King post of the half timber truss (TR1): showing fissures in the king post which were of drying characteristics and were not considered to be structurally significant

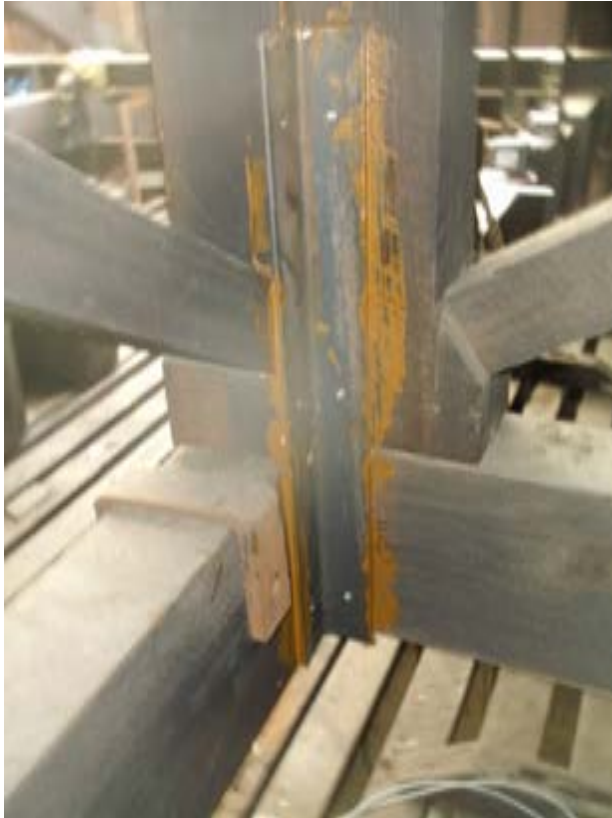
Fig 9:

Intersection between timber half truss (TR1) and king post truss (TR2): showing strengthened timber joint between the king posts and tie beams with epoxy based adhesive and steel angle section. Note that the screw fasteners should not be considered in structural verification of the joint, as they were only holding steel element in place until the solidification of the adhesive from the liquid state

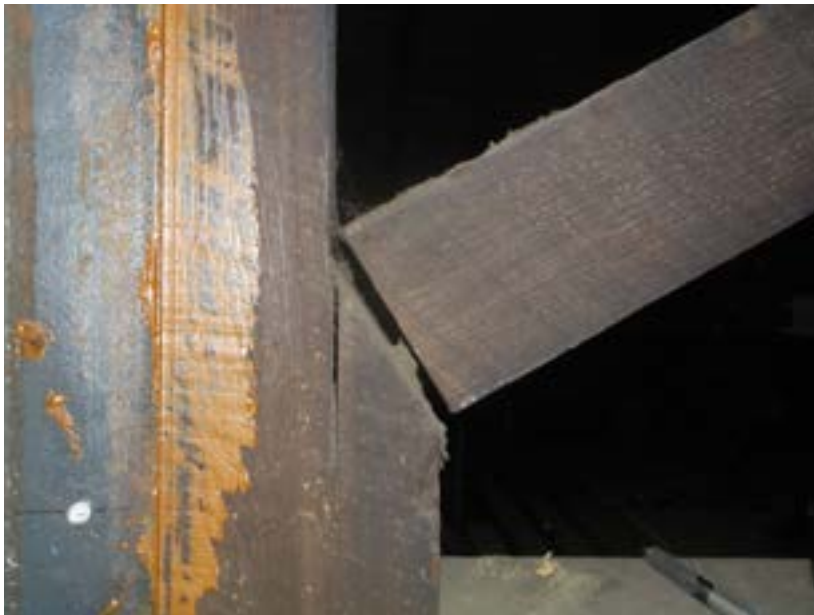
Fig 10:

Joint of the half timber truss (TR1): showing general view of the joint between the strut and king post which were held by 1 no. fastener. This structural configuration of the joint may not be structurally adequate in resisting internal tension forces in the strut

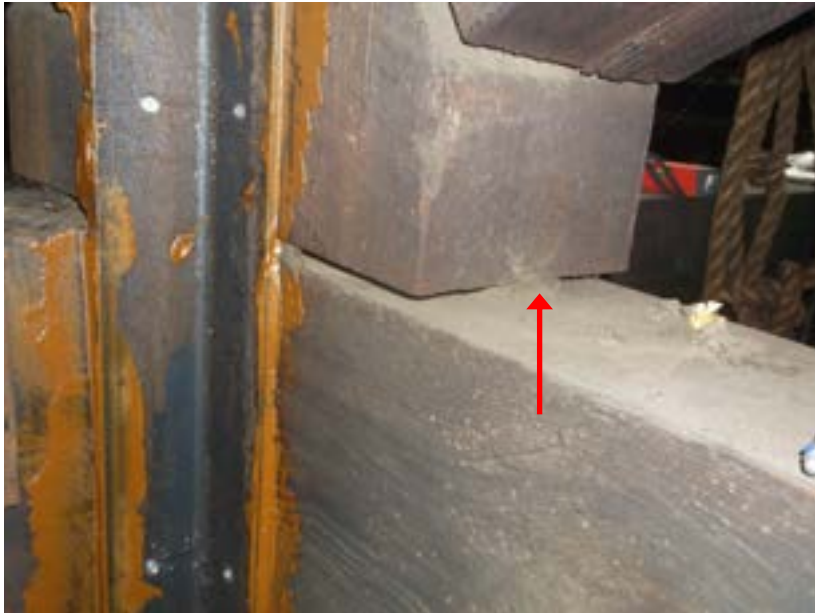
Fig 11:

Joint of the half timber truss (TR1): showing general view of the joint between the king post and tie beam. Note that the tenon had been slightly dislodged due to additional internal bending forces generated from the lighting rigs and supported floor structure. Initial design of this joint was to support post in compression, however due to additional loading to timber tie beams, the joint was acting in tension, hence the instalment of the steel angle

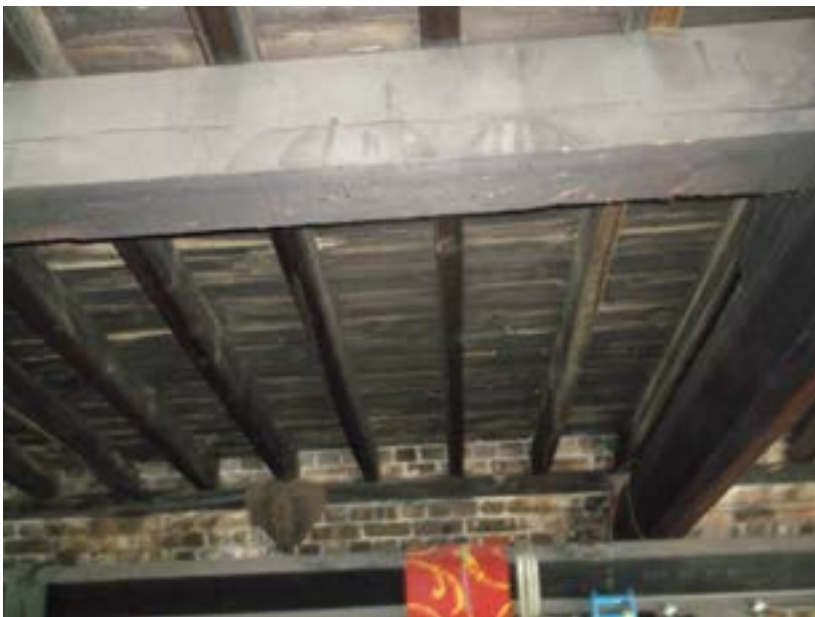
Fig 12:

Timber elements between the south-west hip rafter and king post truss (TR2): showing general view of timber rafters and underlying plate, which were in good condition. Note discoloration to the sarking boards. This suggest that there might be superficial decay to the topside of the boards. No structurally significant decay to the sarking boards was observed from the inside

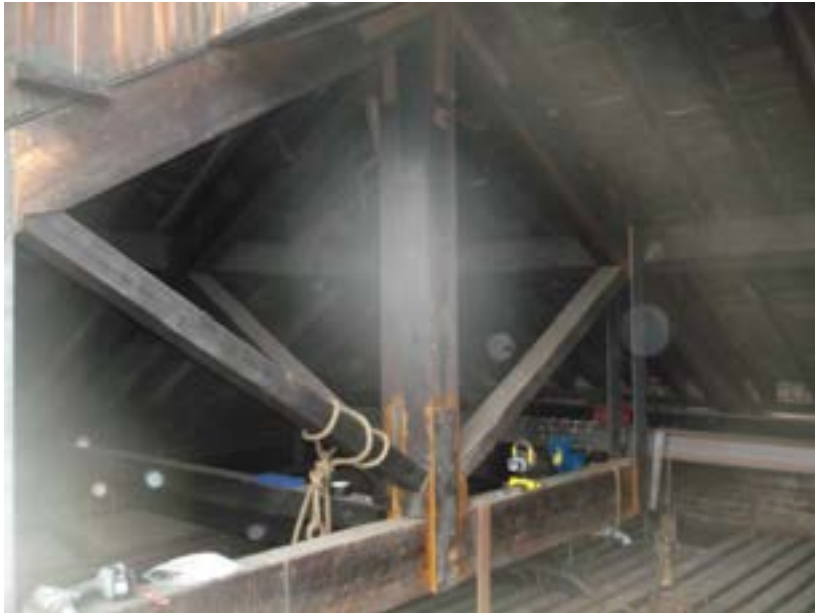
Fig 13:

North plane of the king post truss (TR2): showing general view of the king post truss, where all of the structural elements of this system were strength graded to the strength class C24

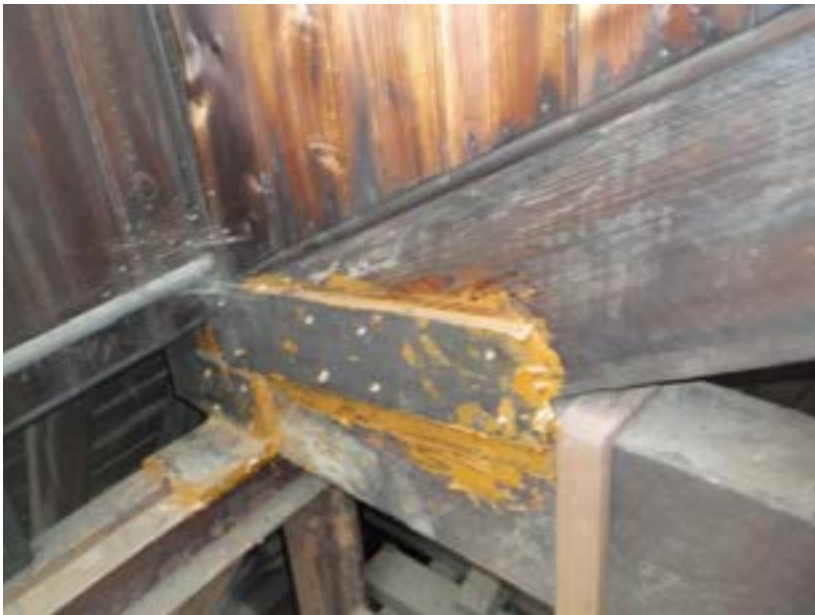
Fig 14:

East bearing end of the king post truss (TR2): showing general view of the bearing end. Note that the joint between the tie beam and principal rafter had been strengthened with steel plate. The contribution of the screw fasteners should not be considered in the joint structural verification. Additionally note that the tie beam had been restrained against the rotation to the top chord of the steel truss

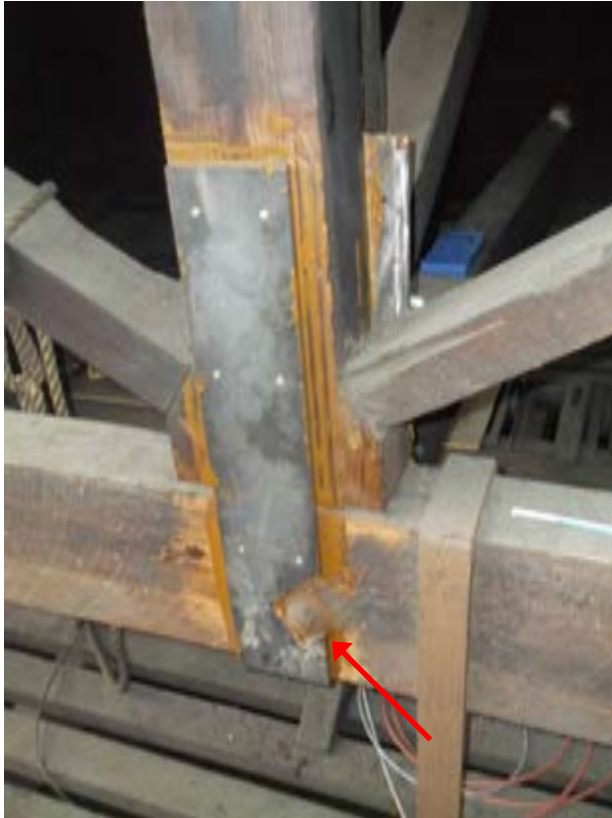
Fig 15:

Joint of the king post truss (TR2): showing general view of strengthened timber joint with steel plate between the king post and tie beam. The contribution of the screw fasteners should not be considered to contribute to the strength of the joint. Additionally note original fastener which was laterally supporting the tie beam of the half truss (TR1)

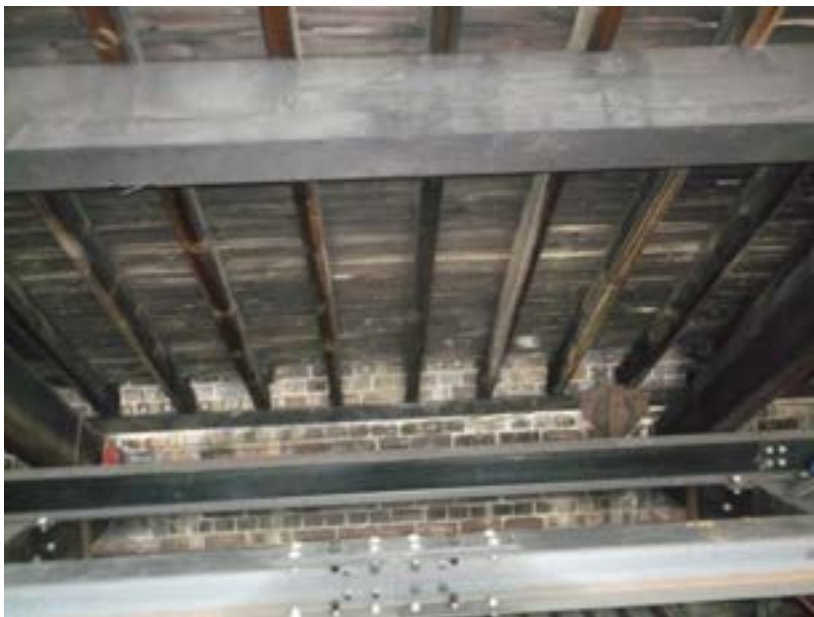
Fig 16:

Structural roof timber elements between TR2 and TR3 king post trusses to the west: showing general view of timber rafters and underlying plate, which were in good condition. Note discoloration to the sarking boards. This suggest that there might be superficial decay to the topside of the boards. No structurally significant decay to the sarking boards was observed from the inside

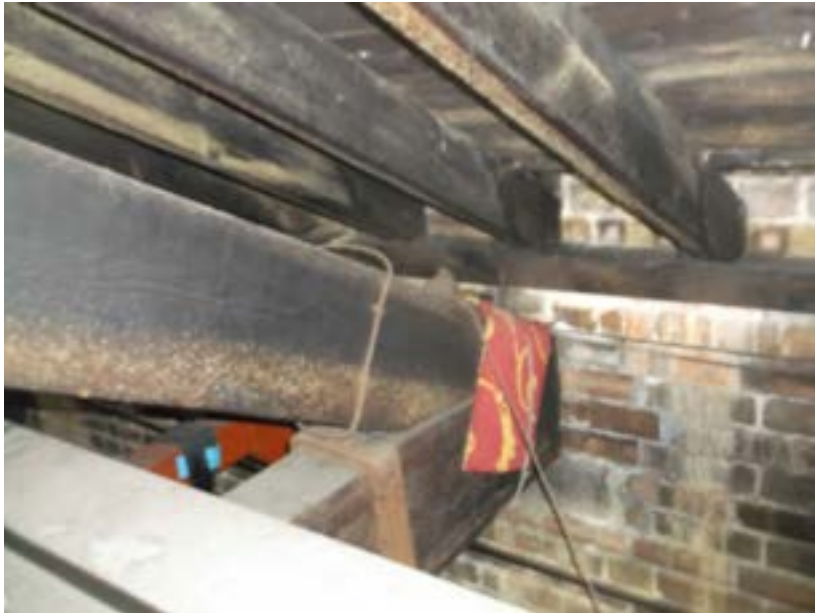
Fig 17:

West bearing end of the truss (TR2): showing general view of embedded bearing end of the truss. No structurally significant decay was detected upon deep drilling

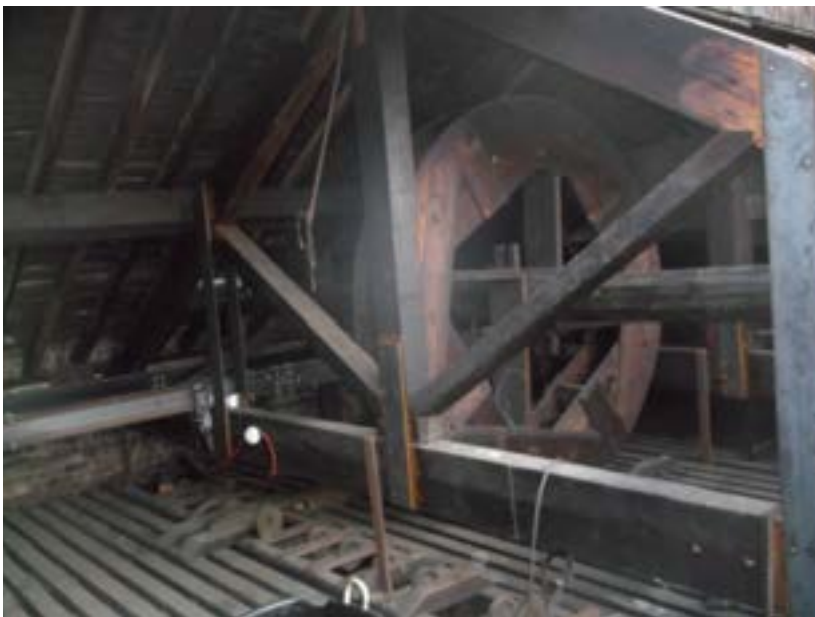
Fig 18:

South plane of the king post truss (TR3): showing general view of the king post truss, where all of the structural elements of this system were strength graded to the strength class C24

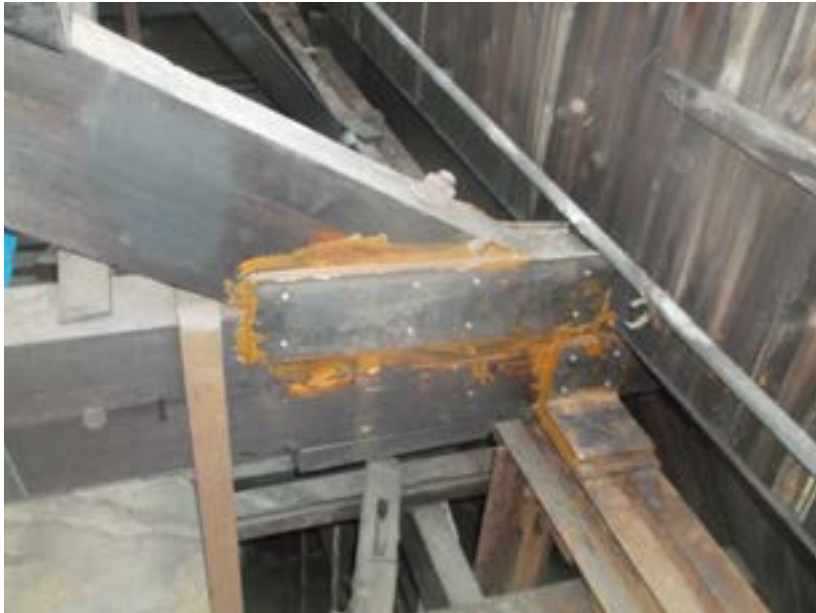
Fig 19:

East bearing end of the king post truss (TR3): showing general view of the bearing end. Note that the joint between the tie beam and principal rafter had been strengthened with steel plate on each side. The contribution of the screw fasteners should not be considered to contribute to the strength of the joint. Additionally note that the tie beam had been restrained against the rotation to the top chord of the steel truss

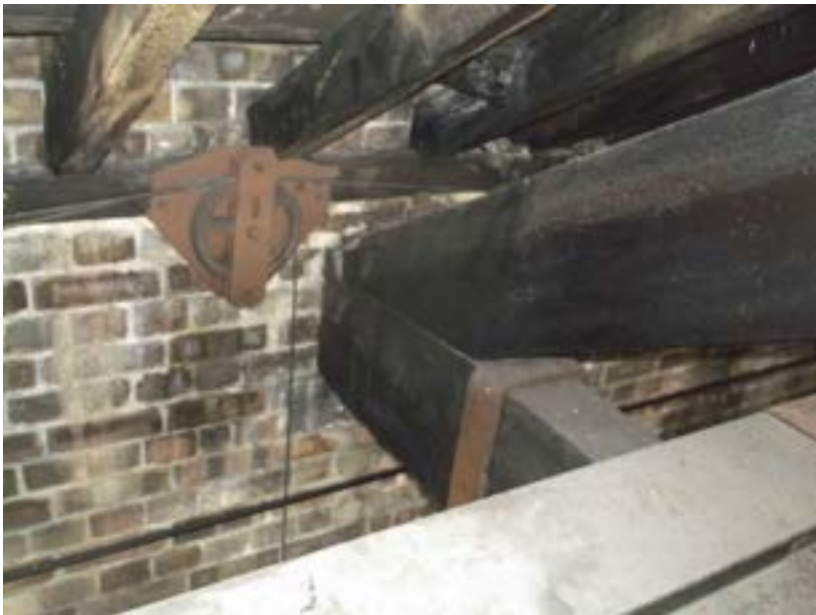
Fig 20:

West bearing end of the truss (TR3): showing general view of embedded bearing end of the truss. No structurally significant decay was detected upon deep drilling

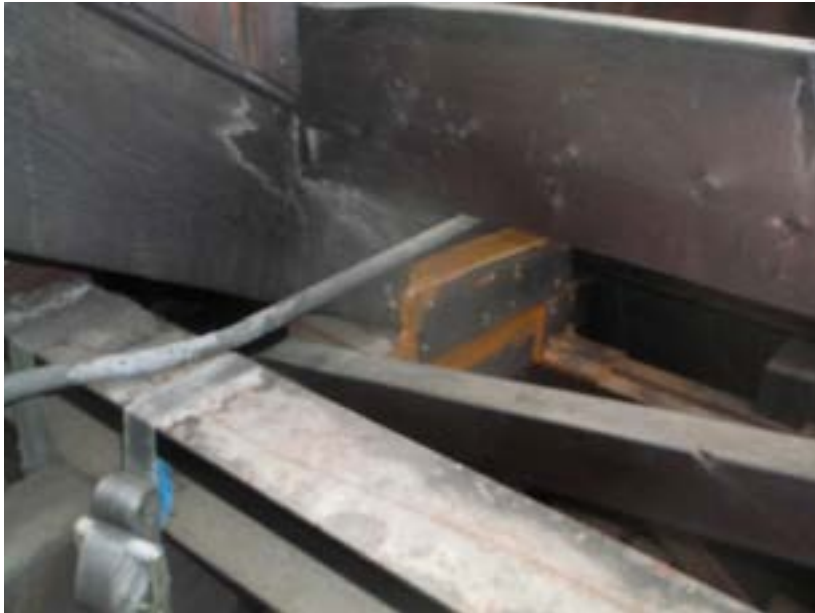
Fig 21:

East bearing end of the king post truss (TR4): showing general view of the bearing end. Note that the joint between the tie beam and principal rafter had been strengthened with steel plate on each side. The contribution of the screw fasteners should not be considered in the joint structural verification. Additionally note that the tie beam had been restrained against the rotation to the top chord of the steel truss

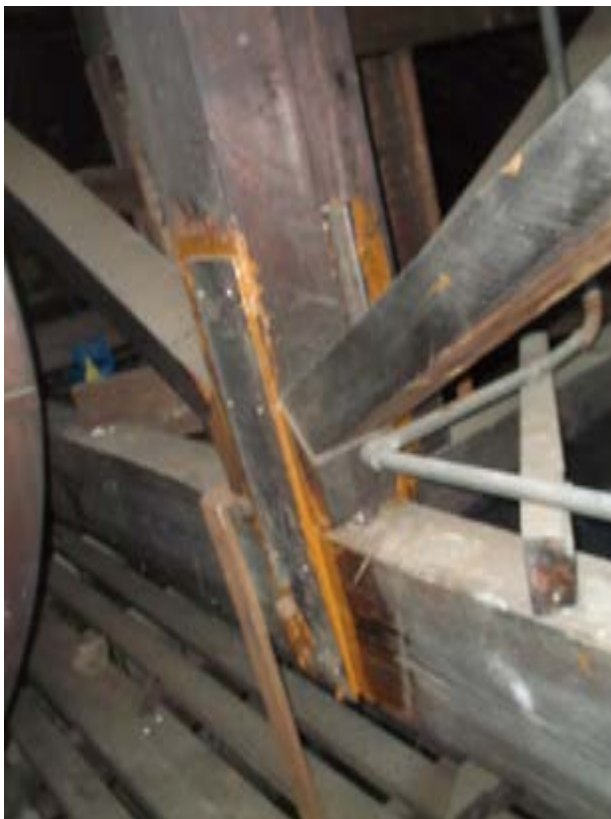
Fig 22:

Timber joint of the king post truss (TR4): showing general view of strengthened timber joint with steel plate between the king post and tie beam. The contribution of the screw fasteners should not be considered to contribute to the strength of the joint. All of the structural timber elements of the truss system (TR4) were strength graded to the strength class C24

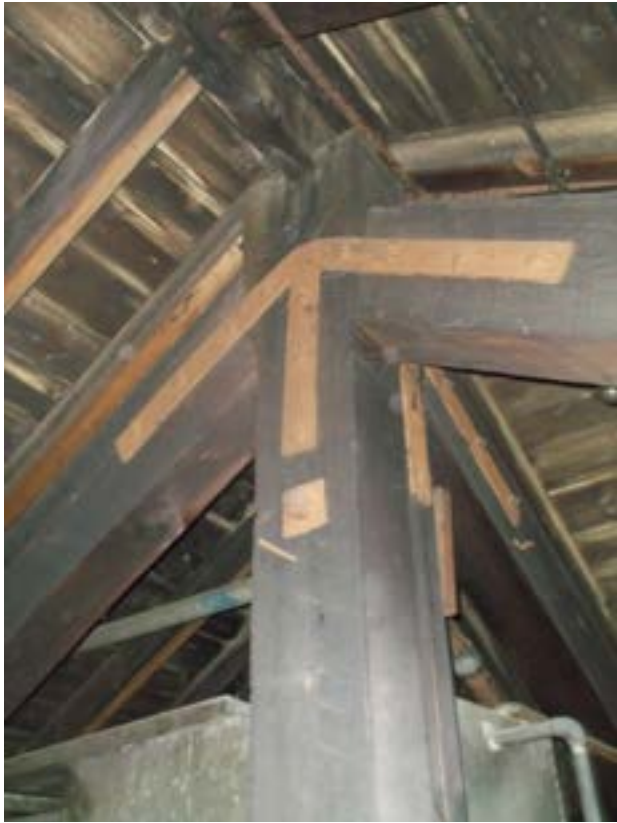
Fig 23:

Upper section of the king post truss (TR4): showing general view of the apex area of the truss system. Note discoloration to the ridge element and sarking boards. This suggested that there might have been some superficial decay to the topside of the sarking boards. The ridge board was not accessible for physical decay detection drilling, however no visual structural decay was observed to the ridge and sarking boards

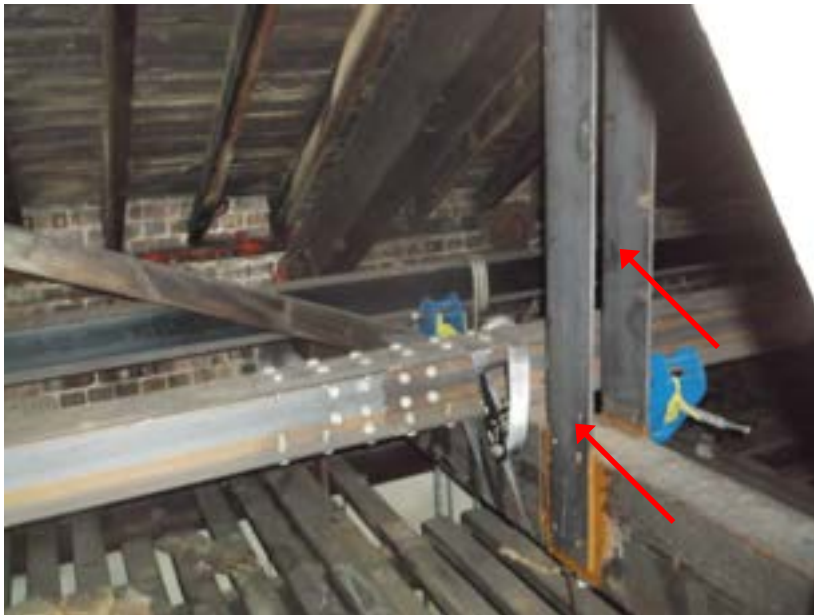
Fig 24:

West half of the king post truss (TR4): showing 2 no. additional steel plates which were installed on either side of the truss to all of the king post trusses

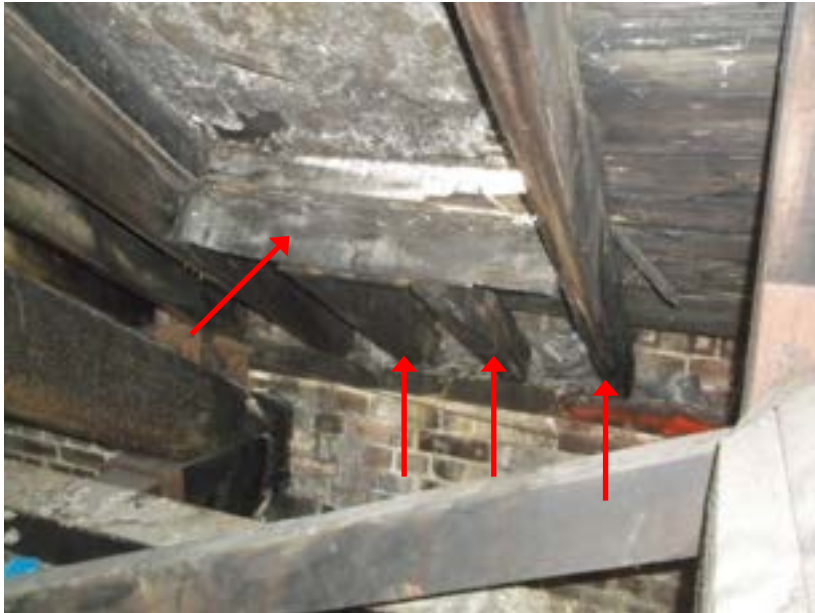
Fig 25:

- 4 Rafters between TR3 and TR4 trusses: 4 no. roof timber elements around the hatch opening, located to the west pitch of the roof, were structurally decayed: 2 no. trimmer rafters and 1 no. trimmer element were structurally decayed in their entirety and 1 trimming rafter, supporting the counter-spanning trimmer element, was decayed for approximately 400mm from the end grain. Additionally, 1 no. adjacent rafter, to the north of the hatch opening, was also structurally decayed for approximately 300mm from the end grain

Hatch between TR3 and TR4 truss systems, to the west pitch: showing general view of structurally decayed 2 no. trimmed rafters and 1 no. trimmer element in their entirety. Additionally, the trimming rafter was structurally decayed for approximately 300mm

Decayed elements in their entirety should be replaced with new structural elements as specified by the Structural Engineer. 2 no. decayed rafters at their feet should be cut back to sound timber and partnered with new timber elements

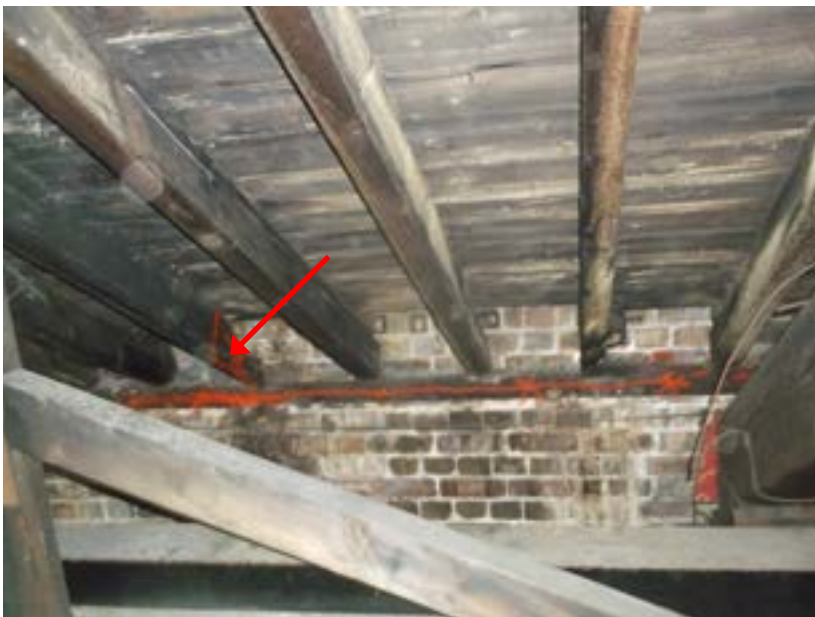
Fig 26:

- 5 Timber plate along the west pitch: Only timber plates along the west pitch were accessible at the time of survey. Physical testing indicated that a segment of approximately 3m in length, between TR3 and TR4 trusses, was structurally decayed by wet rot. Timber plates located along the north, east and south masonry structures visually did not appear to be decayed

Timber roof elements between TR3 and TR4: showing structurally decayed 1 no. rafter foot for approximately 300mm and underlying timber plate for approximately 3m

Structurally decayed timber plate should be cut back to sound timber and replaced with new structural timber. New timber element should be isolated from the masonry with a damp-proof membrane

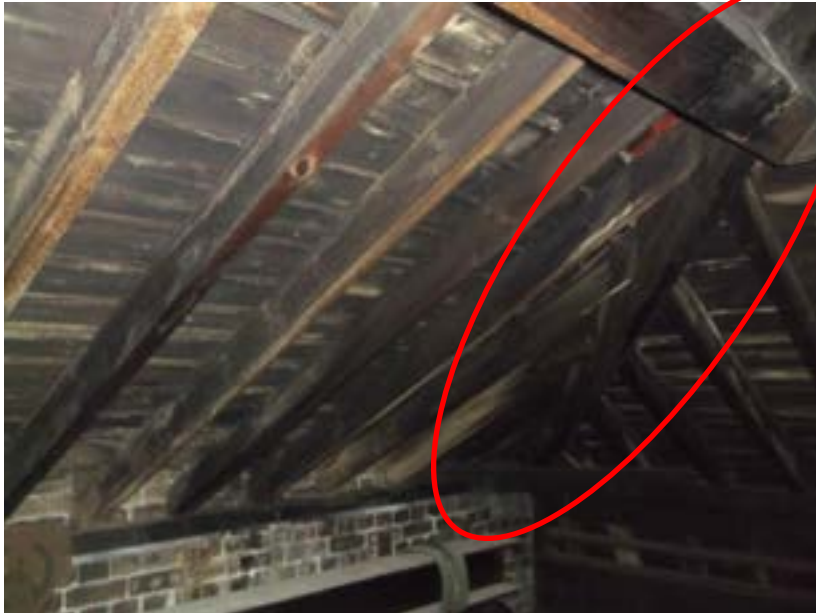
Fig 27:

North-west hip rafter: showing general view of south-east hip rafter and jack rafters. Approximately 4 no. jack rafters along the hip rafter span were structurally decayed at their bearing ends. Additionally, the sarking boards around the hip rafter were decayed, where wet rot decay extended between 100mm and 300mm on the each side of the hip rafter

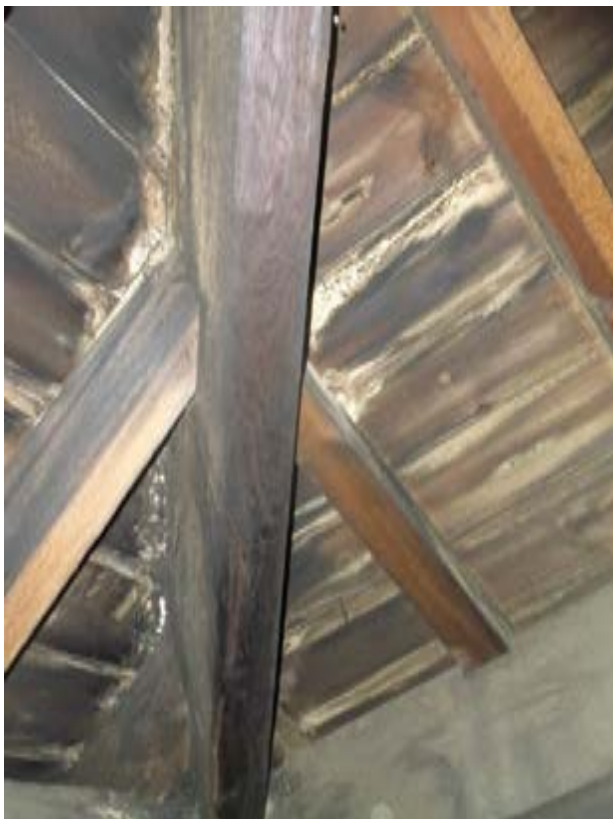
Fig 28:

North-west hip rafter: showing close-up view of structurally decayed sarking boards

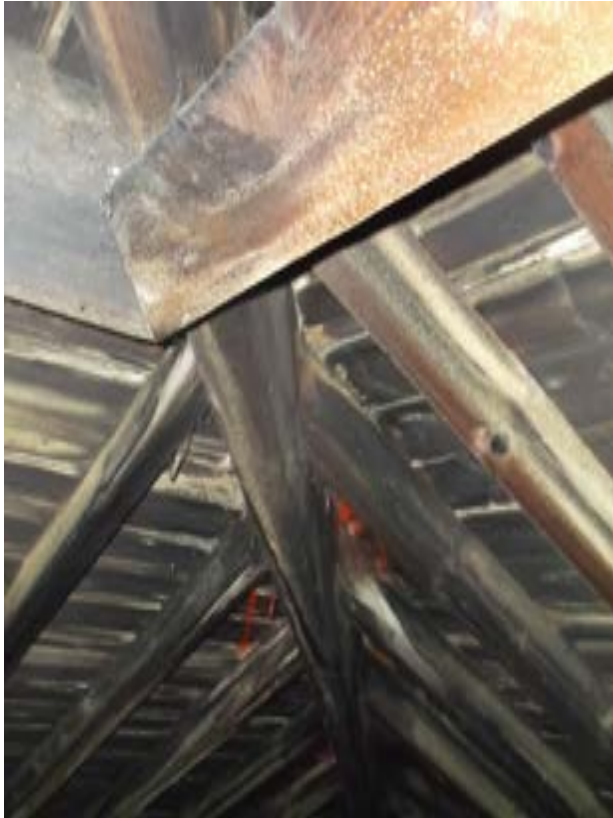
Fig 29:

North-east hip rafter: showing general view of south-east hip rafter and jack rafters. Approximately 3 no. jack rafters along the hip rafter span were structurally decayed at their bearing ends. Additionally, the sarking boards around the hip rafter were decayed, where the wet rot decay extended between 100mm and 300mm on the each side of the hip rafter

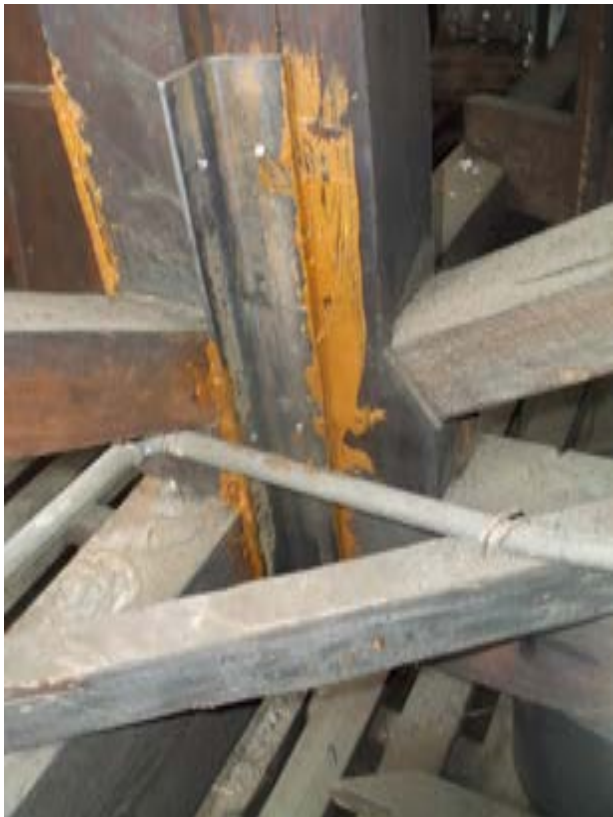
Fig 30:

Intersection between timber half truss (TR5) and king post truss (TR4): showing strengthened timber joint between the king posts and tie beams with epoxy based adhesive and steel angle section. Note that the screw fasteners should not be considered to contribute to the strength of the joint, as their sole use was for holding the steel element in place until the end of solidification process of the adhesive from the liquid state

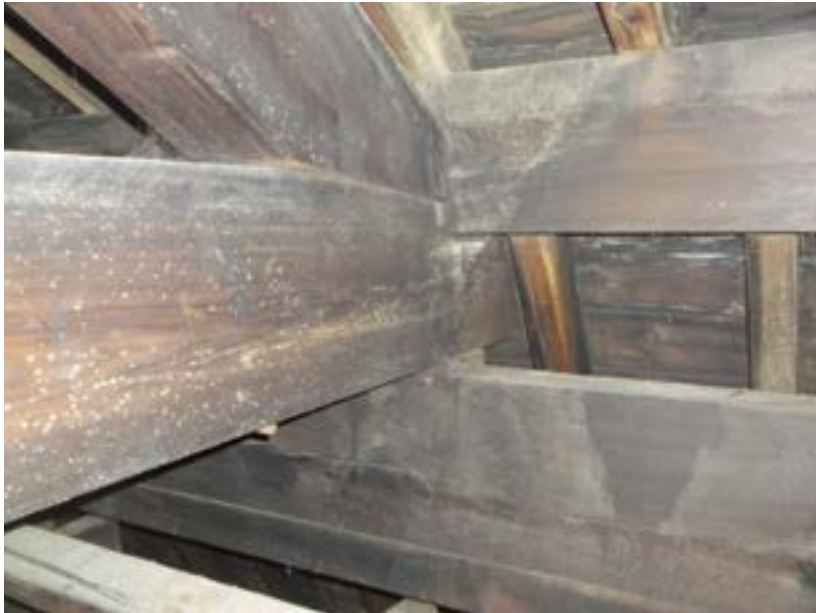
Fig 31:

North bearing end of the half truss (TR5): showing general structural configuration of the south bearing end of the half truss. Note signs of mould on timber tie beam

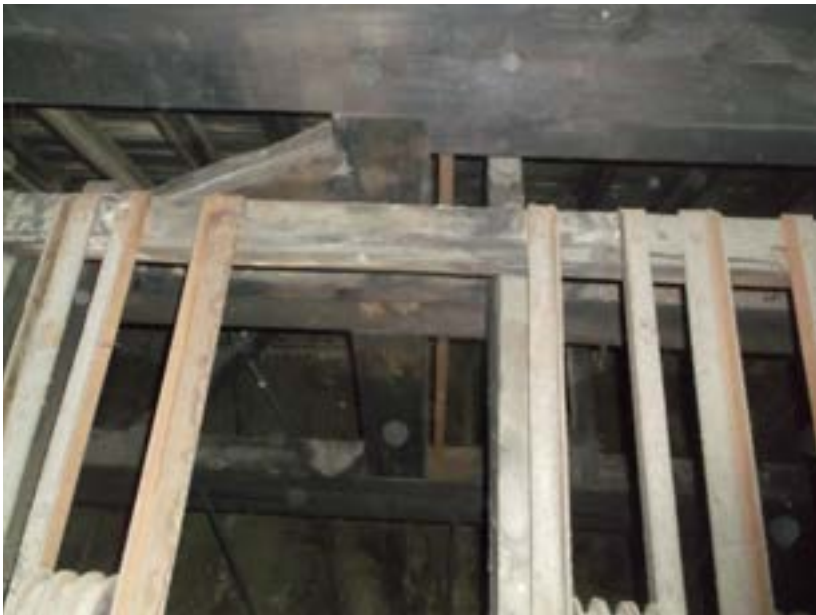
Fig 32:

Timber truss long the north pitch: showing general view of timber truss system which visually appeared to be in good condition

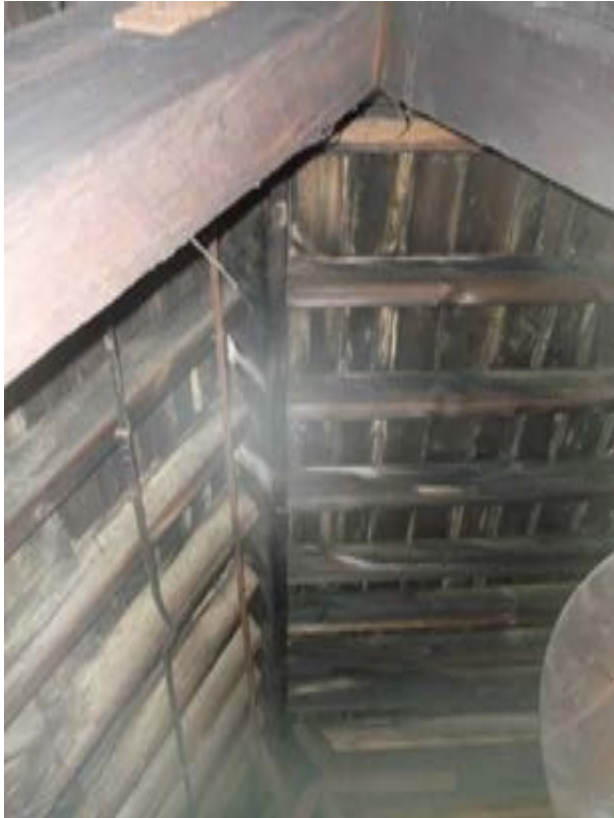
Fig 33:

Roof timber elements between TR3 and TR4 timber trusses: showing general view of the ridge board and sarking boards. Note that these elements had water staining signs. It was anticipated that there was superficial decay to the top side of the sarking boards, however no visual decay was observed to ridge and sarking boards

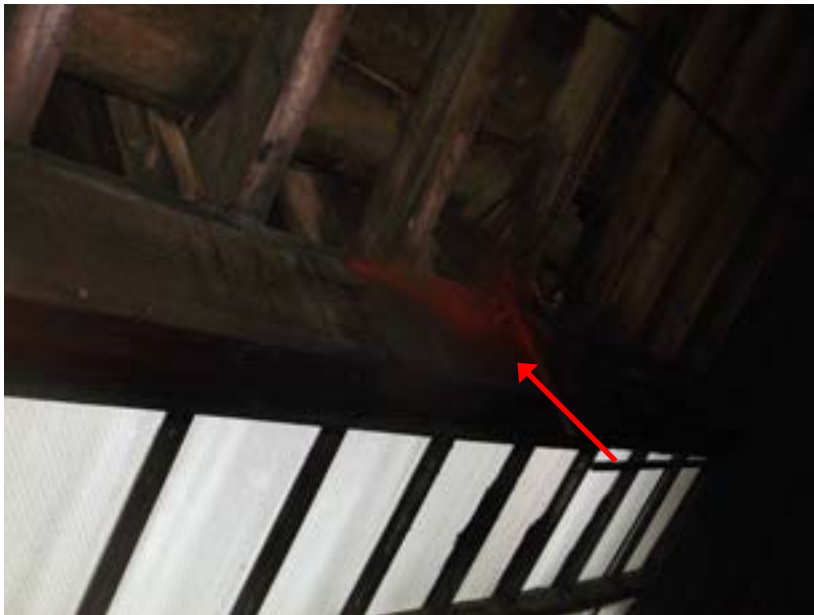
Fig 34:

Purlin along the west pitch between TR3 and TR4 trusses: showing structurally decayed timber purlin at localised area with a cross-sectional loss of approximately 25 per cent

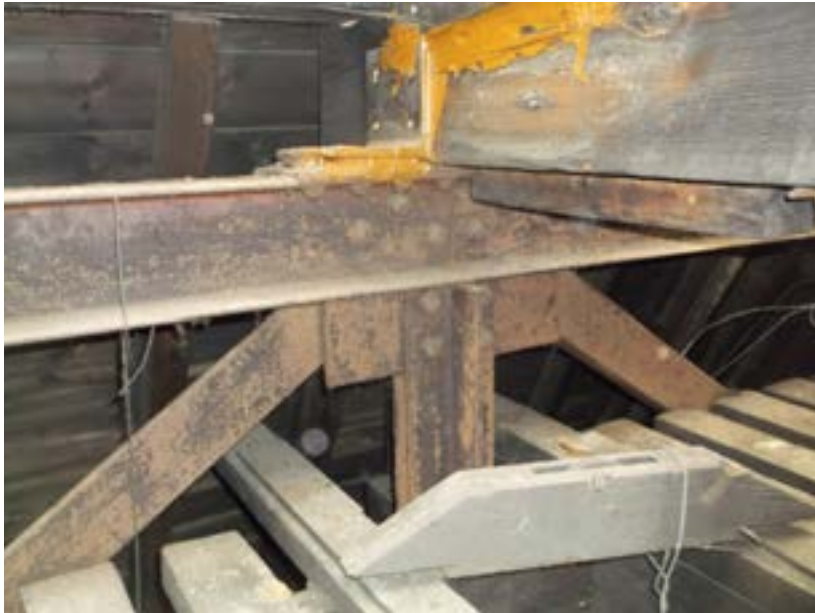
Fig 37:

East bearing end of TR4 truss system: showing truss bearing end supported at node position. Note that each element of the steel truss comprised of different sections

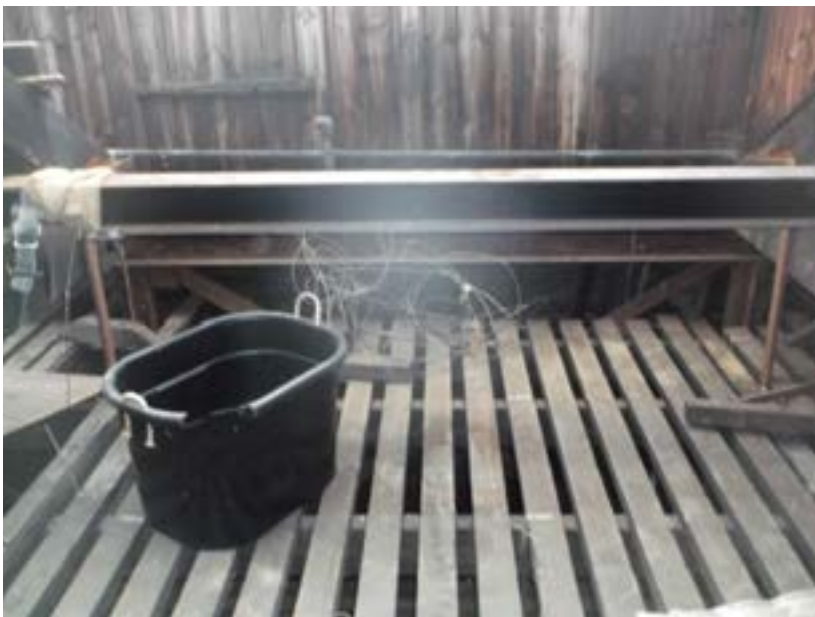
Fig 38:

Upper section of steel truss between TR3 and TR4 timber trusses: showing general view of the steel truss. Note that east bearing ends of timber trusses were supported at steel truss node positions

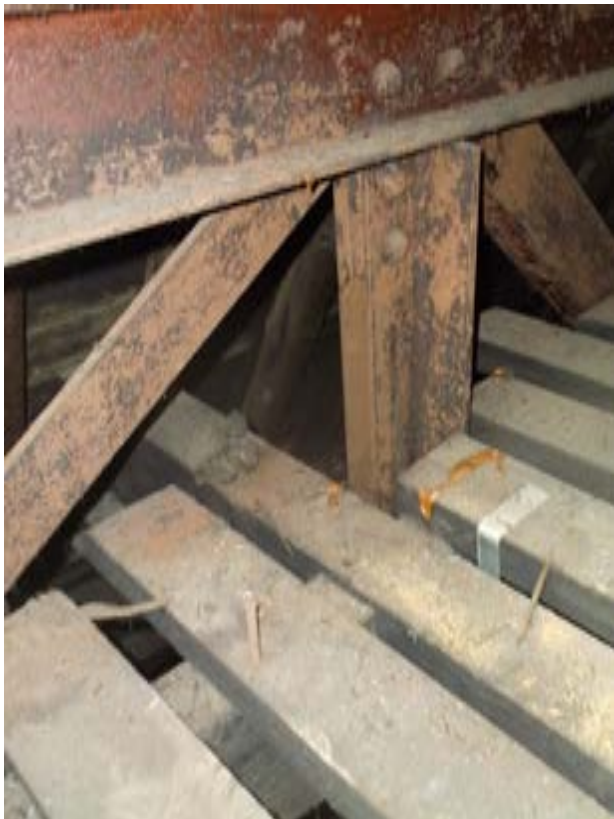
Fig 39:

Steel truss along the east pitch:
showing general view of the node
between the first and second bays,
counting from the south. Note that
each element was of different section
type

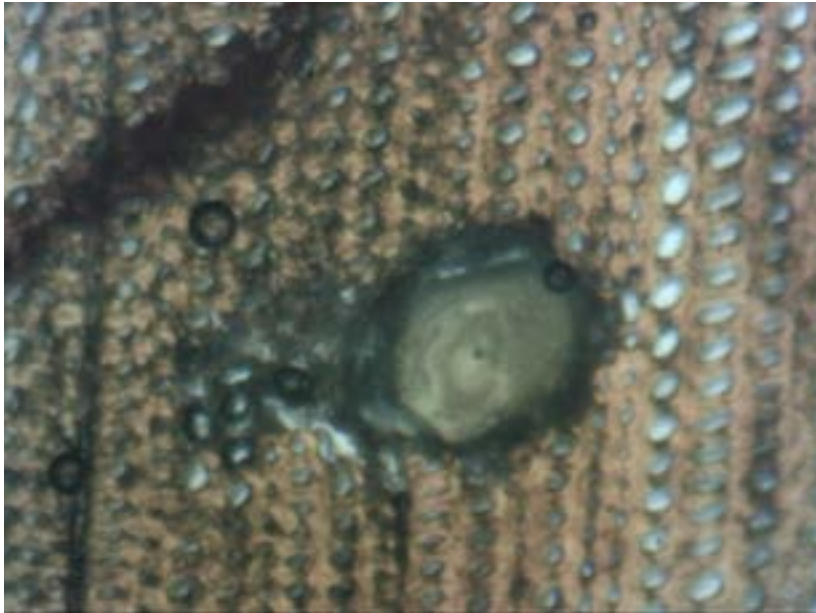
Fig 1:

Showing transverse section of the timber sample on microscopic level. Note the presence of the resin canal. This is a common feature of Pitch Pine timbers
