The Hope Project: Investigation of the 'Fly Tower' roof for condition, strength classes and construction

Site note 2 for 8 March 2018, job no. 146.89

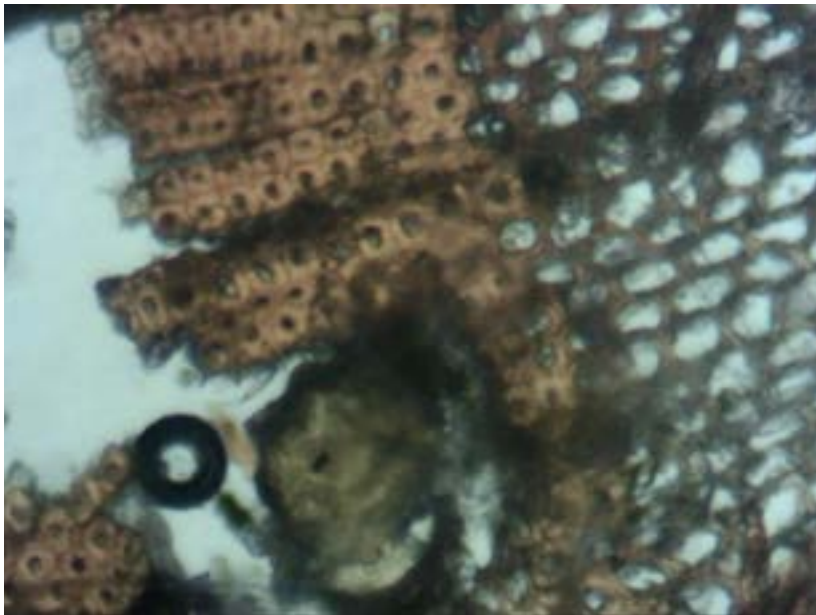
Fig 2:

Showing transverse section of the timber sample on microscopic level. Note sudden change between latewood and earlywood and the presence of the resin canal. These are common features of Pitch Pine timbers

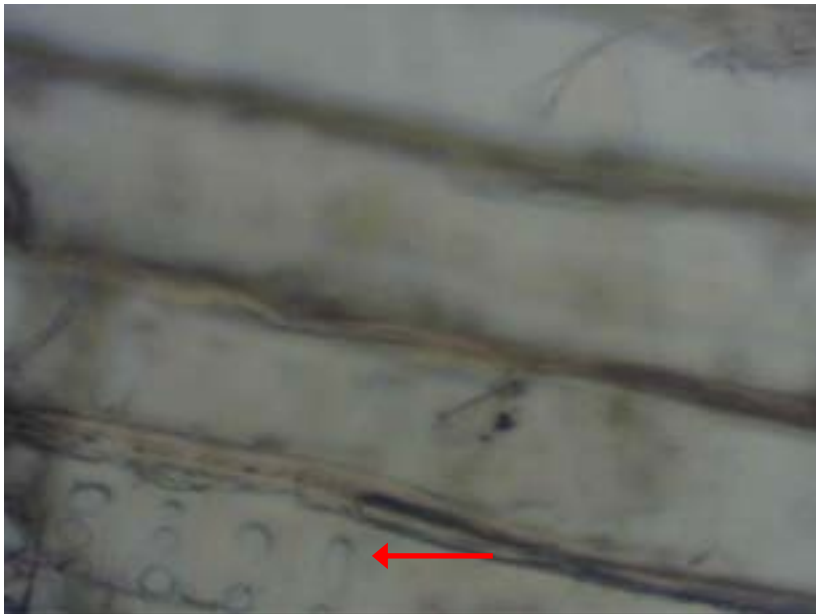
Fig 3:

Showing radial longitudinal section of the timber sample on microscopic level. Note pinoid pitting in the cross field. This is a common feature of Pitch Pine timbers

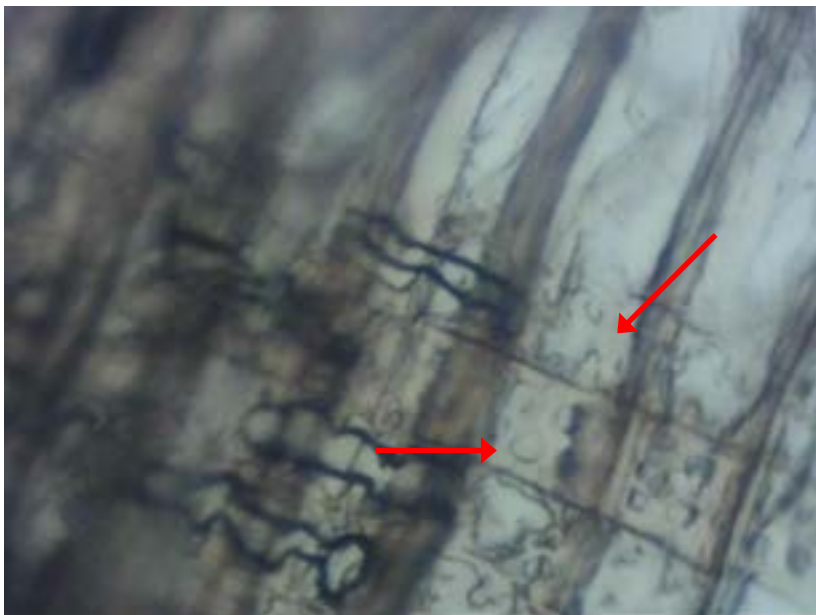
Fig 4:

Showing radial longitudinal section of the timber sample on microscopic level. Note pinoid pitting in the cross field and dentate ray tracheid. These are common features of Pitch Pine timbers
