# **Arboricultural Hazard Assessment Report**

**1 Hollycroft Avenue, London, NW3 7QG**

**November 2017**

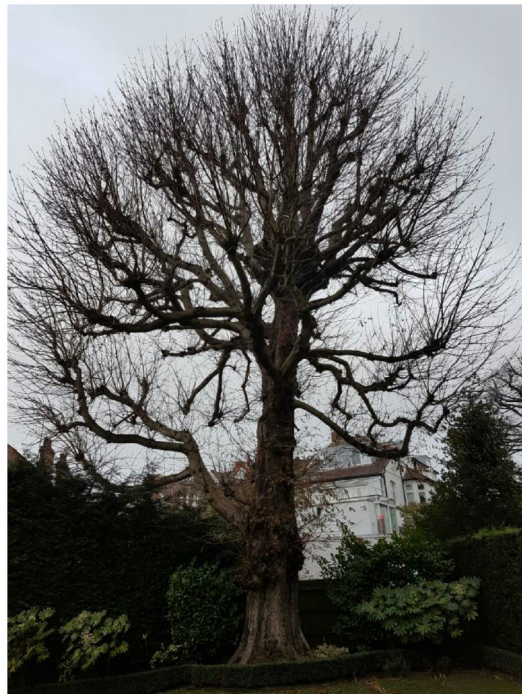
**Photo 1** – Overall view of tree

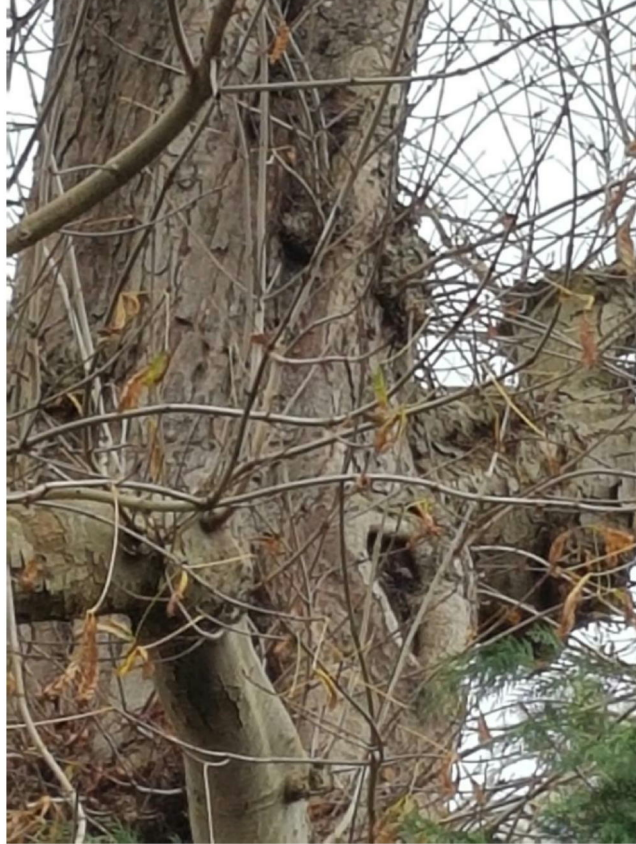
**STEM:** the tree has lost a major scaffold - there is a historic pruning wound a 1.8m that has partially occluded, indicating this may have occurred at some point within the last 20 years. Some patches of red rust were observed, indicating the presence of *Pseudomonas syringae* pv *aesculin* at these locations, as was some bark-lifting but it could not be determined whether this is attributable to normal 'plating' of bark, as is character of a tree of this species & maturity or as a result of the pathogenic colonisation. The stem was probed behind the lifting

**Photo 2** – Showing historic wounding on stem & partial occlusion of wounds

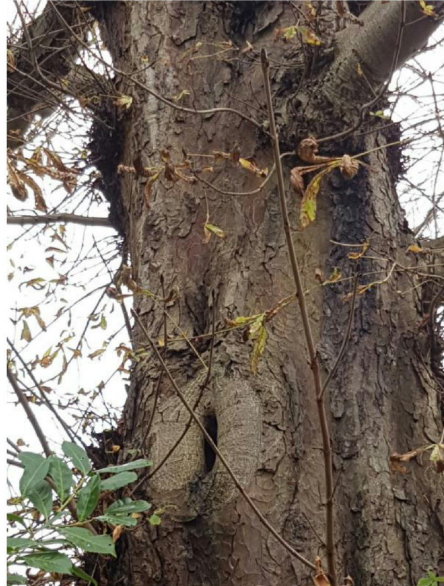
plates & no cavitation was detected. Soundings were taken, with dullness indicating dysfunctionality around areas where exudation was seen, as well as dullness around where bark plates were lifting, (though, of course, this would be expected at these points). There are areas where epicormic shooting has formed over time into burrs, through successive pruning of the epicormic shoots. These are present from 1.8m to crown break at 8m. There are multiple cavities present from 1.8m to 8m, all are historic pruning wounds, and can only be as a result of the removal of large branches, estimated to be within the last 20 years. None have fully occluded, though some show near full occlusion, though others much less so. Those that have not occluded well show deadwood within the wounds, to a greater or lesser extent.

**Photo 3** - Showing more historic wounding on stem & extent of occlusion

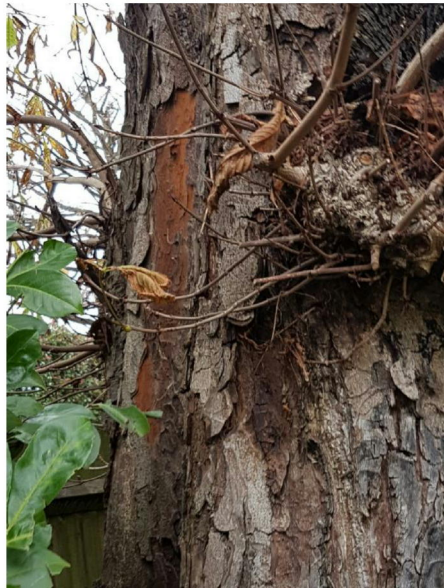
The tree is classed as 'over-mature', but the impact of such a mature specimen being present in such a congested residential area has been significantly mitigated by the management pruning it has received; both historically & in recent times. The lapsed nature of the historic pollarding has restricted the species tendency to grow to great height & to establish very significantly sized stems & scaffolds. Whilst the stem is of a significant girth, (117.3cm Diameter at Breast Height, DBH), the scaffolds have had their growth severely limited by this intervention. The more recent pollarding regime has repeated this effect, thereby enabling such a large specimen to remain manageable & keep its position as focal point in what is a relatively confined space – the rear garden of a residential property. The tree has 2 pathogenic infestations as detailed, but this must be qualified by reference to other specimens of the same species in the locality & throughout London & the South of England. At the present time it is very unlikely that a Horse Chestnut without an infestation of Chestnut Leaf Miner could be found within the South of England. This condition, whilst not fatal to the colonised tree, does restrict the tree's ability to optimally photosynthesise, thereby weakening it's ability to combat secondary pathogenic attack from bacterial colonisation from *Pseudomonas*

*syringae* pv *aesculin*. However, the extent of colonisation in this specimen is very limited – but it is likely only to get more severe as time passes.

**Photo 4** – Showing a patch of red rust, *Pseudomonas syringae* pv *aesculin*

Perform an aerial inspection, to determine extent of pathogenic colonisation of major scaffolds & produce a written report of the findings. Prune the extremities of the branch extending towards the neighbouring property to achieve 1.5m clearance from the built structure. Maintain a programme of pollarding, with next pollard prune to occur within 2 years as a minimum.

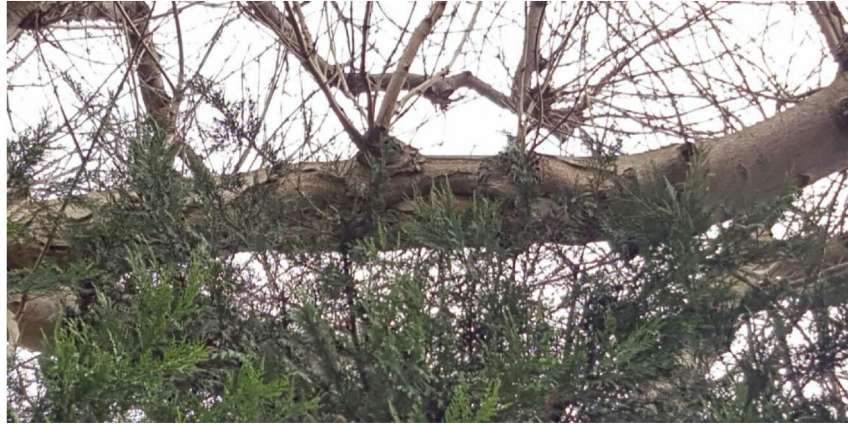
**SCAFFOLDS/MAJOR LIMBS:** observations were limited due to being on ground level. The larger limbs show bark plating & fissuring on lower, underside surfaces, at areas where the wood bears heavy loading, as would be expected of a tree of this maturity & size. One limb over the adjacent hedge/fence has damage to its lower surface consistent with historic squirrel damage, with exposed & deadened heartwood. There has been significant compensatory wound wood regrowth around the scarring. There are some recent pruning wounds that are in varying states of occlusion. Reactive growth from secondary pollarding seems normal on each major limb.

**Photo 5** – Showing squirrel damage to 1 lower limb

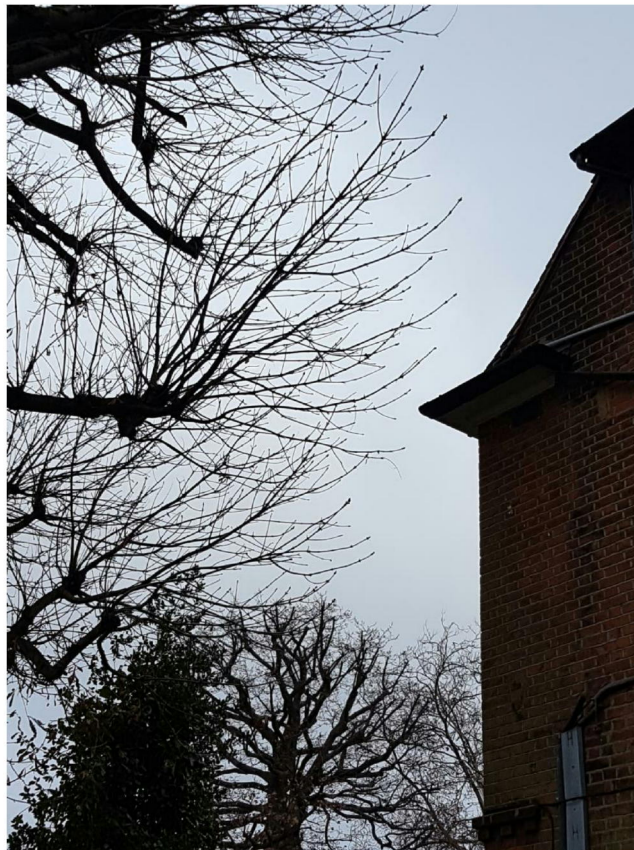
The tree is a historic pollard, with the major crown break at 8m from ground level. Approximately 50% of the crown is supported by the main stem, with 3 major pollard 'knuckles'. There are approximately 8 more scaffolds supporting further pollard points. The branches emanating from the 3 main knuckles & 8 scaffolds are all lapsed pollard growths; the regrowth from the original pollard points is approximately 3-8m long, depending on position in the crown. These regrown branches are approximately 20-40cm in diameter. At the end of these branches are secondary pollard points, which have been pruned in a regular maintenance programme, last undertaken approximately 4-5 years ago. The approximate length of these branches is 2-3m & their approximate diameter is 3-5cm. The outer extremity of these is within 0.5m of the built structure of the neighbouring property.

**Photo 6** – Showing proximity of branch to neighbouring property
