1&1a Montague Street

Structural Report

Curtins Ref: 063007

Client Name: The British Museum

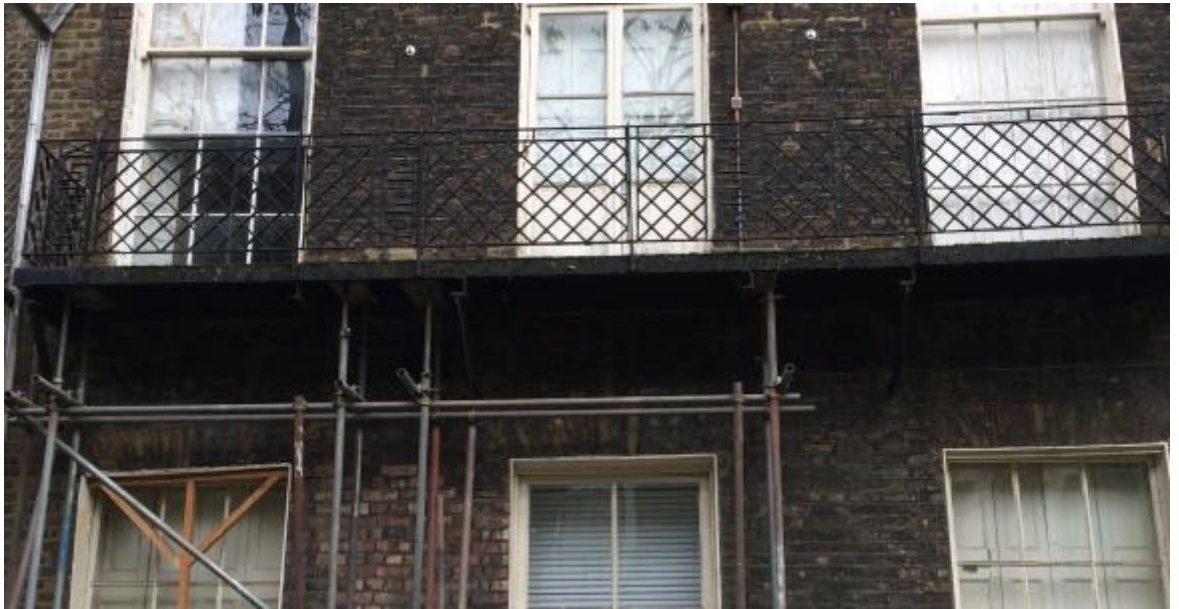
Figure 1 - Existing balcony

More recently, localised exposure works revealed that the balcony is of a much lesser construction than anticipated. Of the six supports, three are just cantilevering out of the thickness of the rear elevation wall, whilst the other three are supported by diagonal braces.

We are of the opinion that as a structure, its supports cannot be justified analytically and certainly not to accommodate loadings from present day standards. If the structure is removed for refurbishment and then reinstated, there is a significant possibility lots of additional strengthening works may be required, potentially impacting upon the elevation brickwork. Certainly the existing cantilever bearing detail would not be acceptable. Consequently, it is proposed the balcony be refurbished in situ, without removal, but with some strengthening works basically just to support the balcony structure.

It is proposed that the existing three braced supports be supplemented with three new braced supports at the locations of the existing cantilever supports, i.e. replicating the existing braced supports. A sketch detail is shown above. Please also refer to BDP drawing (15) AE002, Rev D issued with this report.

The loadings for balconies are much higher than can be accommodated by the present form of construction and indeed higher than would be acceptable for the strengthened form of construction, hence it is NOT to be used as a balcony.

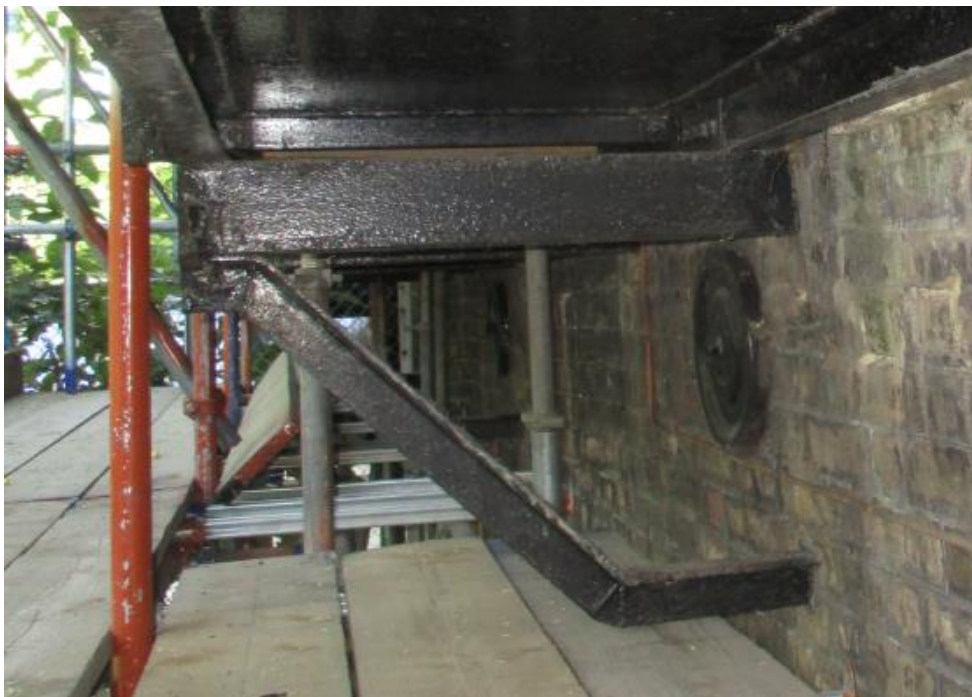
Figure 2 - Example of an existing braced support to the balcony

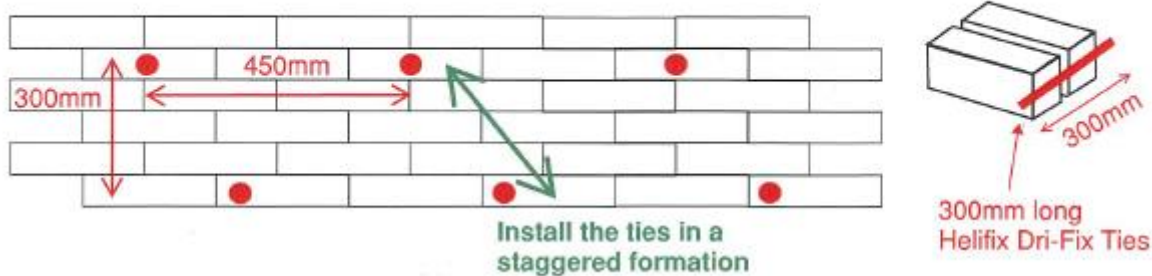
Figure 4 - Repair Works to Rear Elevation

In addition to the balcony, remedial works are required for the rear elevation. In properties of this age and type, frequently the outer skin / external face of the main external walls used to be built by an experienced bricklayer, whilst the inner thickness was built by an apprentice. Thus the thickness of the walls was not fully bonded. Indeed, through the thickness of such walls, bed joints may be at different levels due to inconsistent coursing. This form of construction is described as “snapped header” construction. It is proposed to install remedial ties to ensure that the wall is bonded through its thickness.

- Staggered Helifix DryFix Ties, 295mm long at 225mm (vertical) and 450mm (horizontal) staggered centres

The form of remedial works is shown above. DryFix ties, as their name suggests, do not require resin or grout. They comprise a mechanical pinning, but do not involve mechanical expansion. The ties are easy to install and effective, and finished behind the face of the masonry.

For Montague Street, this form of repair is suggested for the spandrel panel and pier to No.1 at the end of the balcony near the party wall.

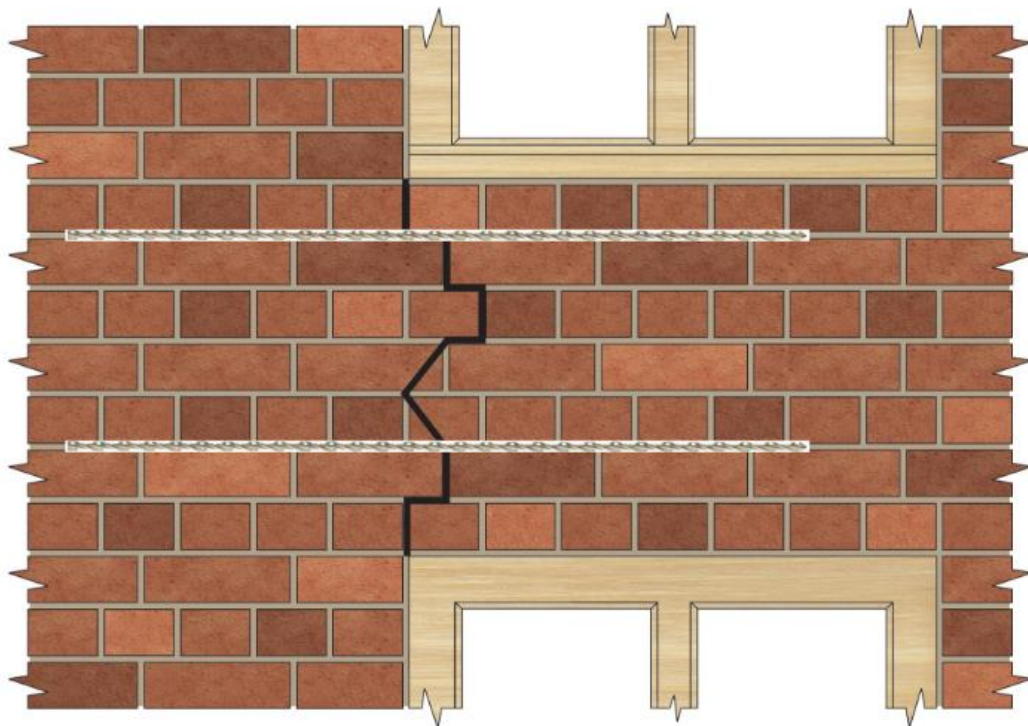
Figure 6 - HeliFix crack stitching repair

Cracks being repaired in this manner have been identified on site, both internally and externally. Those works will be supplemented by (non-structural) repointing works.

Cracking in the elevation brickwork is to be repaired by installation of 1000mm long HeliFix HeliBars, bedded in position at 225mm vertical centres with HeliBond grout – all materials to be used strictly in accordance with the manufacturer's guidelines and recommendations – pointed to match the adjoining areas of face brickwork.

The full length of the cracking, including that between HeliBars, is to be repaired with a proprietary repair mortar, such as an epoxy based weatherproof filler like Crackbond TE – again, all materials to be used strictly in accordance with the manufacturer's guidelines and recommendations.

Lengths of [HeliBar](#) extending 500mm either side of the crack are bonded into cut slots, normally the mortar beds, with [HeliBond grout or resin](#) for a reliable and permanent solution. Where cracks are less than 500mm from an external corner or an opening, at least 100mm should be bent round the corner and bonded into the return wall or bent and fixed into the reveal, avoiding any DPC membrane.

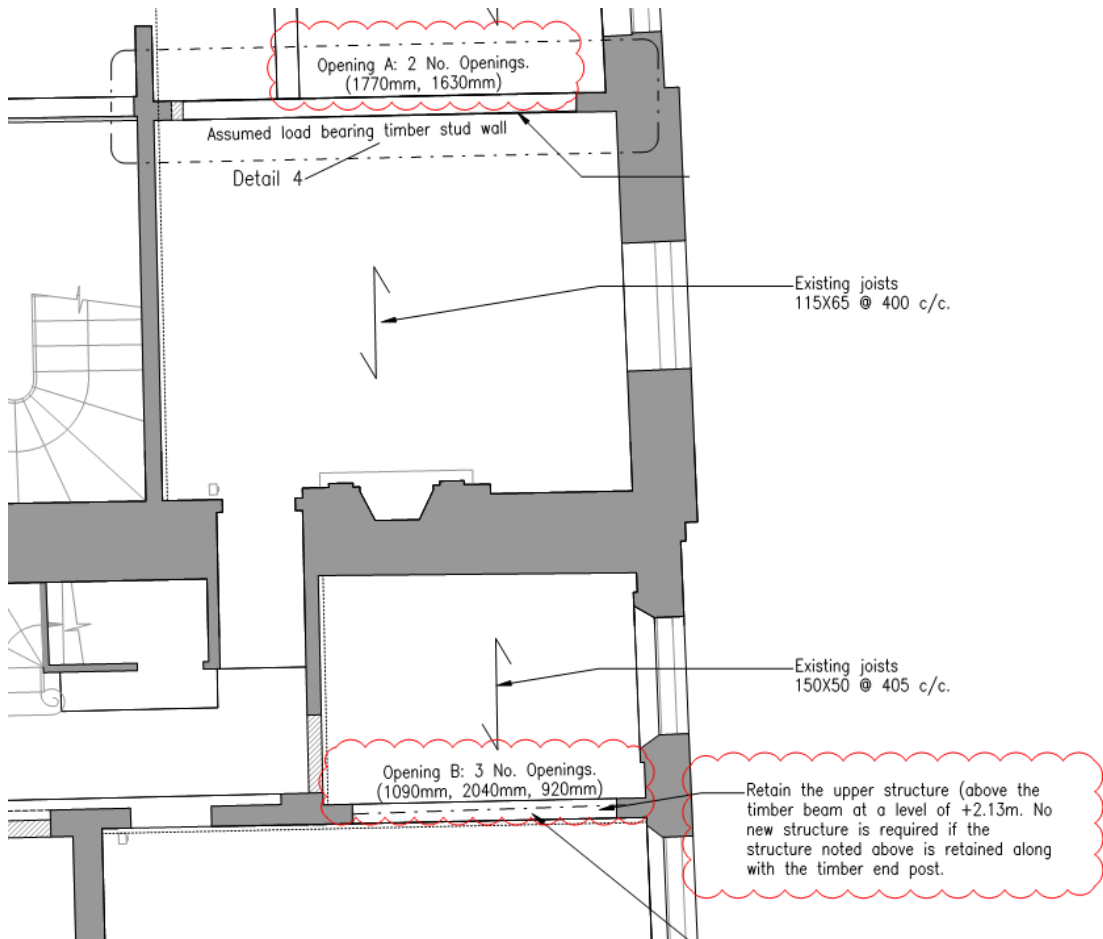
Figure 7 - Extract from second floor drawing showing reduction of opening widths minimising structural interventions (refer to Appendix 2, BDP Drawing (20)AP004_WorkInProgress)

Localised exposure works in advance of creating the openings have revealed there to be elements of more than simple vertical loadbearing timber studs to these internal walls. There are diagonal timber sections within the walls and differing sizes of timber studs.

In order to reduce the level of structural intervention of the existing building fabric and minimise or obviate the need for structural works, we now propose to retain the larger timber studs and generally only remove the smaller timbers. This has the effect of reducing the widths of the proposed structural openings, but still achieving the opening up of the various spaces.

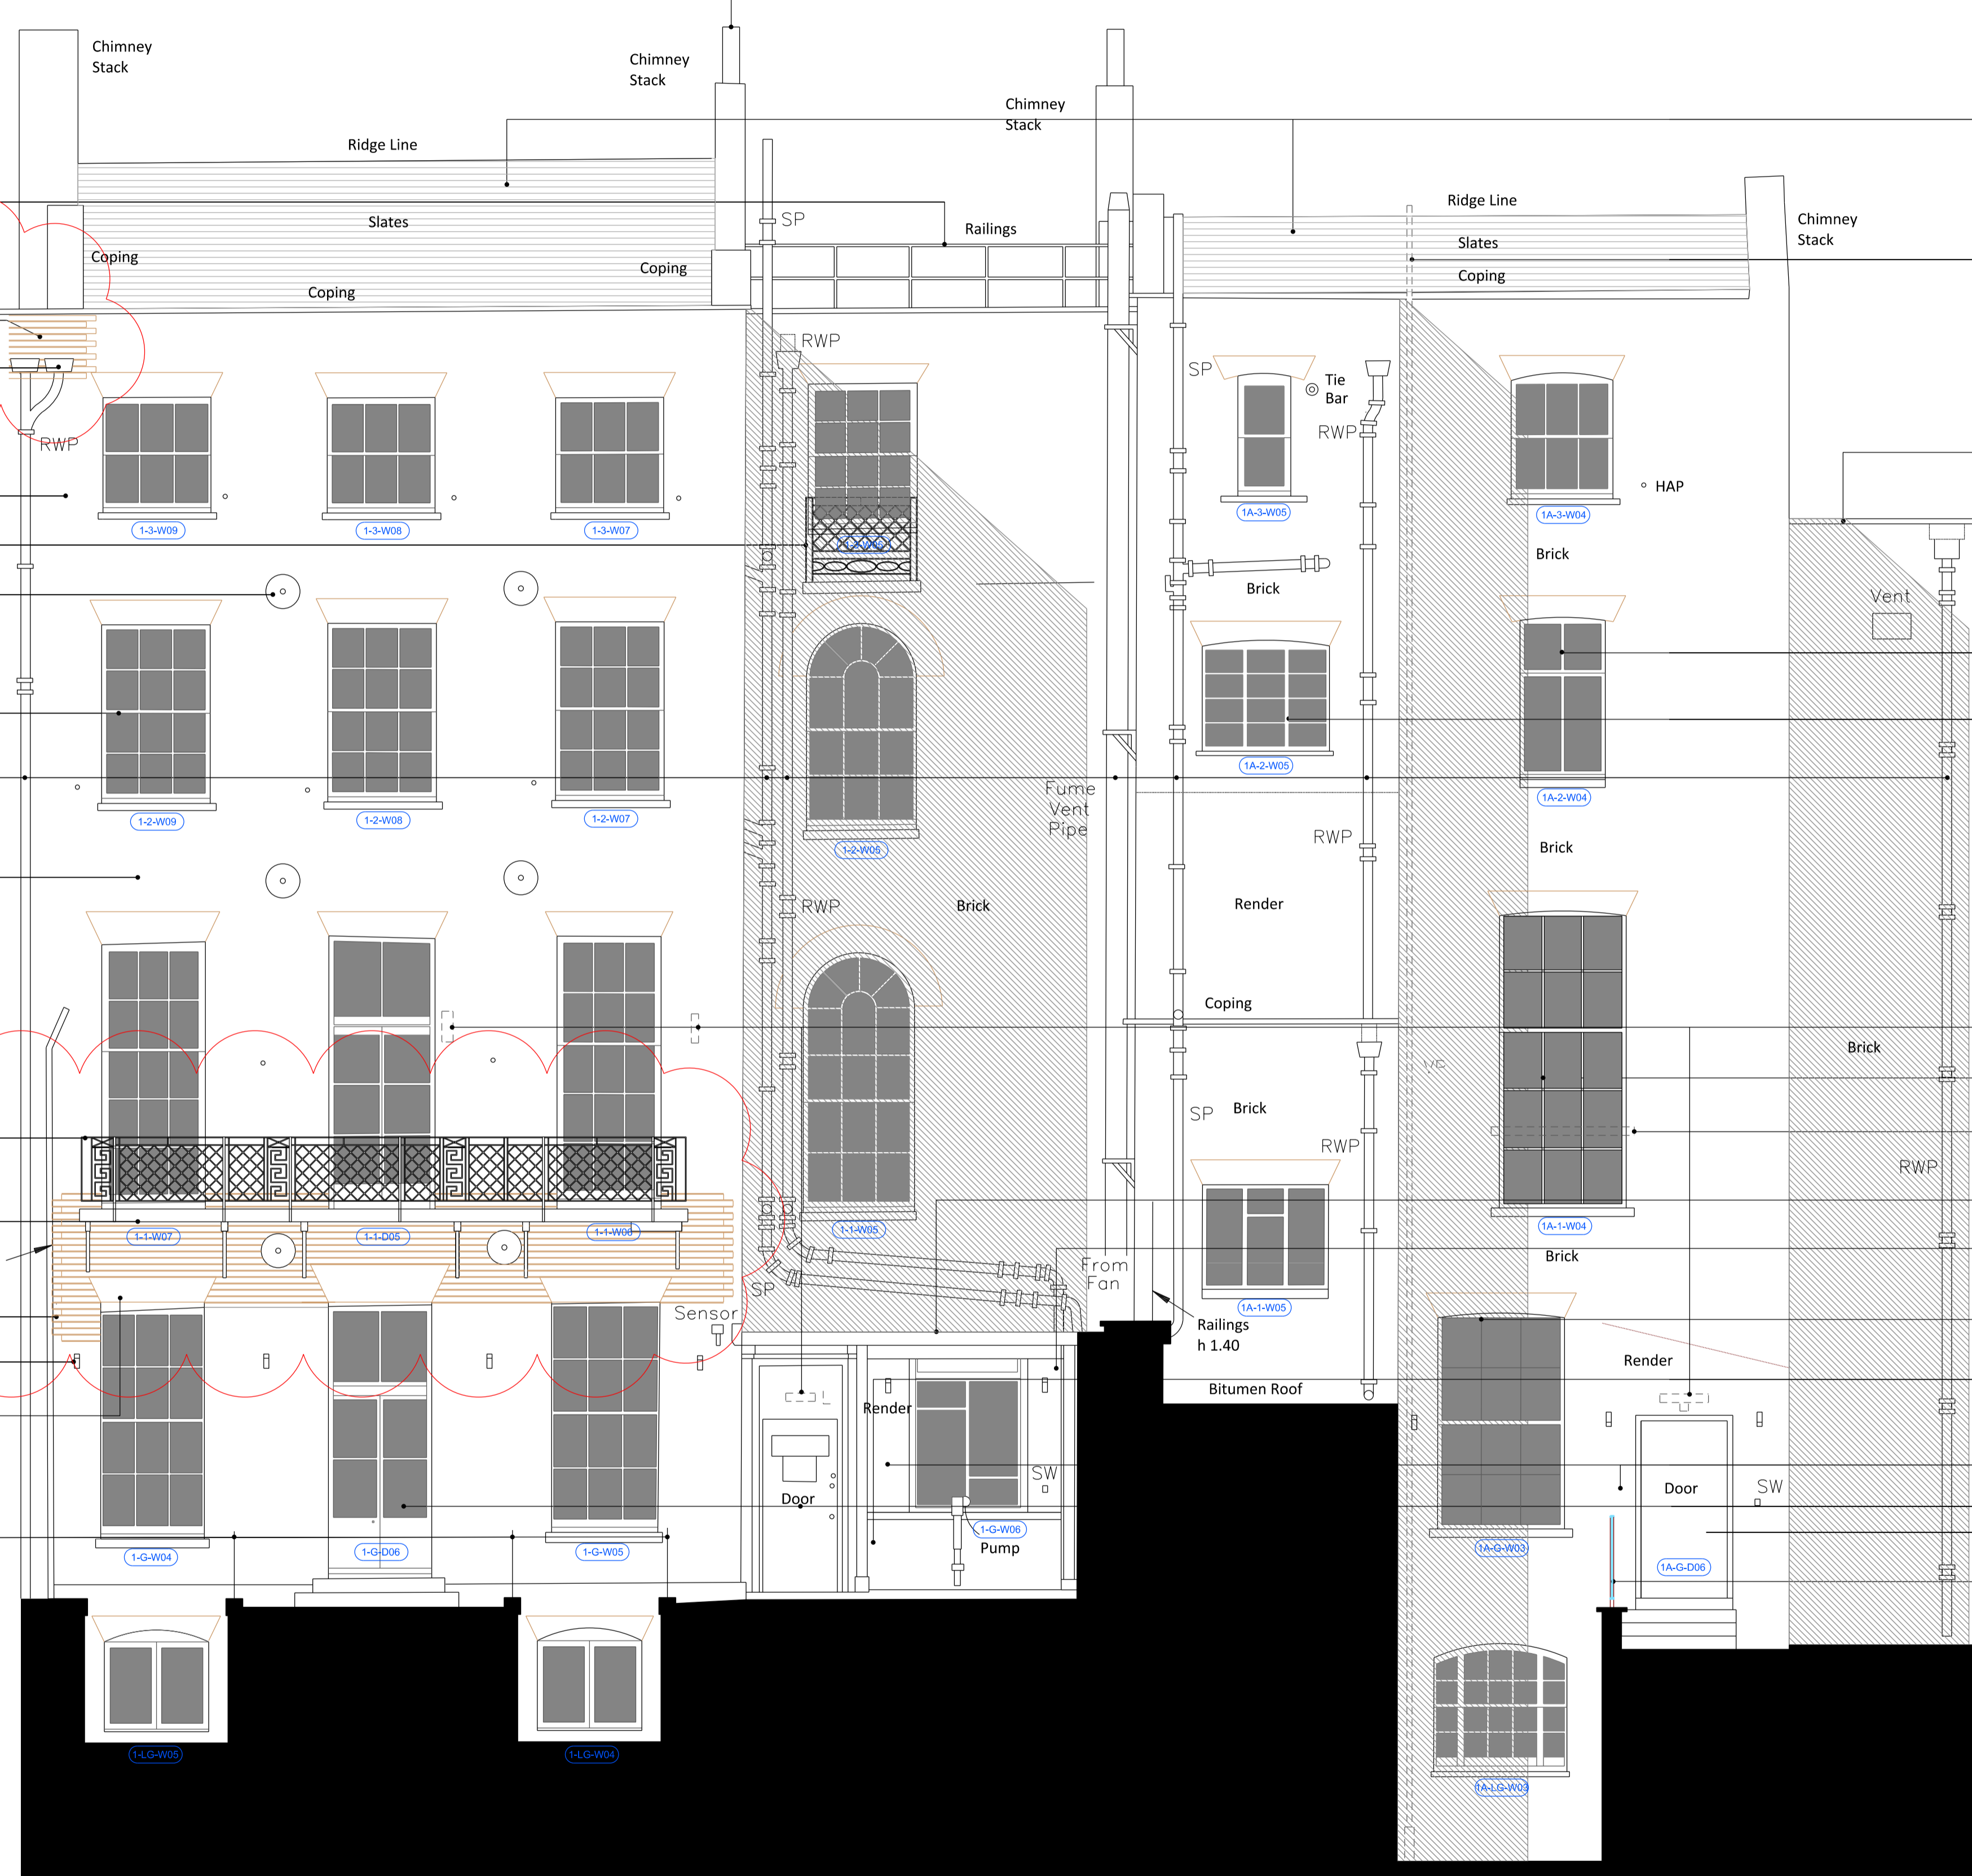
British Museum Perimeter Properties Refurbishment	
P2007246	
DRAWING TITLE 1-1A Montague Street Proposed Rear Elevation	SCALE 1:50@A1
DATE Planning and LBC Application	DATE April '17
REVISION (15)AE002	REVISION D

Existing balustrade to be refurbished to ensure stability and redecorated with exterior grade paint finish to match existing colour.
 Upon close inspection after the erection of the scaffold this brickwork was found to be sound - the distorted appearance from the garden is due to attempts to tie the brickwork into the coursing of the adjacent building.
 Organic growth to be removed.

Decorative Iron Railings around Balconies at First and Third Floors
 Balconies unsafe - No Access

Localised non hydraulic lime mortar repointing where required.
 Existing balcony to be repaired and redecorated. Access to it to be restricted.

Cracking to brickwork to be repaired. Replacement of bricks where required and new bricks where missing.

Existing railing to be tied back into facade and redecorated with exterior grade paint finish.
 Existing balcony to be repaired in line with structural engineers report and redecorated. Brickwork to be carefully removed where necessary for new supports to be retained and replaced with mortar to match existing after the works are complete. Access to be restricted.
 Area of existing brickwork to be restrained in place using remedial DryFix ties in line with structural engineer's details, ties will not be visible.
 New external replacement light fittings. Refer to M&E specifications.
 New timber lintel behind window. Refer to structural engineer detail 10, drawing 063007-07.
