**JOHN CROMAR'S
ARBORICULTURAL
COMPANY**

on tree amenity value and condition

2a Templewood Avenue, London, NW3 7XA

(23rd January 2018)

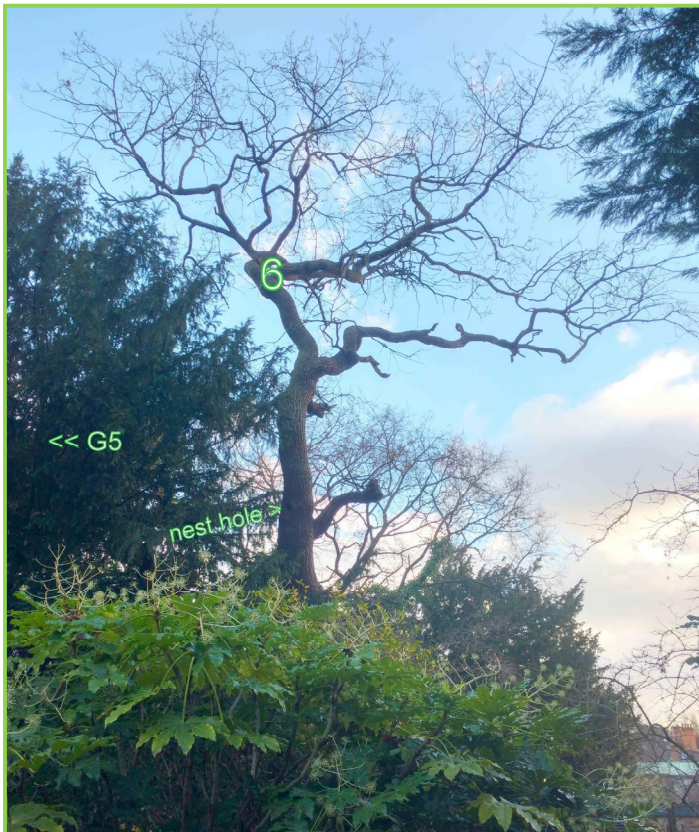
PHOTO – oak 6

A 'tap' test (for sonority) carried out to the base of tree 6 indicated clearly that it is badly decayed. Whilst removal could be defended, there is an opportunity to retain part of it as a much shorter tree, for ecological reasons.
