- 1.1 This report has been prepared by Risk Management Limited for the Client, Messrs. Camden Lifestyle (UK) Limited, under cover of Messrs. G L Hearn Limited's e-mailed instructions to proceed, dated 16<sup>th</sup> April 2018.

- 1.2 The Consulting Engineers for the project are Messrs. TZG Partnership Limited.
- 1.3 The site under consideration was a central courtyard area, with several single-storey and double-storey buildings surrounding, located at Nos. 7 A,B,C Bayham Street, London, NW1 0EY.

- 1.7 Risk Management Limited have now been commissioned to carry out an investigation into the site comprising both a Phase I, *Non-Intrusive*, Desk Study and a Phase II, *Intrusive*, Site Investigation.

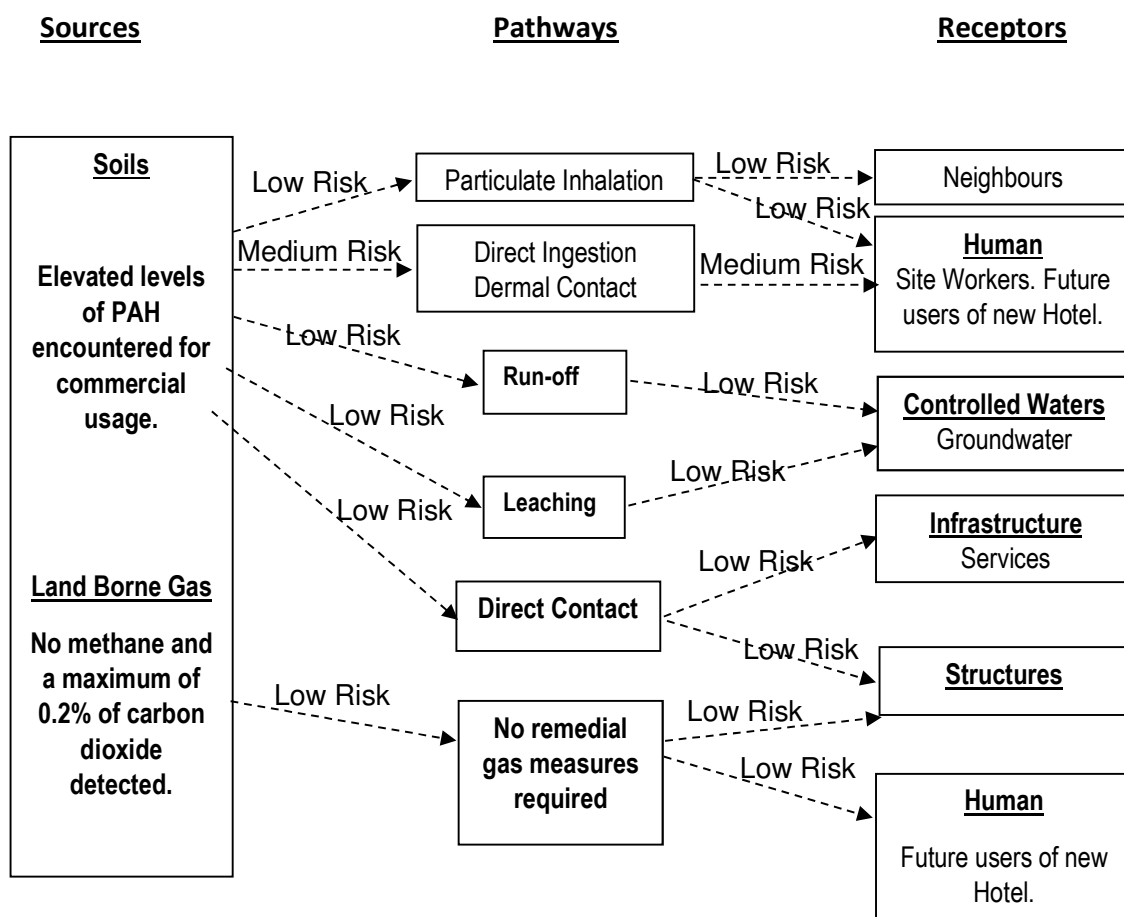
8.53 The following diagram summarises the potential pollution linkages identified for this site in the form of a diagrammatic Conceptual Site Model (CSM).

8.54 By employing the measures discussed in paragraph 8.52 above, the above noted 'medium' risks could be reduced to 'low' risk.
