The Lodge  
Flaxman Terrace  
Camden

Heritage and Design and Access Statements,  
Condition Survey and Schedule of Repairs

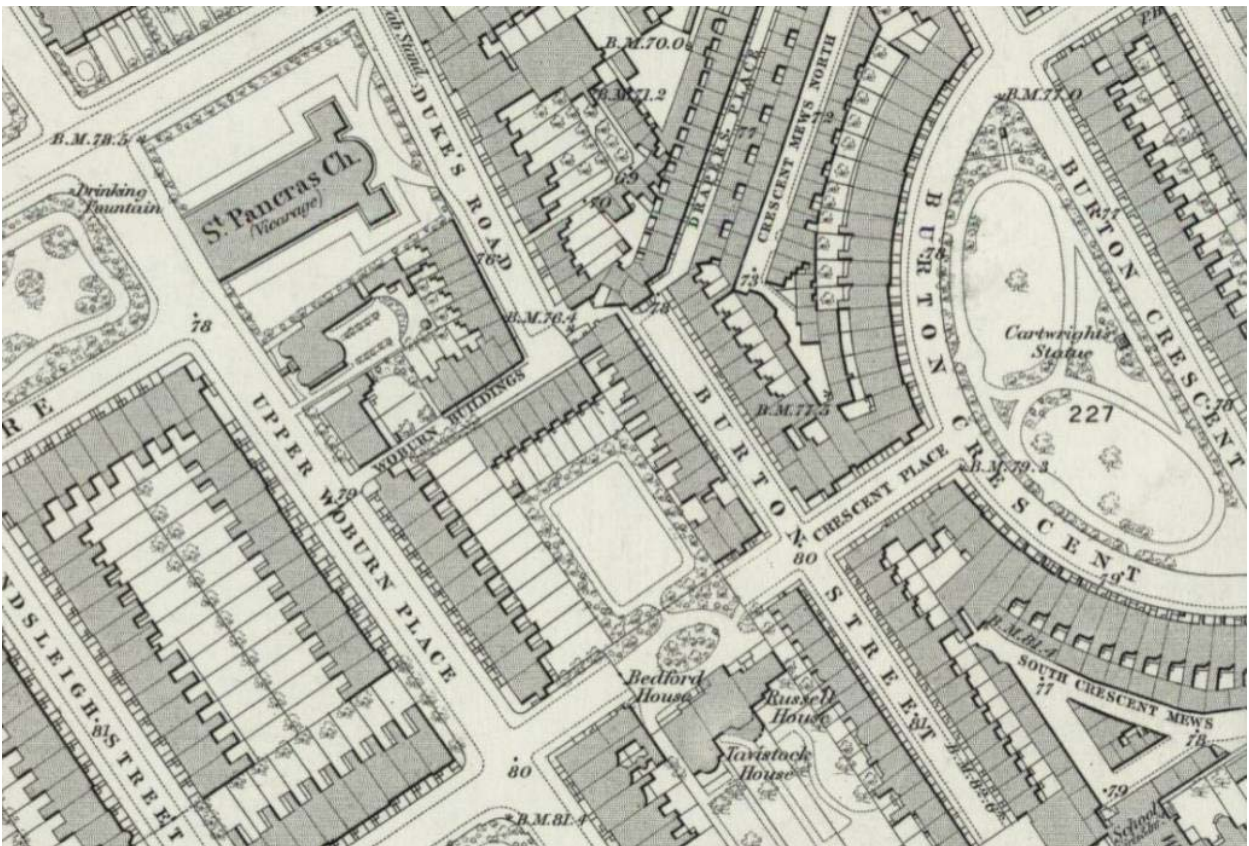
Fig 1 Ordnance Survey London Sheet XXV Surveyed 1870 Published 1876 Scale 25inches to one mile

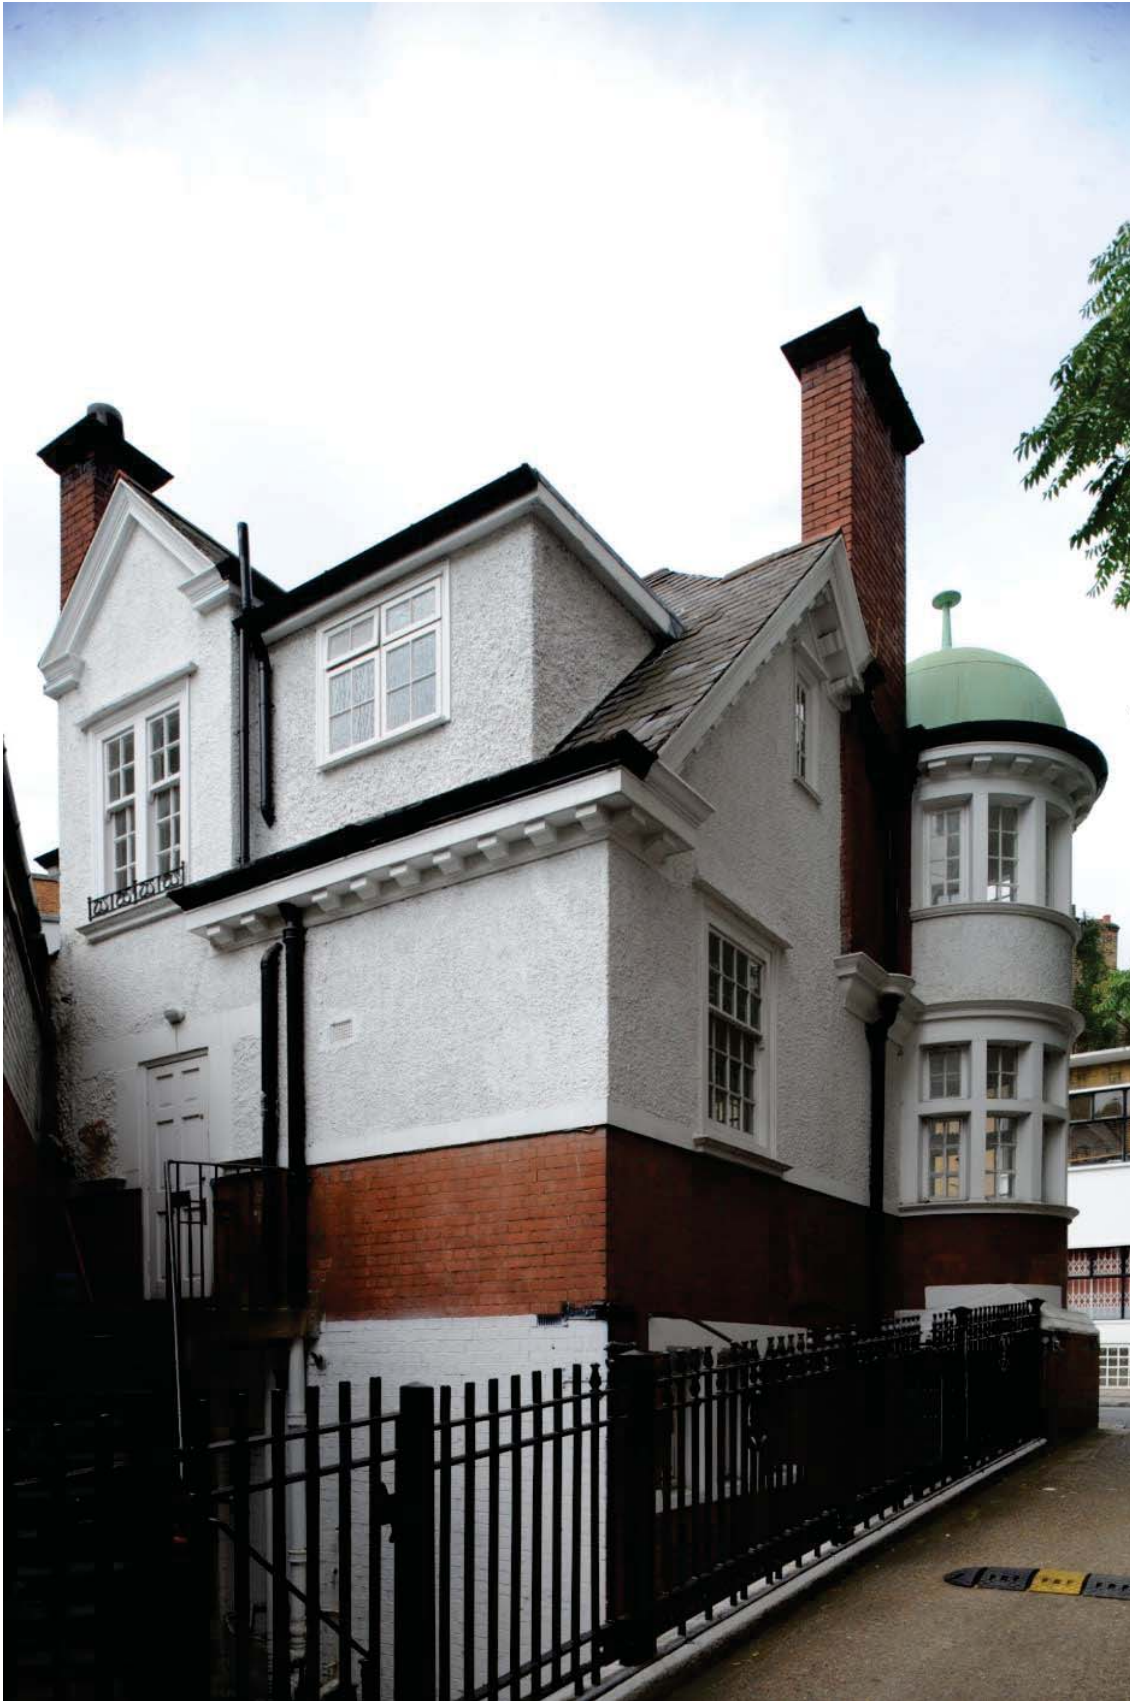
Fig 4 The Lodge from the north-east

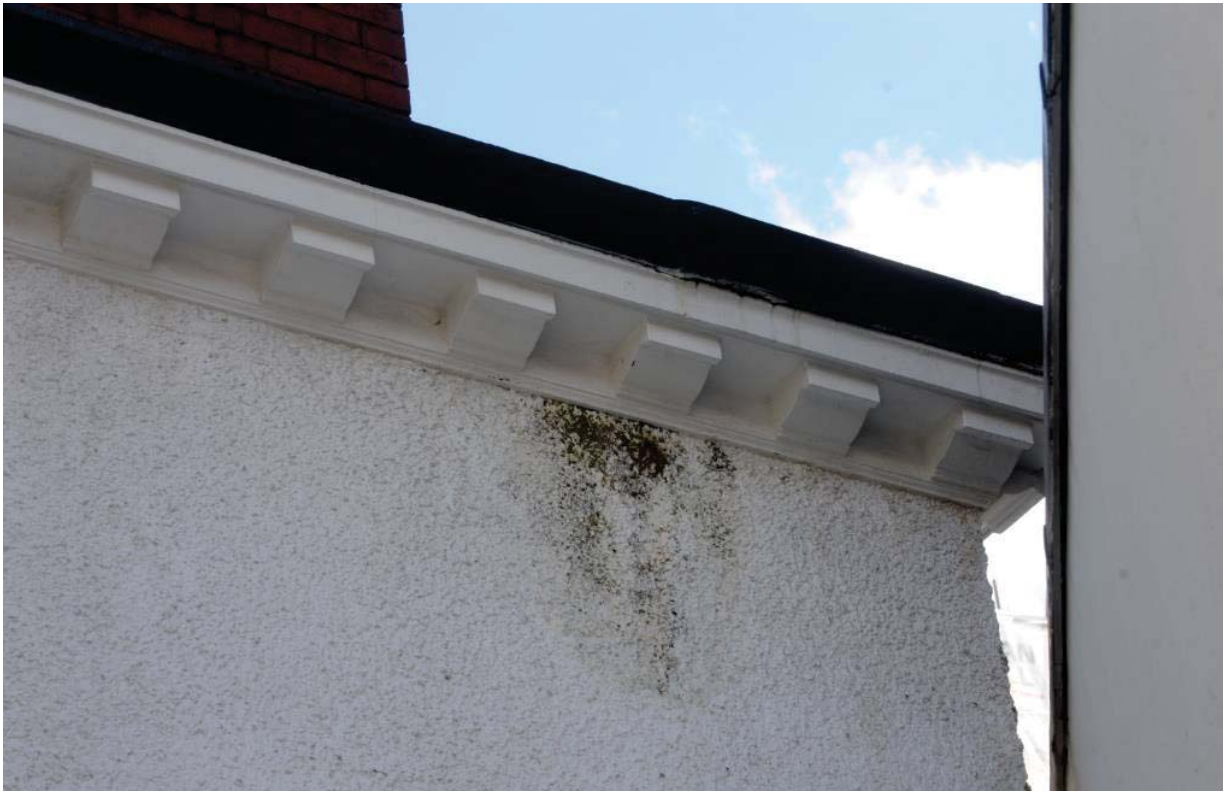
Fig 10 Algae staining of the render under a defective gutter on the south elevation

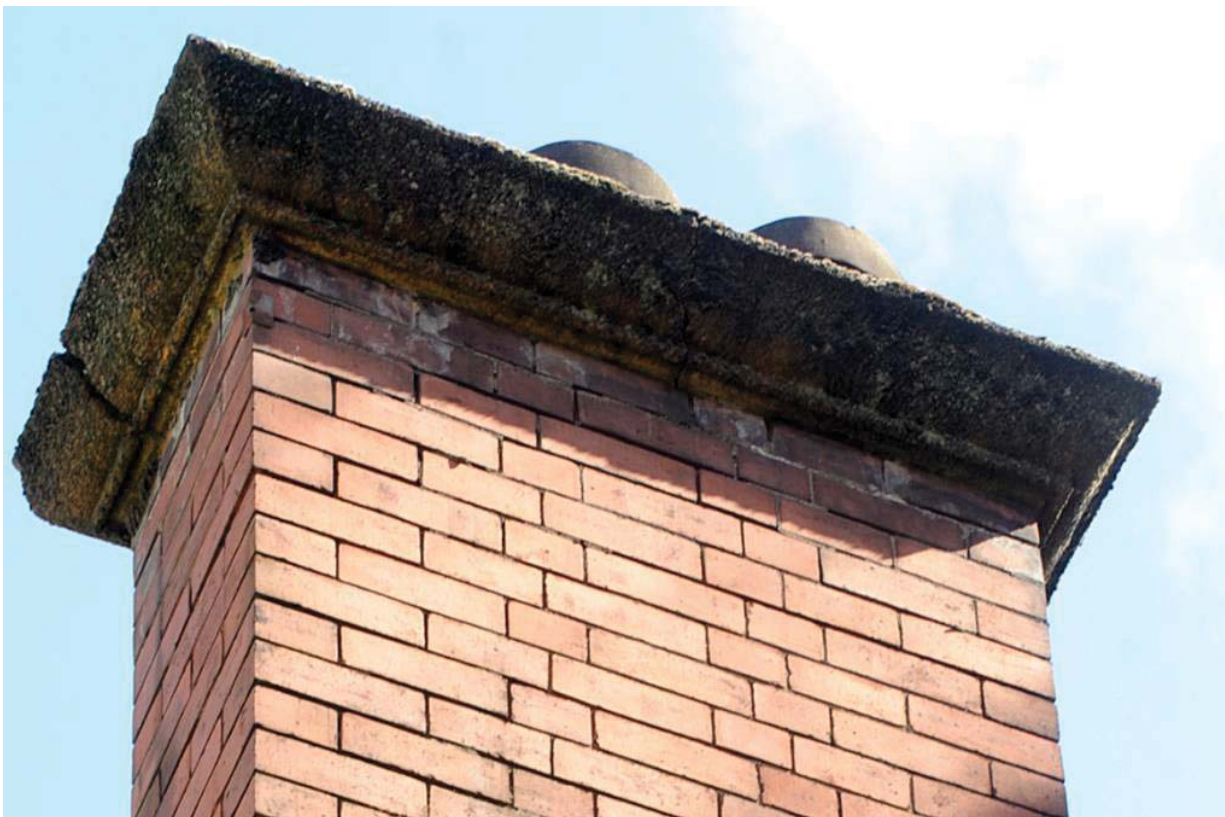
Fig 11 The cracked concrete cap of the south chimney stack

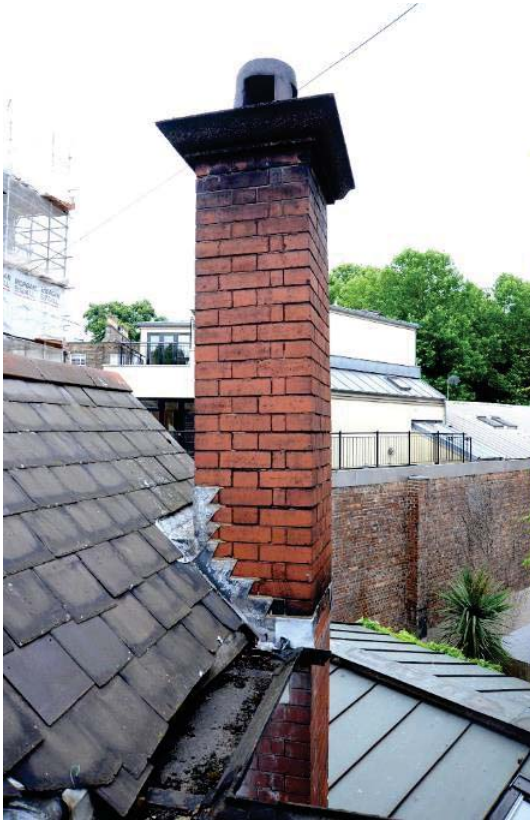
Fig 12 The east chimney stack

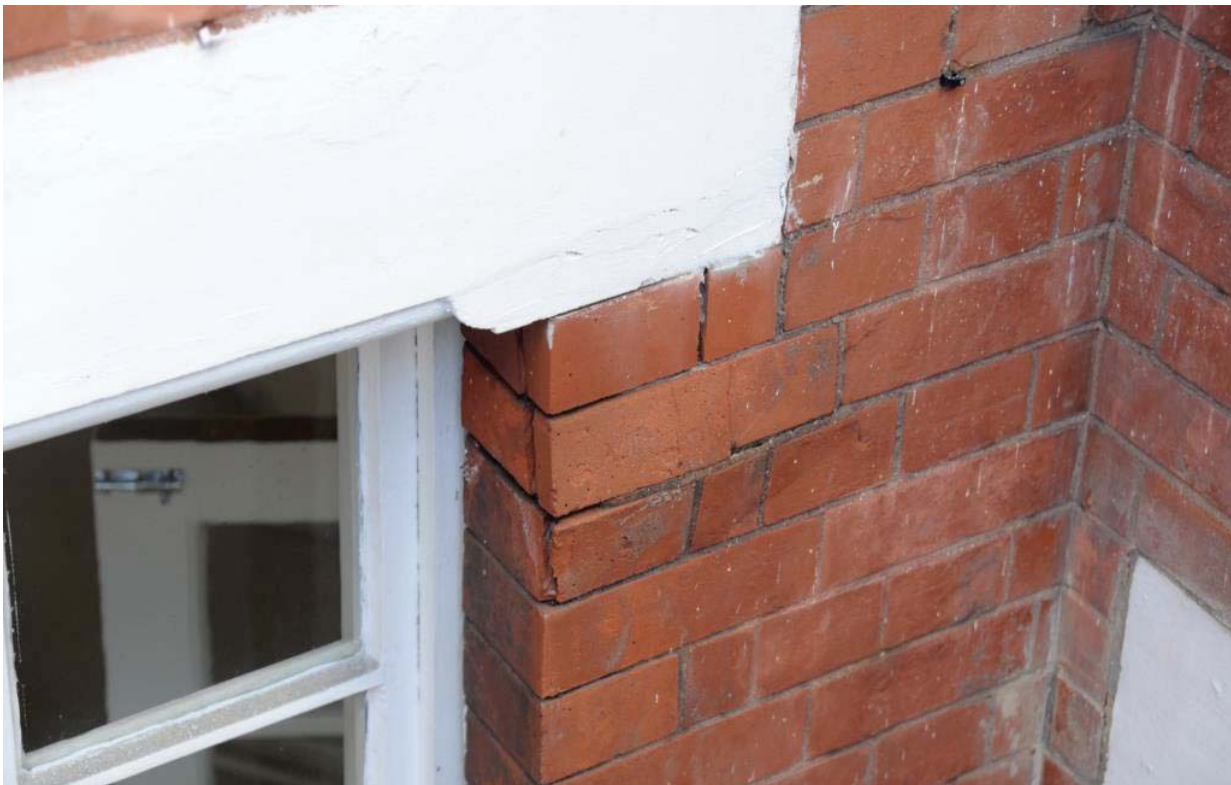
Fig 16 An earlier repair to the south jamb of window W27

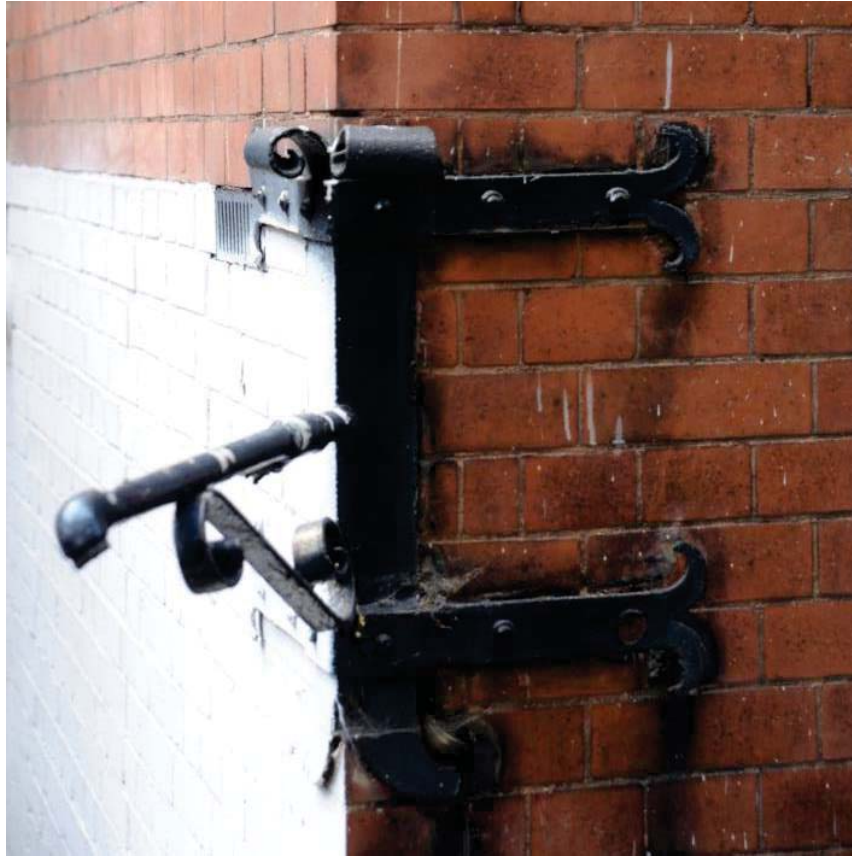
Fig 17 The gas light bracket on the north-east corner of The Lodge

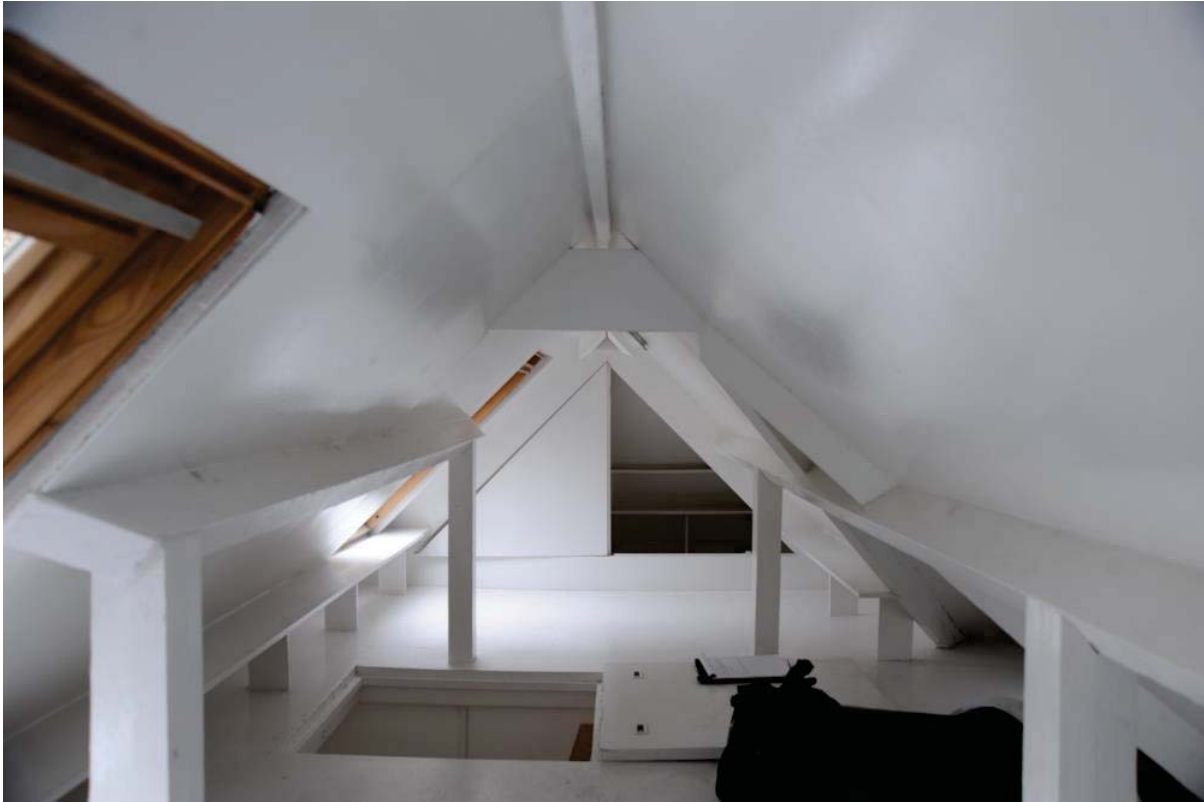
Fig 23 The attic looking south

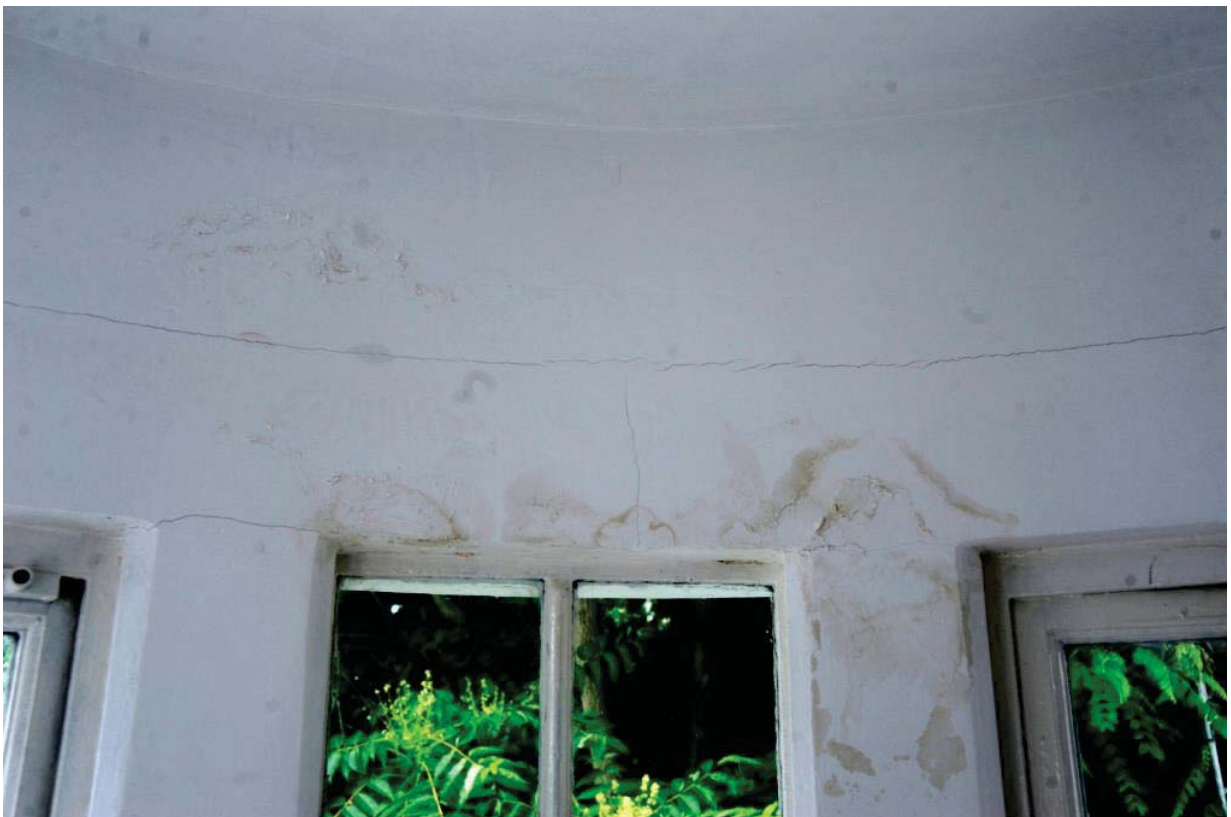
Fig 29 Damp staining above window W50

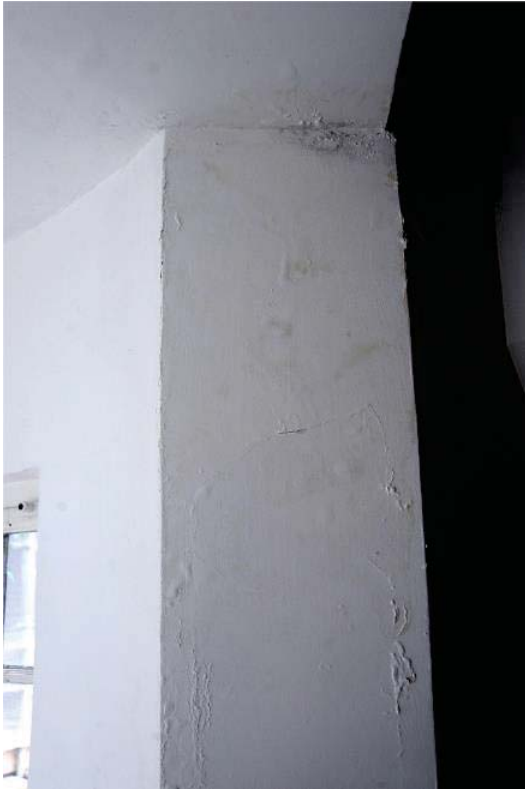
Fig 30 The damp ingress on the wall at the transition between the north-west tower and north room on the first floor

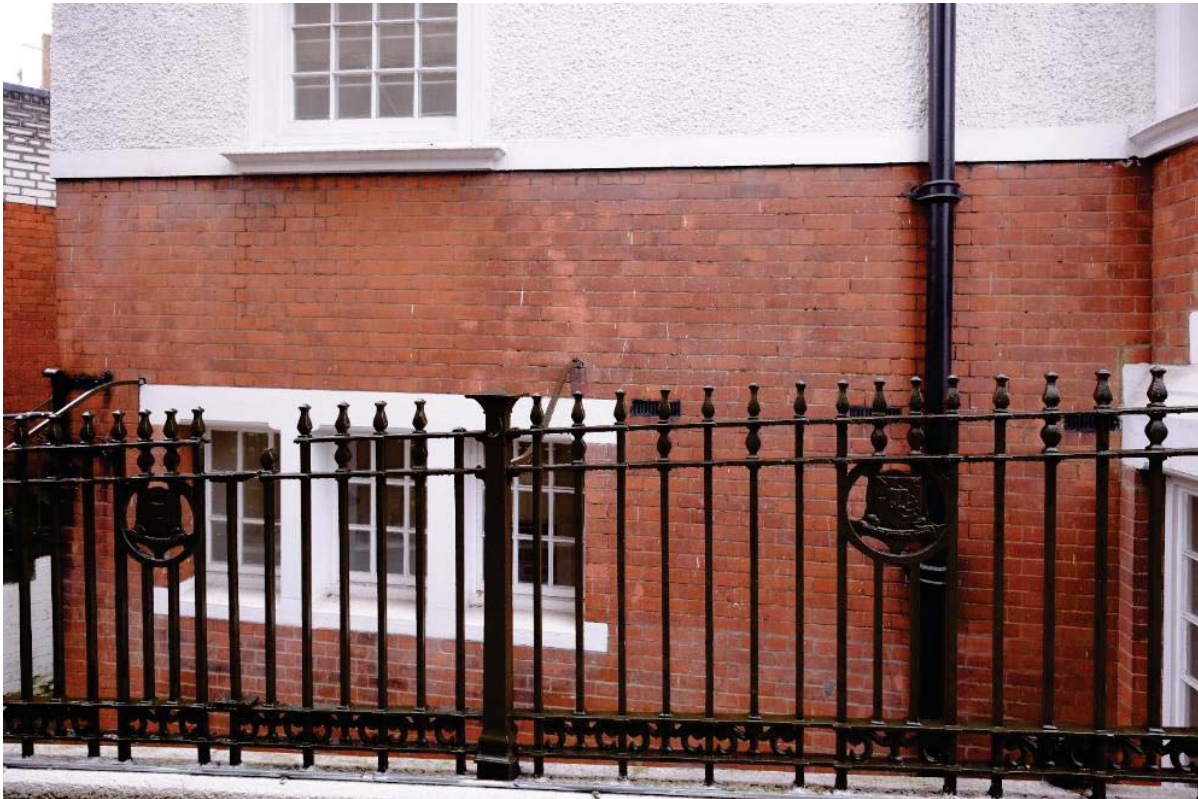
Fig 48 The original iron railings to the north area

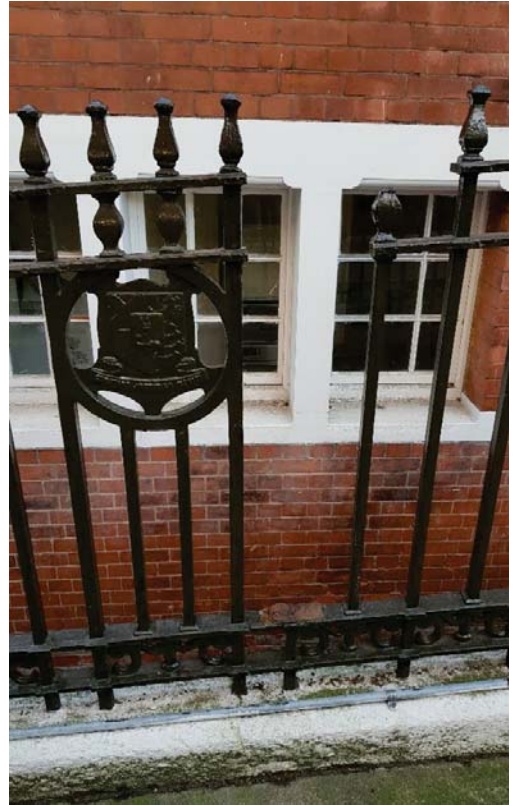
Fig 54 The damaged railing on the north boundary.

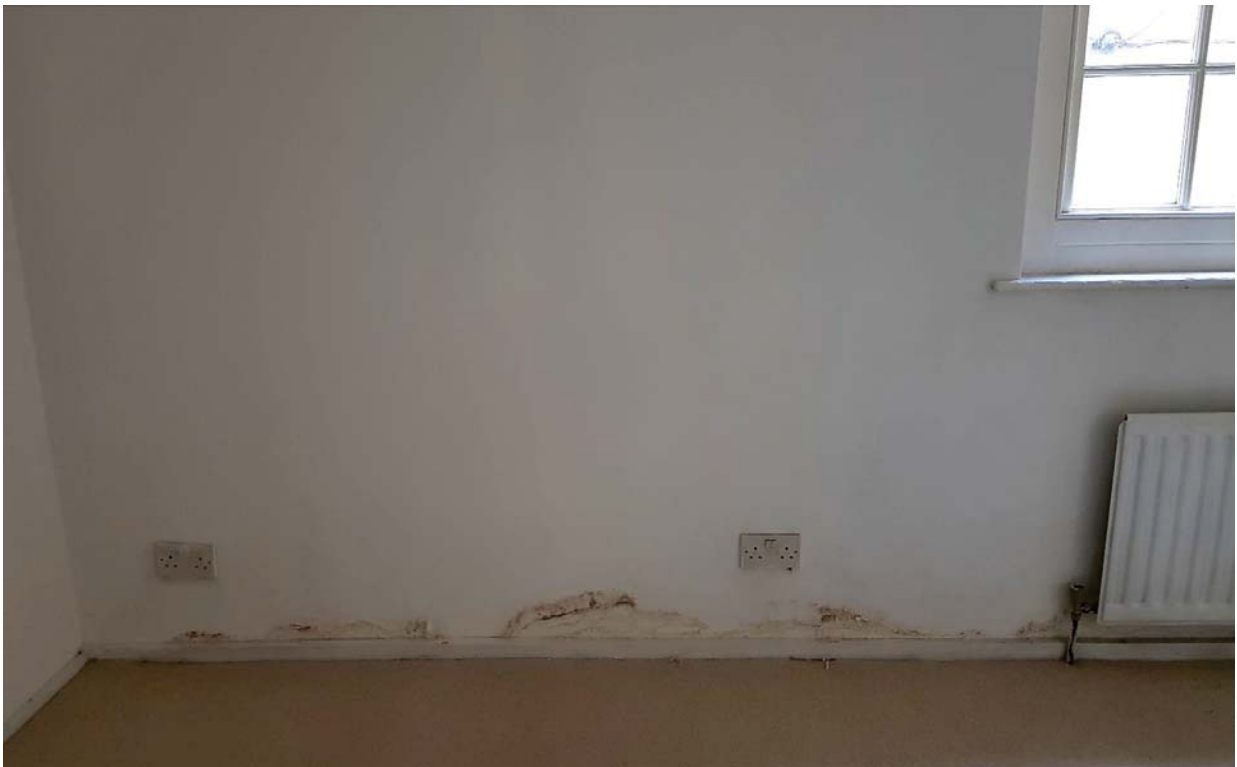
Fig 55 The damp on the west wall
