Tree Condition Survey

Crown Estate Paving Commission

St Katharine's Precinct
Regent's Park
London
NW1

AR/33014/13

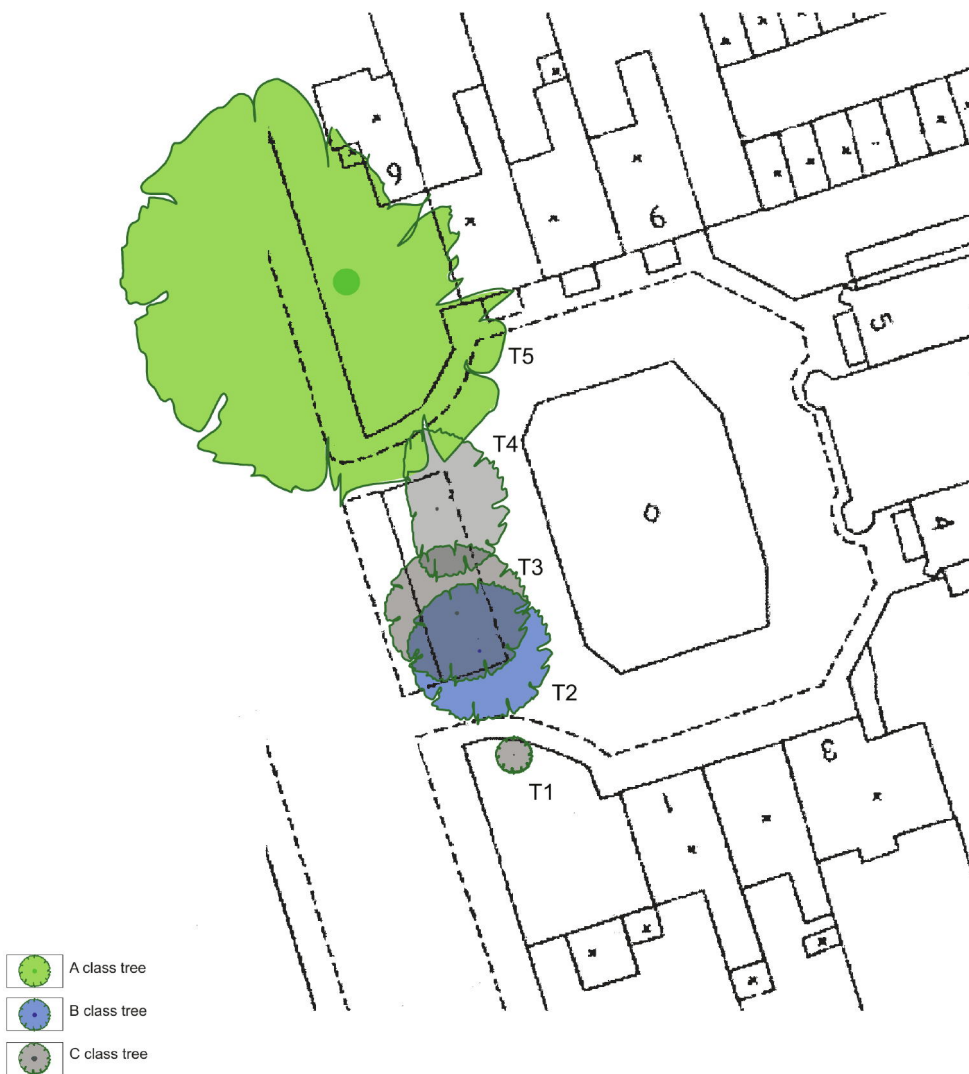
APPENDIX B

Tree No	Species	Ht.	Stem dia.	Crown spread N – S – E - W				CB	Age class	Phy con	Str con	ECR	Class	Observations & recommendations
T1	<i>Amelanchier lamarckii</i>	5	6	1	1	1	1	2	Y	G	G	M	C	Newly planted sapling, establishing well.
T2	<i>Acer palmatum</i>	7	4 x 20	4	4	4	4	2	M	G	G	L	B	Fine specimen. Multi-stemmed from base.
T3	<i>Crataegus monogyna</i>	7	23	4	4	4	4	2	M	G	G	M	C	Good, prominent tree, with good form within crown.
T4	<i>Prunus 'Kanzan'</i>	9	20	5	4	4	1.5	2	M	G	F	M	C	Unexceptional tree with one-sided crown.
T5	<i>Platanus x hispanica</i>	25	120	10	10	10	10	9	M	G	G	L	A	Very prominent, significant tree within the landscape.

Tree No	Species	Condition	Recommendation
T5	Platanus x hispanica	Large tree with a significant proportion of crown over the highway. Recommendation is to reduce the western crown – and thus the level arm within that crown - over the highway.	Reduce the western crown over the highway by no more than 6m, by cutting back to suitable pruning points.
