J. Heard Consulting Ltd

My Ref 1602

1 June 2018

Retaining Wall to rear of 23 Belsize Avenue, Hampstead, London NW3 4BL

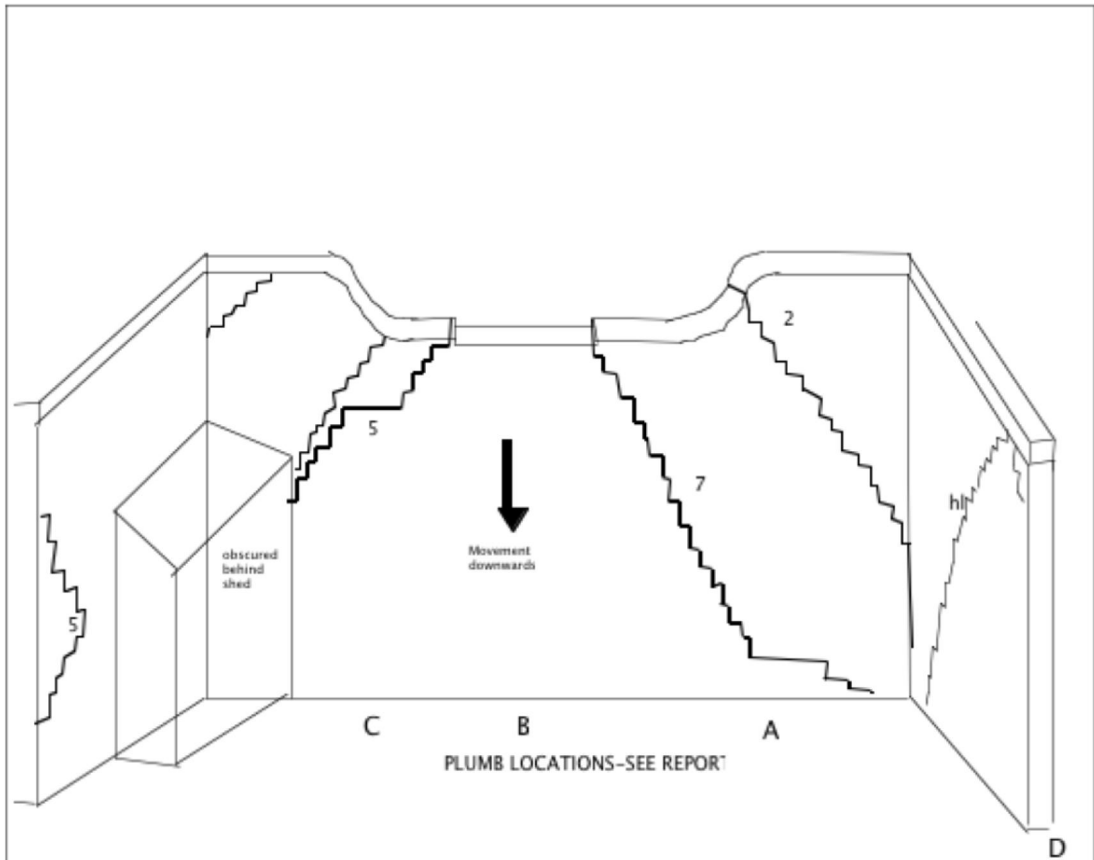
Dwg Title SKETCH OF DAMAGE TO RETAINING WALL TO REAR OF 23 BELSIZE AVENUE, NW3 4BL	J Heard Consulting Ltd Civil & Structural Engineering

The damage can best be described by referring to Fig 1, which is a sketch of the most obvious cracks. The wall was also checked for plumb in several locations. At location A in Fig 1, the wall leans inwards at the top towards the patio by 45mm. At location B, it leans inwards by 60mm and at C it leans inwards by 68mm. At location D, The return wall adjacent to the gate to the side path leans inwards towards the patio by 40mm. The main retaining part of the wall also bows inwards towards the patio along its length by approximately 50mm at a location some 400mm down from its top.

The pattern of damage is consistent with differential foundation movement, with the central section of the main retaining part of the wall moving downwards on its foundations compared to the higher parts of the wall and return walls. The raking cracks so formed are characteristic of subsidence damage. The crack damage can be classed as moderate damage, in accordance with the classification given in the Building Research Establishment Digest No 251, entitled "Assessment of Damage in Low-Rise Buildings".

Further investigation would be required to prove the subsidence theory and the cause, but the most likely reason is shrinkage of the clayey subsoil beneath the foundations due to desiccation caused by the abstraction of moisture from the soil by tree roots from the nearby trees, possibly exacerbated by shallow foundations and dry weather. This is corroborated by the shrinkage gaps in the soil between the lawn and the planter wall and between the soil in the planter and the rear of the subject wall.

As stated above, the pattern of crack damage is consistent with downward movement. It is considered that it has not been caused by lateral movement due to the weight of soil behind the wall, even though the distortion of the wall shows it is under pressure. The leaning and bowing distortion looks to be of some considerable age. Whilst the distortion is considered to be unrelated to the subsidence damage and probably preceded it, the subsidence may have exacerbated the distortion somewhat. Notwithstanding this, the subject wall is understood to be of some considerable age and as such, it has passed the test of time.

With respect to the distortion, a lean of almost 70mm, whilst not ideal, is within acceptable tolerances for a 337mm thick wall. A thinner wall would be verging on being structurally unstable. The higher parts of the wall are 337mm thick. It is reasonable to assume that the main section of the wall is of similar thickness, but this should be verified.

A site investigation should be carried out to confirm the cause of cracking and ascertain the width of the wall and the depth of its foundations. It would be a waste of money to undertake remedial works at this stage without determining the cause of the damage. The cause may also shed light on whether the damage is likely to be progressive.

If tree root induced subsidence is confirmed, then the normal method to deal with the problem is either to drastically prune the culprit trees or more likely in this case, remove them altogether. Following a period of recovery, when the ground recovers its natural moisture content and during which the structure is monitored to determine when relative stability is reached, repairs can be carried out. This will likely entail cutting out the cracked sections of brickwork and re stitching it back together. Modern resin bonding techniques are unlikely to be a successful alternative to the traditional brick stitching method as the mortar in an old wall is likely to be of a relatively weak mix. A specialist firm may be able to install some bed joint reinforcement across the cracked areas as an added safeguard, but again, with weak mortar, there is a risk that the reinforcement will be ineffective.

Alternatively, if the trees are to remain, then the foundations of the wall will likely need to be underpinned to take them below the influence of the tree roots to prevent a reoccurrence of the damage.

No weepholes* were noted: they may be present below the level of the decking and gravel base. If there are none, some weepholes should be drilled in the base of the wall with a coring tool to prevent the build up of water behind the wall. 75mm diameter holes angled slightly downwards at 2m centres is a common specification.
