**Kenton Brauer**  
Stained Glass & Casements

## **Lauderdale House, Highgate, London Cupola Report Site Survey & Scheme of Works Conducted on Tuesday 6th June 2017**

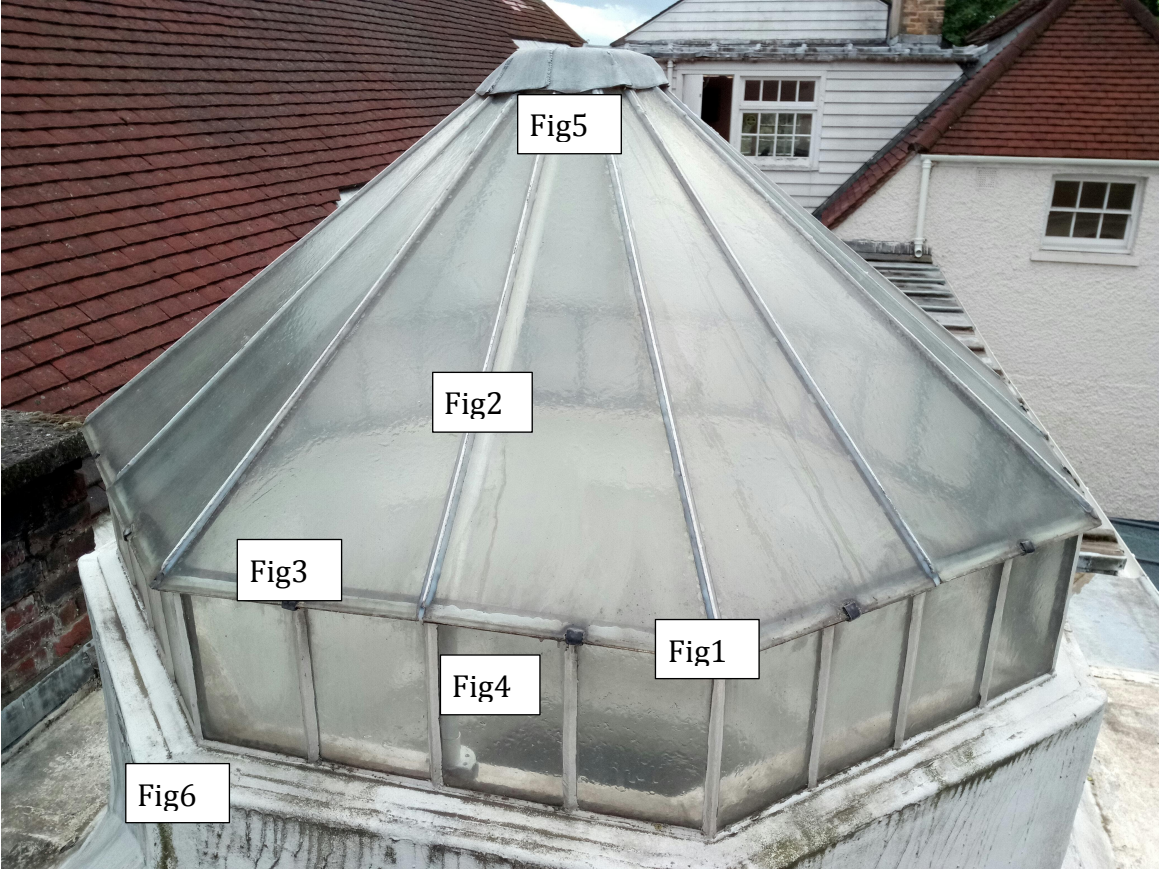
**Recent photo of Cupola during visit. See for Figure codes.**

**Glazing** – The top sections of glass are laminated with a very poor rough edged finish. These do not overhang enough due to the sloping steel sections being too short that hold the glass in place, causing any water run off to not clear properly. See Fig1

**Glass Fixing** – The glazing would have been fitted with a traditional linseed oil putty. The bottom glazing is putted with many layers of paint applied on top but the above glazing has been bedded in with a clear silicone which is very unsightly and incorrect. Also, the steel section that holds the top glazing in place is of an insufficient sized profile to take the thick laminated glass as there is limited room to apply a good sized bead of putty. See Fig2

The top glazed sections are also held back by safety clips incase the putty fails which prevents the glass slipping away. These are made of lead and are very weak and insufficient. See Fig3

**Ventilation** – There is a slight gap between the top of the bottom glazing frame and the underside of the top glazing all the way around, but this has been sealed up with silicone all the way around probably in an attempt to stop any leaks. This should act like a trickle vent that you get in modern day windows. A Trickle Vent does exactly that and allows air to trickle into an area at a reasonable rate so that you will not feel a cold draught, keeping condensation at bay and giving you a balanced environment all year round. The gap also provides an escape route outside for any moisture that could potentially built up on the underside of the top glazing. See Fig4

There is a leaded cap on the very top point of the cupola which is for weather proofing and also ventilation. The removal and further inspection of this when work starts will provide evidence to see if it is sufficient enough for ventilation. See Fig5

weatherproofing and sealing around the outside seems to be inadequate as the lead sheeting appears to just butt up to the steel frame. This was difficult to see due to paint treatments to the lead and steel. See Fig6

- A) **Frame** – Remake the frame copying the design of the existing but if possible making it symmetrical if the footprint of the base it fits on to allows. Extend the sloping steel profiles in which the top glazing sits into allowing the water run off to completely clear the cupola below. Use a larger steel profile on the sloping glazing and side glazing to allow a correct sized bead of fixing sealant to the glass and steel on the outside. We also recommend fitting a fully welded cill or skirt all the way around the bottom of the frame to clear the lead cill it now sits on. This will eliminate sealing problems and all water run off would go straight to the roof floor.

- E) **Glass fixing** – We recommend using a new type of sealant called “Dry Seal.” This is ideal as a permanently elastic and paintable alternative to linseed oil putty and is for new glazing applications, renovation and restoration. It’s a permanent replacement for putty in steel frames and it’s made for external and internal applications. Fully cured after 2 hours and compatible with double-glazed sealed units, laminated & acoustic glass. It is moisture and UV-resistant with excellent adhesion to glass and steel. It is also available in white so no painting would be required if the frame was to be finished in white.

We recommend the top glazing hold back clips to be made out of stainless steel also by who ever manufactures the frame and also powder coated white. Otherwise, these could be made from copper or

F) **Ventilation** – The frame should be manufactured in the same way as the existing leaving a small gap, a so called trickle vent as written above in the existing ventilation section. This should not be sealed up. This gap also provides access to the anchor point for the hold back clips to the glazing above. With regards to the cupola weather cap and further inspection, it maybe possible to either use the existing cap or remake another out of lead as the existing does not look very well made. There is also the possibility of having something completely bespoke manufactured in a different material, but still making sure weatherproofing and ventilation is key.

G) **Base** – Assuming the base in which the frame sits on is to be renewed, we would just recommend again screwing it down but using substantial stainless steel screws at more points, maybe three to four fixings on each side. The frame can also be bedded down onto a bead of the “Dry Seal” as written above, which has great permanent water proofing and fixing properties to timber as its also made for wooden window frames.
