4 Eton Villas, London, NW3 4SG

Specific Defect Report

31.01.2018

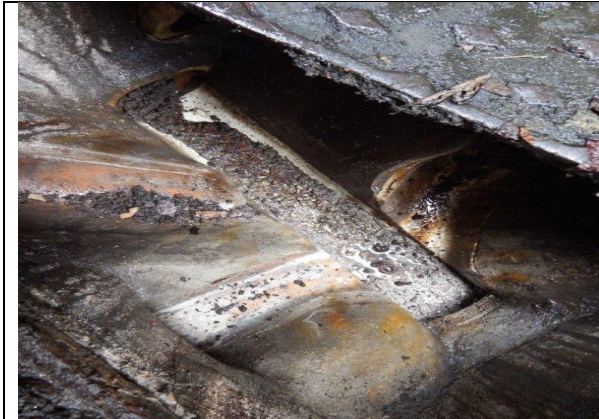
The chamber by the side door is full of soil. This indicates that the drains are fractured and soil is entering into the system. This also means that water will leak and erode soil and this can cause movement to foundations,

Drain Full Of Soil

I strongly recommend that you instruct a CCTV survey and obtain quotes to repair or replace as necessary, prior to purchase.

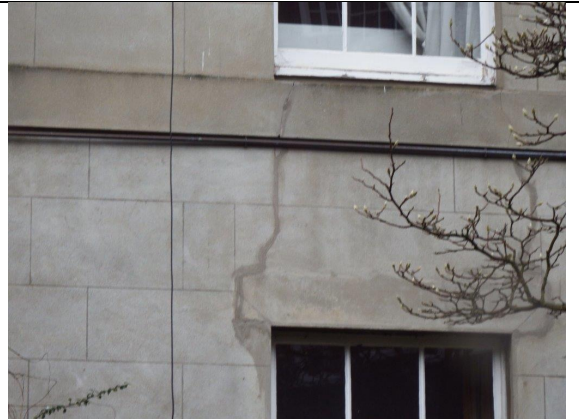
The render finish is generally satisfactory although there are some cracks present. These should be repaired in order to prevent water penetration via capillary action. Fine cracks can be raked out and filled with proprietary filler. Larger cracks should be cut out with a disc cutter to a width of at least 40mm with edges undercut so that new render has a mechanical key. If cracks penetrate the wall then professional advice should be obtained prior to making good.

Cracks to Render

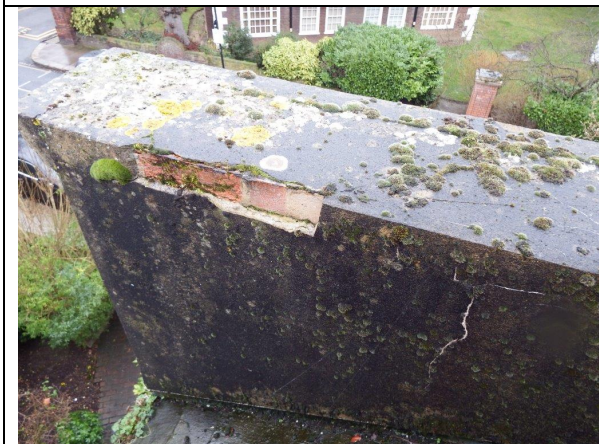
The parapet walls are in a neglected condition and all require overhaul. There are areas of missing and cracked render to the parapets and this is permitting additional rainwater to enter the property and cause significant damp damage.

Parapet Walls Need Overhaul

You should obtain a quote to overhaul ALL parapet walls now to be carried out in conjunction with roof works.

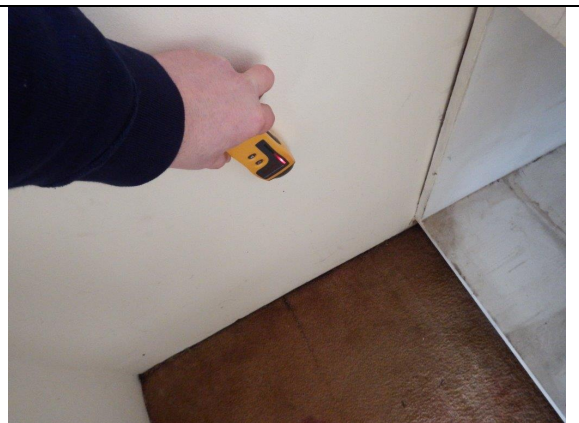
Lateral Damp Penetration

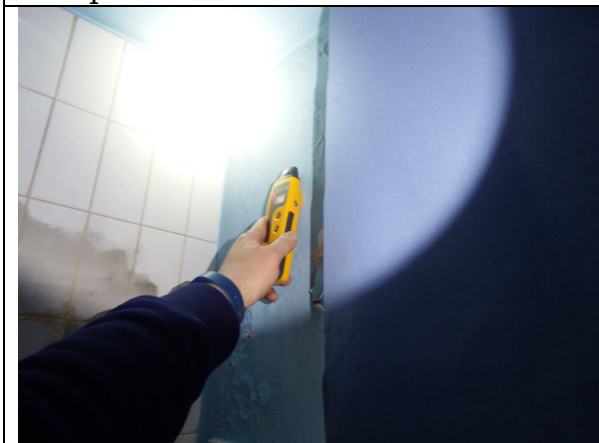
Lateral Damp Penetration
