## **Simon Pryce Arboriculture**

### **Report**

**Site:** 36 Elsworthy Road, London, NW3 3DL

**Subject:** Deodar cedar and damage to garden wall

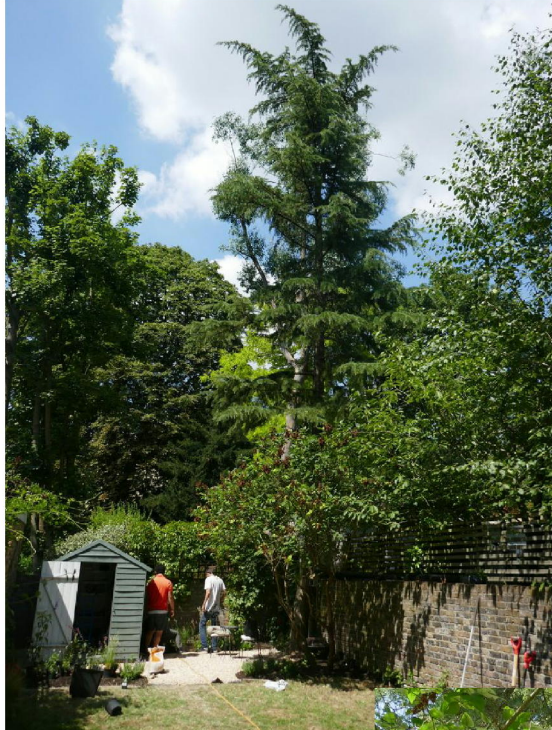
- 3.1 The tree causing concern is a deodar cedar growing in the far right hand corner of the garden of no.36. This is about 16m high and has a single vertical trunk about 330mm in diameter at 1.5m, about 350mm just above the root flare at the base, which is not very pronounced. The base is about 170mm from the wall and the lower trunk leans slightly to the right, so the gap reduces to about 110mm at the top of the wall. This makes the trunk centre approximately 345mm from the wall at the base and 275mm at the top of the wall.
- 3.2 The first main branches start at about 4m and crown has a radial spread of about 4m. There is some minor dead wood but that is normal and the foliage is dense and healthy looking indicating good physiological condition.

1) View of the tree from near the back of the house.

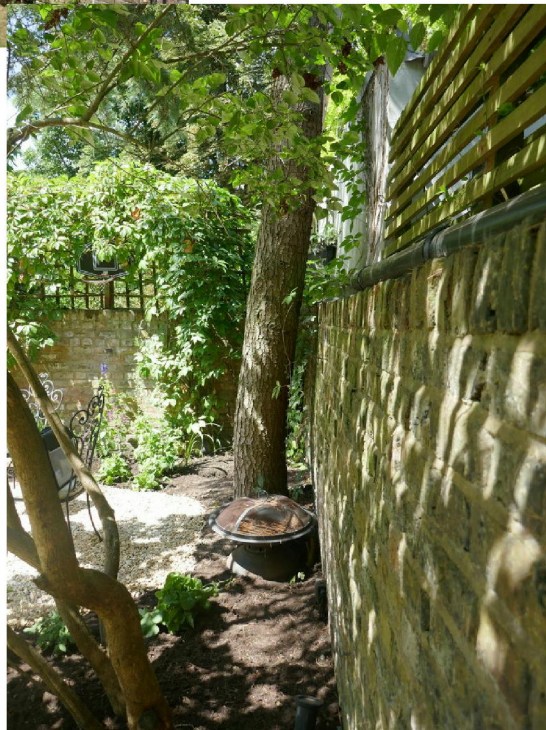
- 2.4 The garden wall looks original, but has been maintained and repointed and is about 1.6m high by one brick length thick. The area of concern is in the rear right hand part of the garden. The upper section leans towards the garden of no.34 (photo 2) and there are two vertical cracks, one near the front corner of the outbuilding at no.34 and the other about 3.5m forward of that.

- 2.6 The right hand wall continues some way beyond the rear ones and there is a gap at the junction, which is also consistent with the side wall leaning to the right.

2) View along the wall towards the tree showing lean in the wall and trunk. White structure is the outbuilding at no.34.

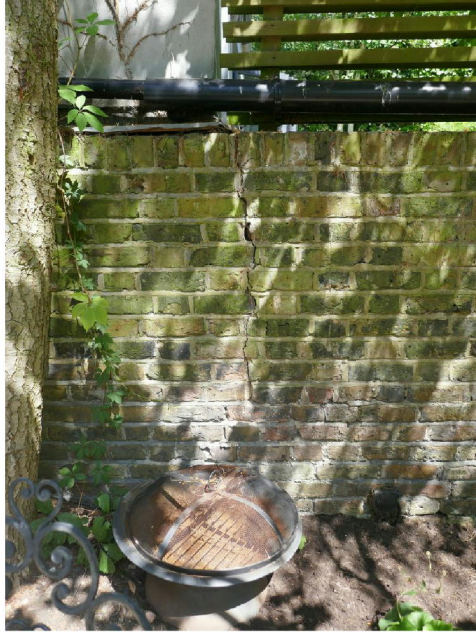
- 2.5 The crack near the outbuilding appeared in about April of this year and there has been no noticeable movement since then. It partly follows the joints between the bricks, but also goes through some of them indicating that it has been made with some force. It is wider at the top than at the base indicating that the wall has lifted at that point or possibly that the parts each side of the crack have dropped.

- 4.4 Soil shrinkage is usually greatest close to the tree concerned, but the crack widens with height, which indicates that the wall has been lifted there by a root growing beneath or that the sections each side the tree have dropped. In practice it is likely that the wall is being affected by both causes.

3) Crack in the wall near the outbuilding, trunk of the tree to the left.

- 4.8 It is possible to control the growth and water uptake of some trees by reduction and regular pruning, ideally started at an early age, but conifers do not tolerate that kind of management as well as most broadleaved species. Growing this close to the wall the cedar would need to have been maintained as little more than a shrub and it has grown well beyond the stage at which it might have been possible to start such a regime. Therefore the only viable way to allow the current damage to be repaired and prevent worse problems in future is to remove it.

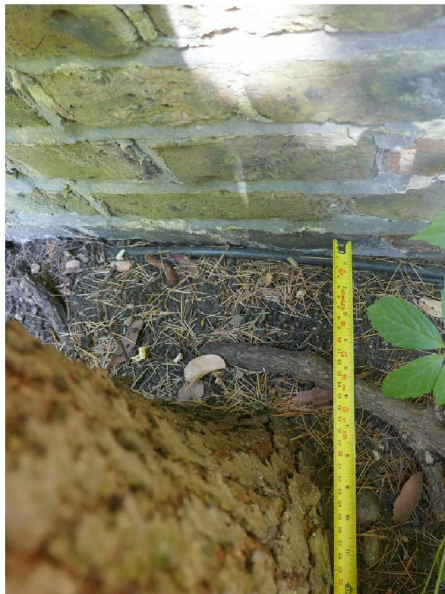
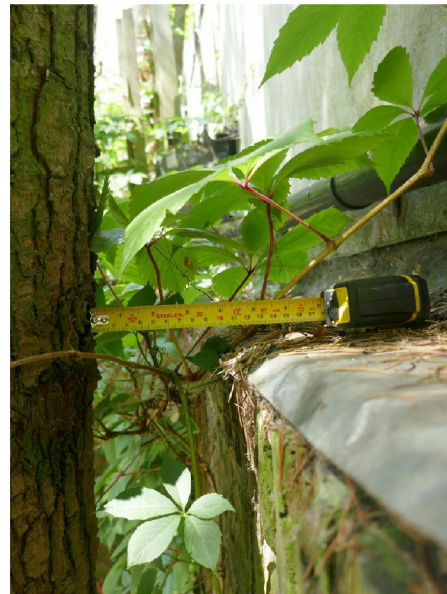
- 4.3 Cedars and other conifers have more compact roots than broadleaved species, so the effects are more localised, but for the same reason the drying effect at close range can be more intense. The wall is well within the tree's likely zone of influence, but is also close enough to be affected by direct pressure from the main roots and base of the trunk expanding as the tree grows.

4) & 5) Distances between the tree and the wall at base and at 1.6m.
