# Tree Report

- 1.1 This report is to assess the options and reasons of work to 4 mature trees in a rear garden of 17 Frognal , London , NW3 6AR. There is 2 mature Limes and 2 Sycamores that are the focus of the report
- 1.2 The garden is owned by Nick Sofroniou

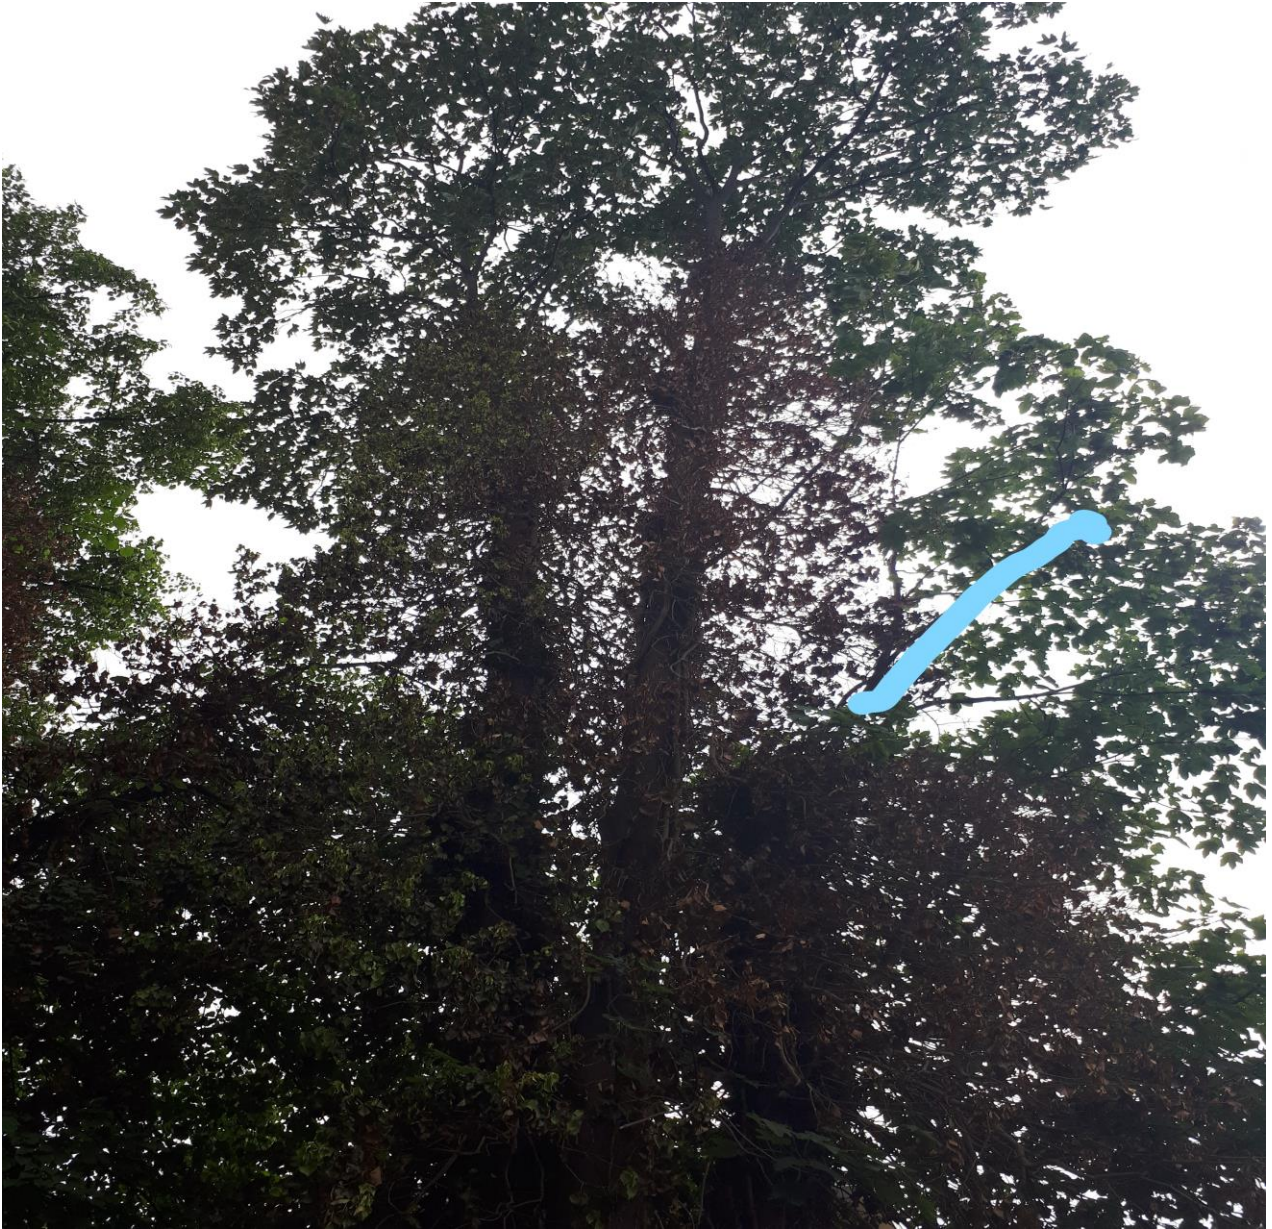
Photo 1

- 5.5 T1 has multi stemmed from the base and splits into 3 main stems approximately halfway up one of these stems it appears that previously it has failed leaving the last 2 remaining stems to extend further upwards . See Photo1 the blue line shows the point of the lost stem.

- 6.1 T1 Stands close to garages and if any failure to the remaining high stems there is the potential of catastrophic results to property and /or public and users of the garden.
- 6.2 I would recommend that the remaining high stems be reduced to the same level as the lowest stem. This would balance the crown and reduce the sail of the crown and so the pressure further down the trunk. This would have the effect of retaining the tree sustain it for many years
- 6.3 T2 and T3 I would recommend for an overall crown reduction of 2 metres and to lift the crown 3 metres. Additionally, to remove all dead wood and to clear some of ivy in the upper crown.
- 6.4 T4 there is a clear line that is visible suggesting an included stem which

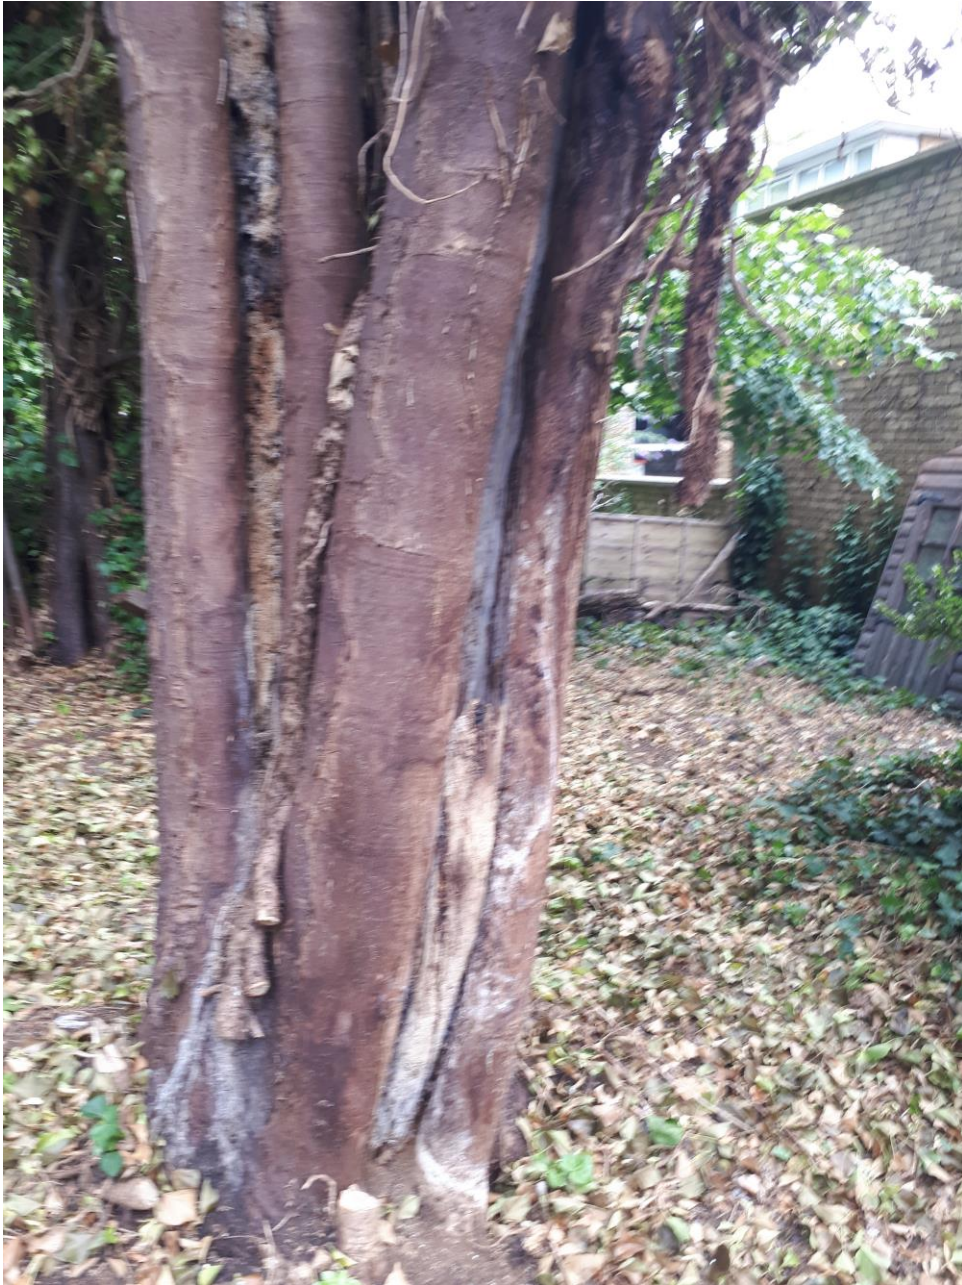
Photo 2

- 5.6 At the base of the trunk there are large wounds extending vertical up the stem which seemed to of sealed well. See photo 2

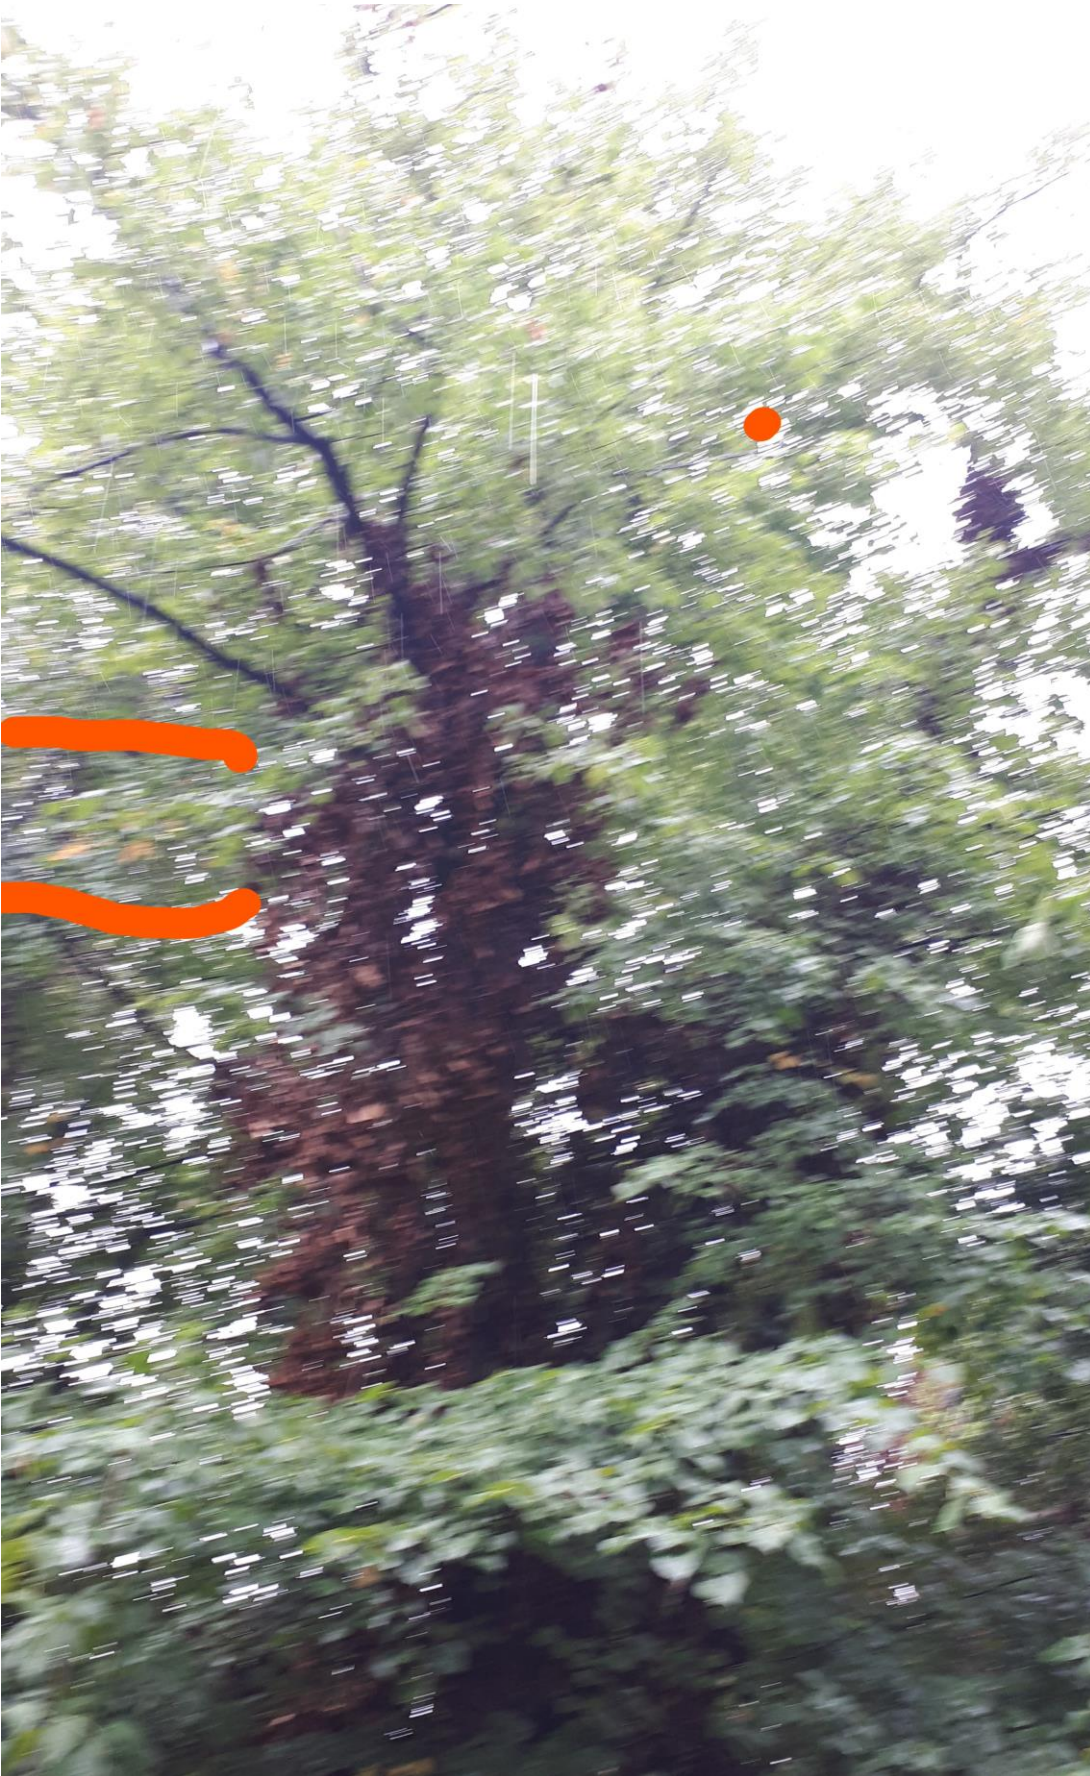
**Photo 3**

- 5.7 T2 is a Lime tree. It stands approximately 13 metres has a crown spread of approximately 7.5 metres. It has a good-looking vitality and a healthy-looking crown spread. See photo 3.
- 5.8 This tree is also covered in ivy and as the ivy has retreated, due to the severing at the base, 2 lateral limbs can be seen that have completely failed and are detached from the stem and are being held in position by the encompassing ivy. Photo 3 shows the lime , the orange lines are approximates of the position of the detached limbs .
- 5.9 T3 is also a Lime tree and stands directly on the opposing boundary to T2.
- 5.10 It also stands approximately 13 metres high and has a crown spread of approximately 7.5 metres.
- 5.11 Again, there are smaller dead lateral branches that have detached from the main stem and are held in position by the encompassing ivy.

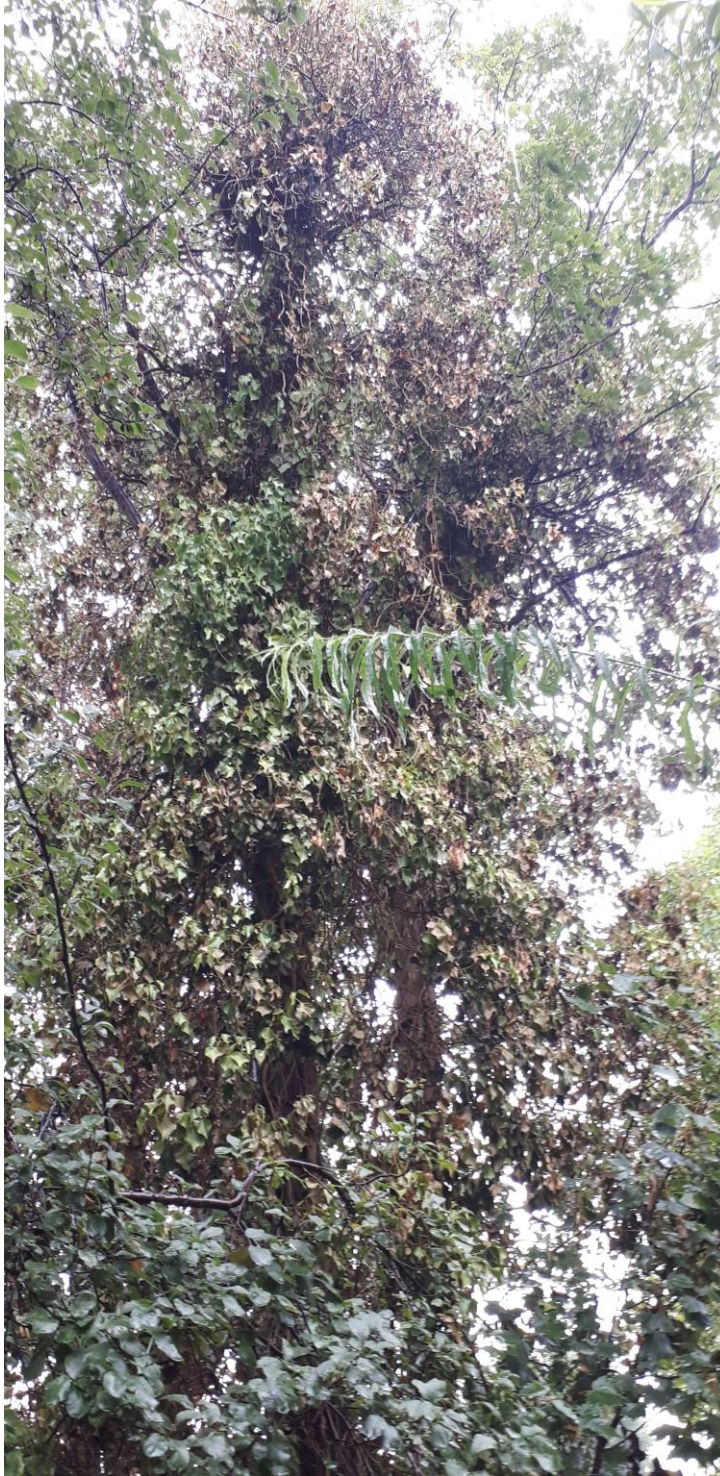
**Photo 4**

- 5.12 **T4** is a Sycamore, It stands approximately 16 metres high and has a crown spread of approximately 7 metres . Its condition seems fair .Photo 4 shows crown
- 5.13 The stem splits into two just above ground and there can clearly be seen an occluded front , where the two stems join. Photo 5 shows the base of T4 and between the blue line is the occluded front of the two stems.

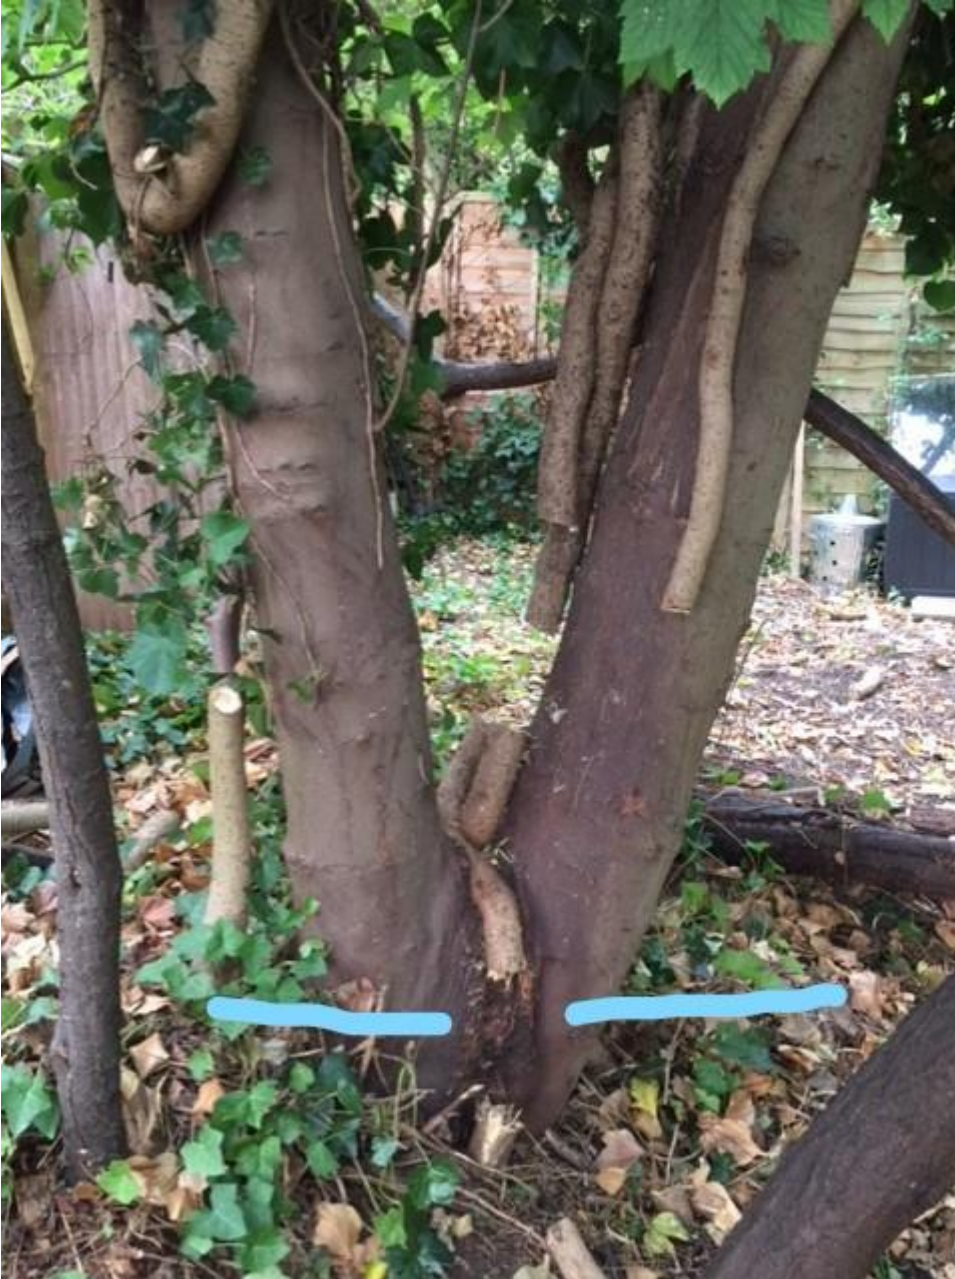
**Photo5**

goes into the root ball. This is where two stems grow separately but due to their proximity incremental annual growth, grows around this point sealing the union. This union has high potential of failure as the sail from further up the limbs can literally pull one stem away from another, due to this poor union.

6.5 Due to the proximity of the tree to the neighbouring garden and the potential hazards of failure to one or both stems, I would recommend that this tree be felled to ground level.
