**TECHNICAL REPORT ON A SUBSIDENCE CLAIM**

**Ms Miriam Jane Ramsey  
30B Croftdown Road  
Kentish Town  
London  
NW5 1EN**

**SUBSIDENCE CLAIM**

26 April 2018

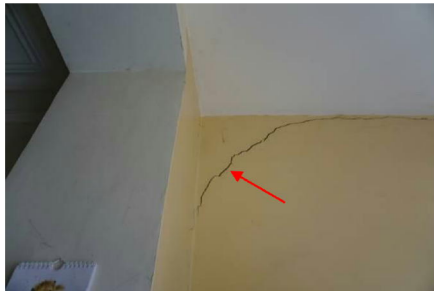
30B – Kitchen – Diagonal Crack to Left Wall

- Diagonal crack to left wall at high level - 7mm
- Vertical crack to left junction between main house and rear projection - 2mm
- Vertical crack to right wall to rear - 3mm
- Staining to ceiling
- Ceiling junction crack to left and rear wall - 2mm

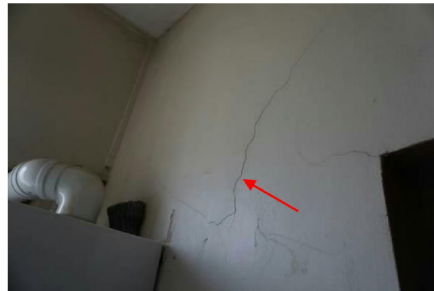
30B – Utility Room – Diagonal Crack to Right Wall

- Diagonal crack to right wall - 1mm
- Vertical crack to left wall to rear - 2mm

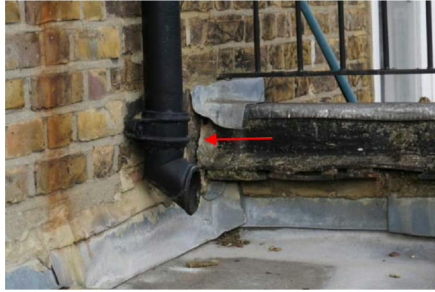
View of Rear Projection Roof – Separation of Parapet from rear elevation of main house

- Vertical separation of the rear projection from the main house - 8mm

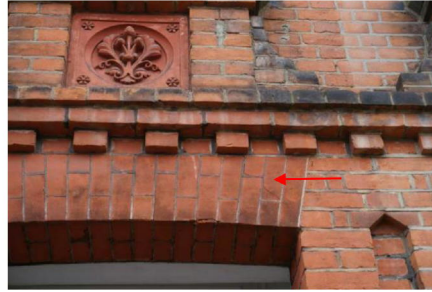
Front Elevation – Crack above entrance porch (not subsidence)

- Crack above entrance porch - 1mm - not subsidence

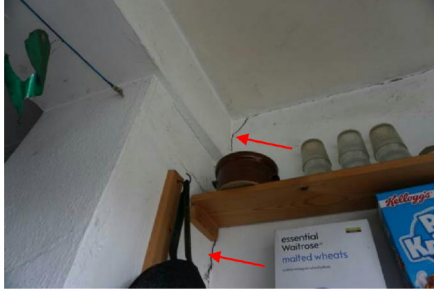
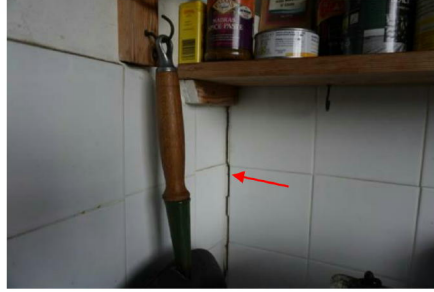
- Vertical tapering crack to the left junction between the main house and rear projection - 3mm
- De-bonded tile at the junction at low level

30C – Kitchen – Vertical Crack at junction

30C – Kitchen – Vertical Crack at Junction

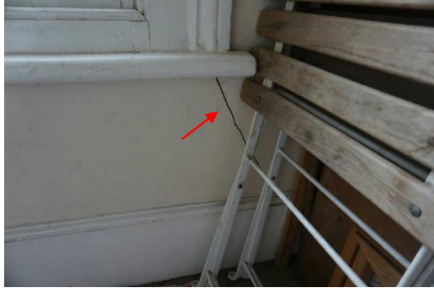
- Diagonal crack on rear wall below window - 2mm

Communal Stairs – Diagonal Crack below window

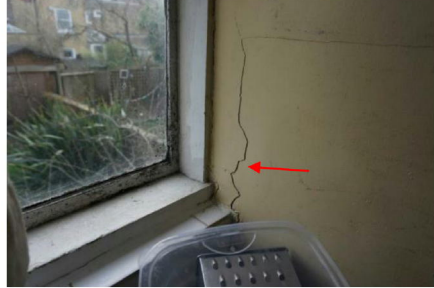
30B – Kitchen – Vertical Crack

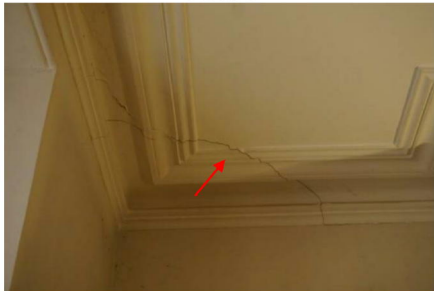
- 2 x cracks in the ceiling to the front left - 1mm - not subsidence
- Hairline diagonal crack to right wall - blown plaster - not subsidence

30B – Front Bedroom – Crack in ceiling – not subsidence

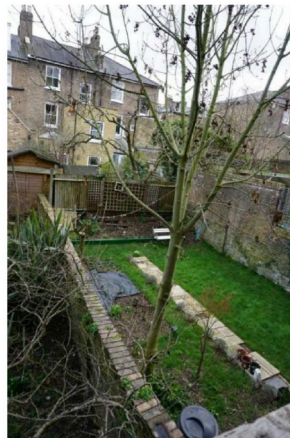
View of No.28 - T1

Type	Height	Distance	Ownership
T1 - Deciduous	7 m	3 m	No. 28
T2 - Cherry	3 m	3 m	30A
T3 - Deciduous	7 m	6 m	30A

The cause of the movement needs to be dealt with first. We have completed a soil risk analysis (VISCAT Assessment) and we are satisfied that your neighbour's T2-T3 trees at 30A can be removed, along with your neighbours T1 at No.28. Our Mitigation Unit will liaise with your neighbours in this respect.

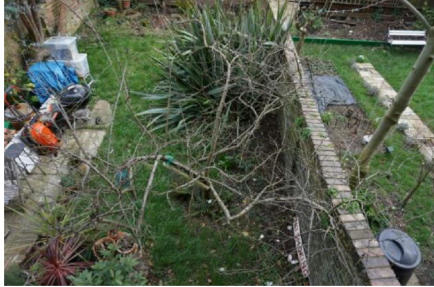
View of 30A – T2 Cherry
