## Demolition Survey

MANSTON  
AGAR GROVE  
LONDON

APRIL 2018

Report prepared for:	Hill Holdings (Essex) Ltd The Power House Gunpowder Mill Powdermill Lane Waltham Abbey Essex EN9 1BN
Report reference:	J113683
Issue date:	May 2018
Survey completed by: Scott Brookes Senior Surveyor

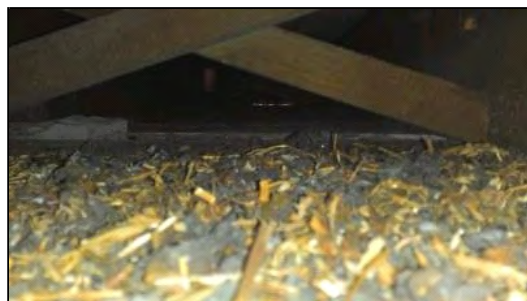
Item No:	000001	Laboratory sample no:	CF009139	
Accessibility:		N/A		
Installation:		Roofing felt		
Approx extent (m² unless stated)		N/A		
Asbestos Type:		NAD		
Condition:	N/A	Surface Treatment:	N/A

Material Risk Assessment	0	Priority Risk Assessment (PA)	N/A	Total Risk	
Recommendation:	None				
Comments: please note the debris is scattered in every ceiling void

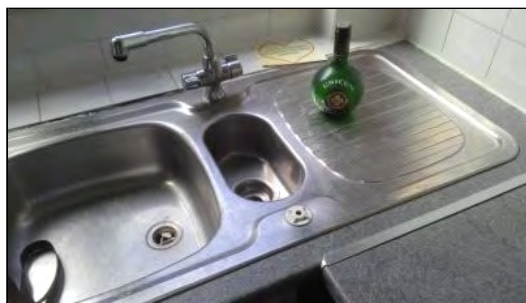
Item No:	000007	Laboratory sample no:	CF009145	
Accessibility:		N/A		
Installation:		Sink pad		
Approx extent (m² unless stated)		N/A		
Asbestos Type:		NAD		
Condition:	N/A	Surface Treatment:	N/A

Material Risk Assessment	0	Priority Risk Assessment (PA)	N/A	Total Risk	
Recommendation:	None				
Comments:

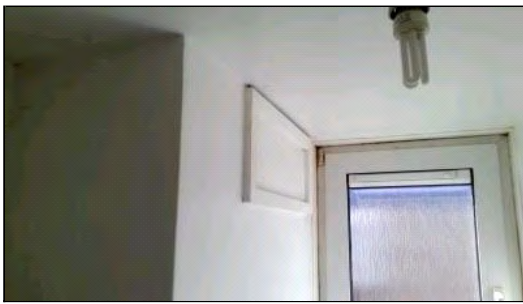
Item No:	000011	Laboratory sample no:	CF009149	
Accessibility:		Moderate		
Installation:		Boarding (2)		
Approx extent (m² unless stated)		<1		
Asbestos Type:		Chrysotile + Amosite (2)		
Condition:	Low damage (1)		Surface Treatment:	Surface sealed (1)

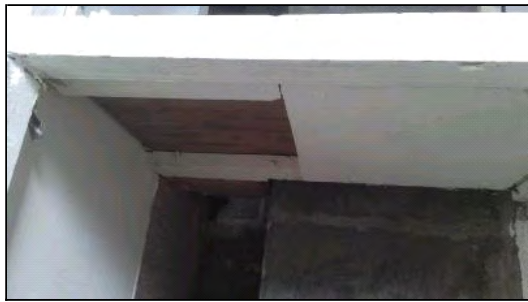
Item No:	000020	Laboratory sample no:	CF009153	
Accessibility:	Easy			
Installation:	Boarding (2)			
Approx extent (m² unless stated)	<1			
Asbestos Type:	Chrysotile + Amosite (2)			
Condition:	Low damage (1)	Surface Treatment:	Surface sealed (1)

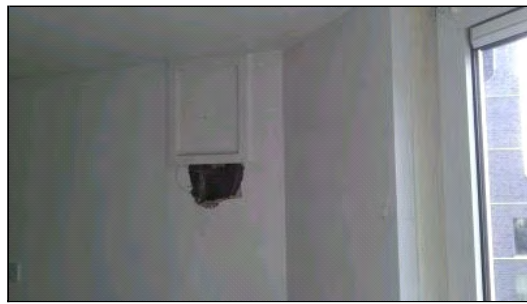
Item No:	000021	Laboratory sample no:	CF009154	
Accessibility:		Moderate		
Installation:		Boarding (2)		
Approx extent (m² unless stated)		<1		
Asbestos Type:		Chrysotile + Amosite (2)		
Condition:	Low damage (1)	Surface Treatment:	Surface sealed (1)

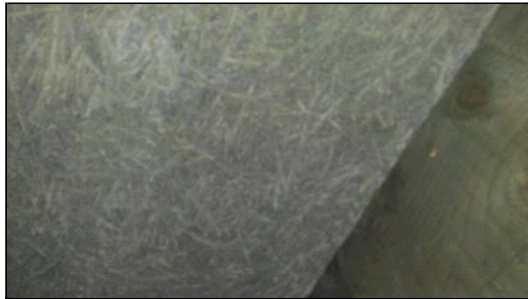
Item No:	000023	Laboratory sample no:	CF009156	
Accessibility:	N/A			
Installation:	Boarding			
Approx extent (m² unless stated)	N/A			
Asbestos Type:	NAD			
Condition:	N/A	Surface Treatment:	N/A

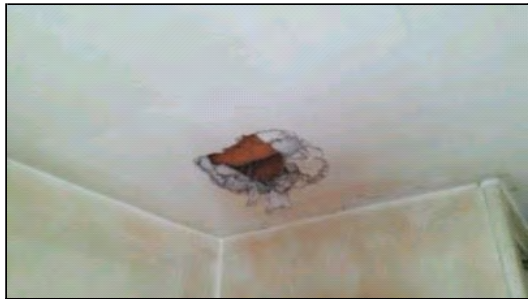
Item No:	000024	Laboratory sample no:	CF009157	
Accessibility:	N/A			
Installation:	Paper / cardboard			
Approx extent (m² unless stated)	N/A			
Asbestos Type:	NAD			
Condition:	N/A	Surface Treatment:	N/A

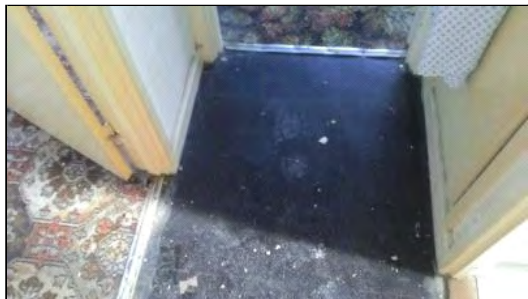
Item No:	000041	Laboratory sample no:	SP CF009159		
Accessibility:		Easy			
Installation:		Floor tile(s) & bitumen (1)			
Approx extent (m <sup>2</sup> unless stated)		40			
Asbestos Type:		Chrysotile (1)			
Condition:		Low damage (1)	Surface Treatment:	Completely sealed (0)

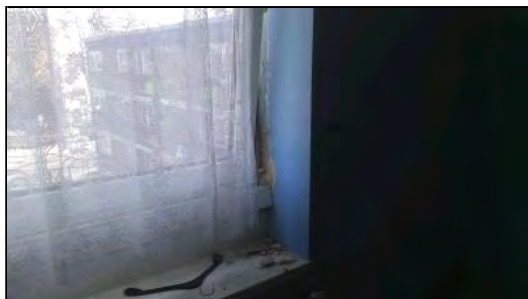
Item No:	000042	Laboratory sample no:	SP CF009160		
Accessibility:		N/A			
Installation:		Felt			
Approx extent (m <sup>2</sup> unless stated)		N/A			
Asbestos Type:		NAD			
Condition:		N/A	Surface Treatment:	N/A

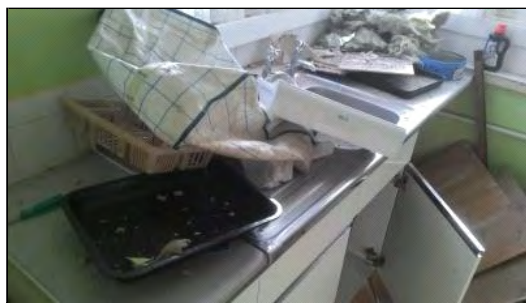
Item No:	000043	Laboratory sample no:	CF009170	
Accessibility:		N/A		
Installation:		Sink pad		
Approx extent (m² unless stated)		N/A		
Asbestos Type:		NAD		
Condition:	N/A	Surface Treatment:	N/A

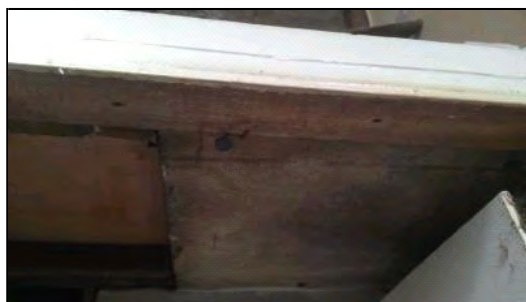
Item No:	000044	Laboratory sample no:	CF009171	
Accessibility:		Easy		
Installation:		Boarding (2)		
Approx extent (m² unless stated)		<1		
Asbestos Type:		Chrysotile + Amosite (2)		
Condition:		Low damage (1)	Surface Treatment:

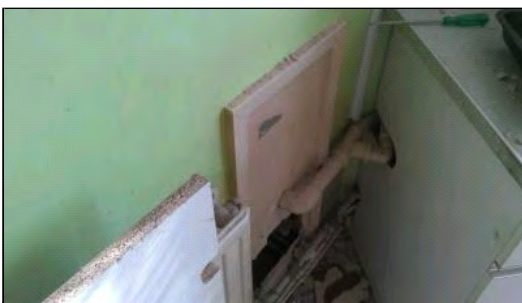
Item No:	000045	Laboratory sample no:	CF009172	
Accessibility:		Easy		
Installation:		Boarding (2)		
Approx extent (m² unless stated)		<1		
Asbestos Type:		Chrysotile + Amosite (2)		
Condition:	Low damage (1)	Surface Treatment:	Surface sealed (1)

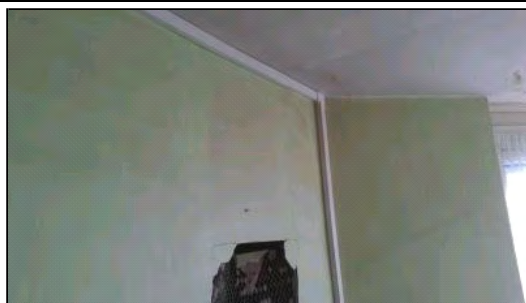
Item No:	000046	Laboratory sample no:	CF009173	
Accessibility:		Moderate		
Installation:		Boarding (2)		
Approx extent (m² unless stated)		<1		
Asbestos Type:		Chrysotile + Amosite (2)		
Condition:	Low damage (1)		Surface Treatment:	Surface sealed (1)

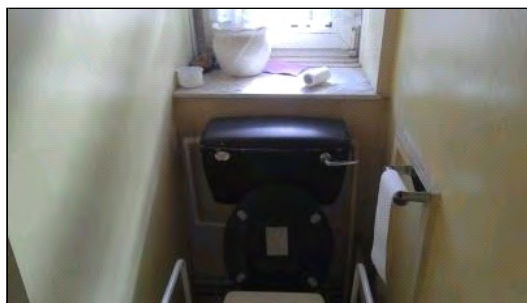
Item No:	000049	Laboratory sample no:	SP CF009169	
Accessibility:		Easy		
Installation:		Toilet cistern(s) (1)		
Approx extent (m² unless stated)		1no.		
Asbestos Type:		Amosite (2)		
Condition:		Low damage (1)	Surface Treatment:

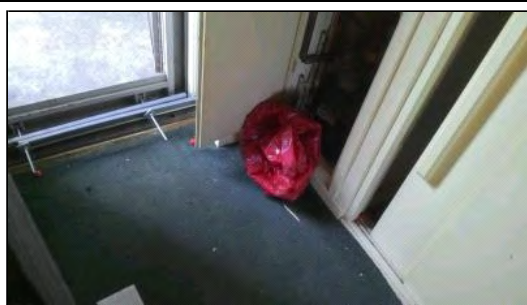
Item No:	000050	Laboratory sample no:	CF009175	
Accessibility:		Easy		
Installation:		Textile (2)		
Approx extent (m² unless stated)		4no.		
Asbestos Type:		Chrysotile (1)		
Condition:	Low damage (1)		Surface Treatment:

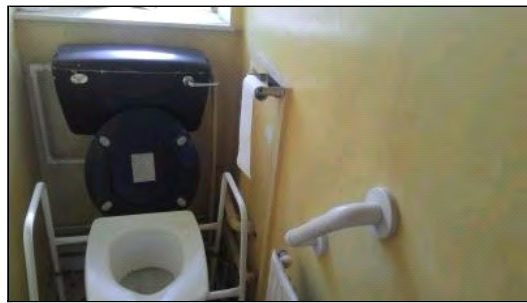
Item No:	000051	Laboratory sample no:	CF009176	
Accessibility:		Easy		
Installation:		Boarding (2)		
Approx extent (m² unless stated)		<1		
Asbestos Type:		Chrysotile + Amosite (2)		
Condition:	Low damage (1)	Surface Treatment:	Surface sealed (1)

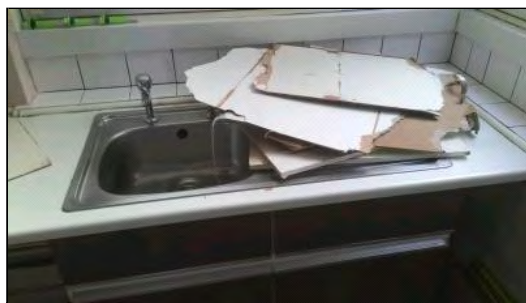
Item No:	000055	Laboratory sample no:	CF009180	
Accessibility:	N/A			
Installation:	Sink pad			
Approx extent (m² unless stated)	N/A			
Asbestos Type:	NAD			
Condition:	N/A	Surface Treatment:	N/A

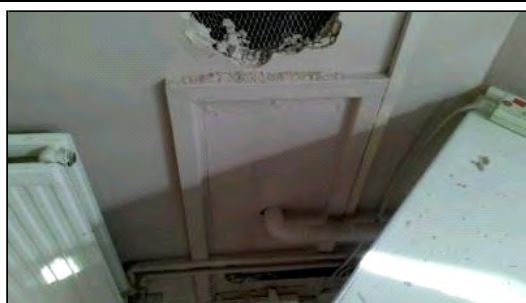
Item No:	000056	Laboratory sample no:	CF009181	
Accessibility:	Easy			
Installation:	Boarding (2)			
Approx extent (m² unless stated)		<1		
Asbestos Type:	Chrysotile + Amosite (2)			
Condition:	Low damage (1)	Surface Treatment:	Surface sealed (1)

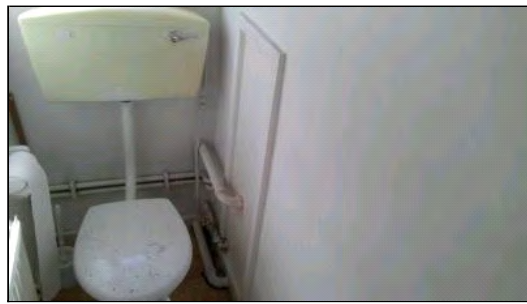
Item No:	000059	Laboratory sample no:	CF009184	
Accessibility:		Easy		
Installation:		Boarding (2)		
Approx extent (m² unless stated)		<1		
Asbestos Type:		Chrysotile + Amosite (2)		
Condition:	Low damage (1)	Surface Treatment:	Surface sealed (1)

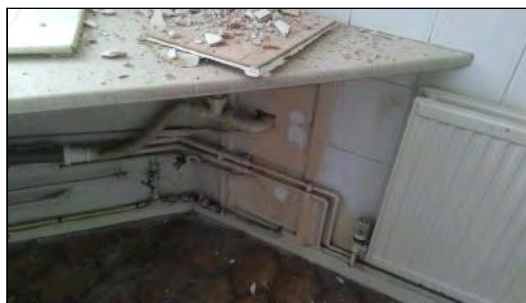
Item No:	000063	Laboratory sample no:	CF009185	
Accessibility:		N/A		
Installation:		Boarding		
Approx extent (m² unless stated)		N/A		
Asbestos Type:		NAD		
Condition:	N/A	Surface Treatment:	N/A

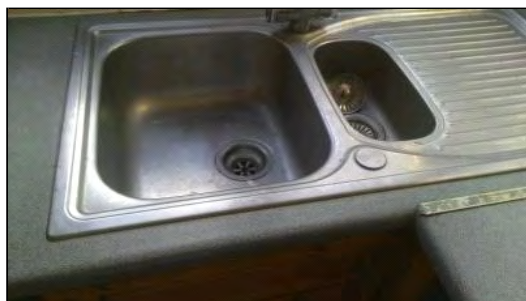
Item No:	000072	Laboratory sample no:	CF009192	
Accessibility:	N/A			
Installation:	Sink pad			
Approx extent (m² unless stated)	N/A			
Asbestos Type:	NAD			
Condition:	N/A	Surface Treatment:	N/A

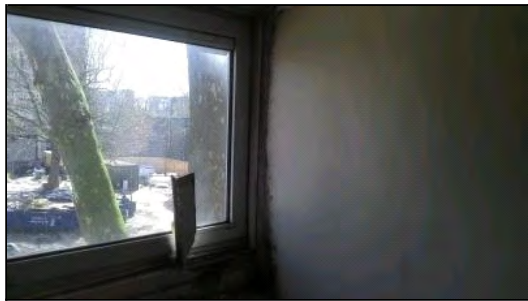
Item No:	000075	Laboratory sample no:	SP CF009188	
Accessibility:		N/A		
Installation:		Felt		
Approx extent (m <sup>2</sup> unless stated)		N/A		
Asbestos Type:		NAD		
Condition:	N/A	Surface Treatment:	N/A

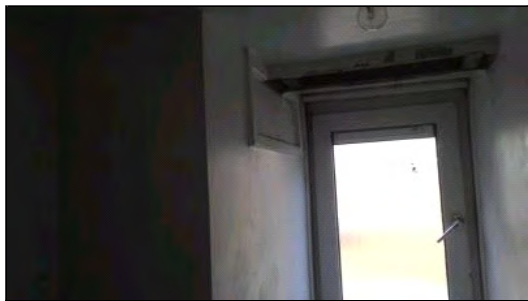
Item No:	000076	Laboratory sample no:	CF009193	
Accessibility:		N/A		
Installation:		Boarding		
Approx extent (m <sup>2</sup> unless stated)		N/A		
Asbestos Type:		NAD		
Condition:	N/A	Surface Treatment:	N/A

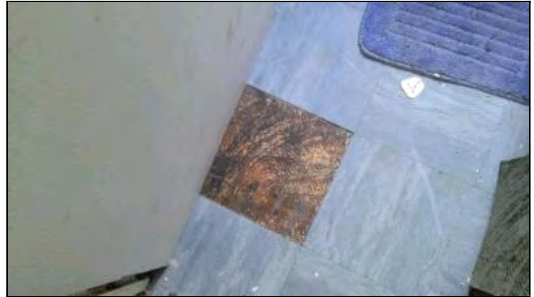
Item No:	000077	Laboratory sample no:	CF009194	
Accessibility:	Easy			
Installation:	Bitumen (1)			
Approx extent (m² unless stated)	12			
Asbestos Type:	Chrysotile (1)			
Condition:	Low damage (1)	Surface Treatment:	Completely sealed (0)

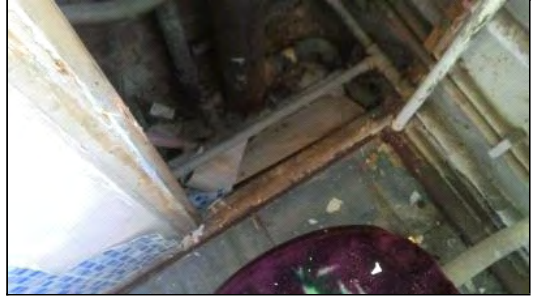
Item No:	000078	Laboratory sample no:	CF009195	
Accessibility:	N/A			
Installation:	Boarding			
Approx extent (m² unless stated)	N/A			
Asbestos Type:	NAD			
Condition:	N/A	Surface Treatment:	N/A

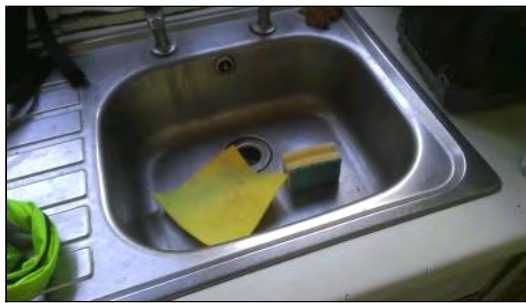
Item No:	000079	Laboratory sample no:	CF009196	
Accessibility:	N/A			
Installation:	Sink pad			
Approx extent (m <sup>2</sup> unless stated)	N/A			
Asbestos Type:	NAD			
Condition:	N/A	Surface Treatment:	N/A

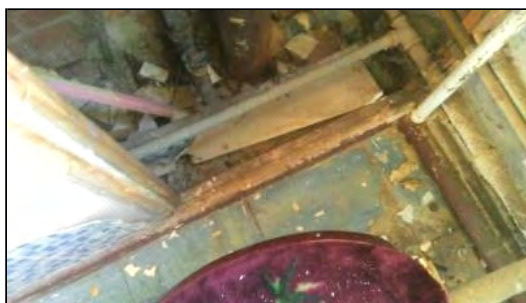
Item No:	000080	Laboratory sample no:	CF009197	
Accessibility:	N/A			
Installation:	Boarding			
Approx extent (m <sup>2</sup> unless stated)	N/A			
Asbestos Type:	NAD			
Condition:	N/A	Surface Treatment:	N/A

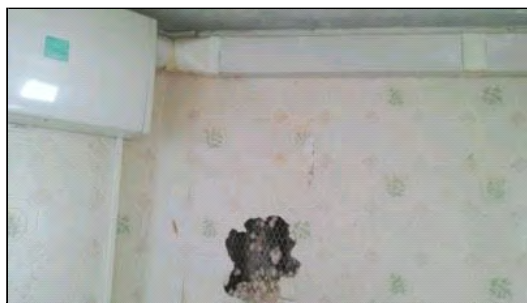
Item No:	000087	Laboratory sample no:	CF009204	
Accessibility:		Moderate		
Installation:		Boarding (2)		
Approx extent (m² unless stated)		<1		
Asbestos Type:		Amosite (2)		
Condition:	Low damage (1)		Surface Treatment:	Surface sealed (1)

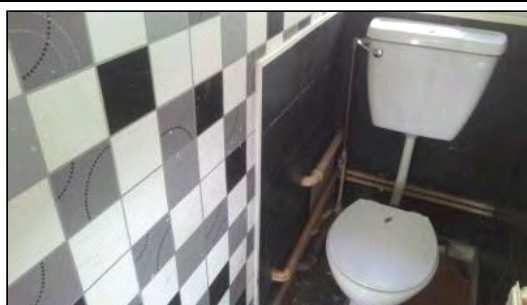
Item No:	000088	Laboratory sample no:	CF009216	
Accessibility:	Easy			
Installation:	Boarding (2)			
Approx extent (m² unless stated)		1		
Asbestos Type:	Chrysotile + Amosite (2)			
Condition:	Low damage (1)	Surface Treatment:	Surface sealed (1)

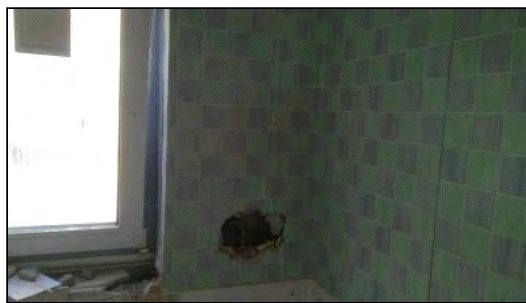
Item No:	000089	Laboratory sample no:	CF009205	
Accessibility:		Moderate		
Installation:		Cement (1)		
Approx extent (m² unless stated)		1no.		
Asbestos Type:		Chrysotile + Crocidolite (3)		
Condition:	Low damage (1)	Surface Treatment:	Surface sealed (1)

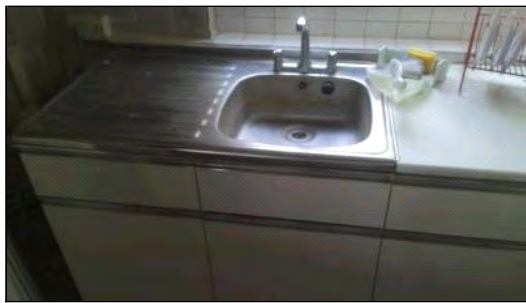
Item No:	000093	Laboratory sample no:	CF009206	
Accessibility:	N/A			
Installation:	Sink pad			
Approx extent (m <sup>2</sup> unless stated)	N/A			
Asbestos Type:	NAD			
Condition:	N/A	Surface Treatment:	N/A

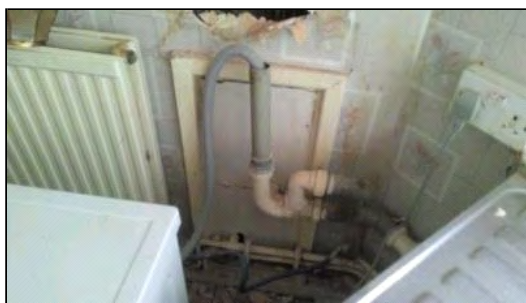
Item No:	000094	Laboratory sample no:	CF009207	
Accessibility:	N/A			
Installation:	Boarding			
Approx extent (m <sup>2</sup> unless stated)	N/A			
Asbestos Type:	NAD			
Condition:	N/A	Surface Treatment:	N/A

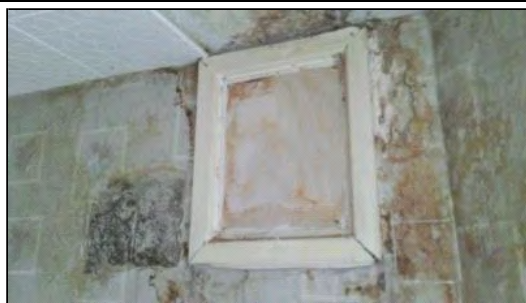
Item No:	000096	Laboratory sample no:	CF009209	
Accessibility:		N/A		
Installation:		Boarding		
Approx extent (m² unless stated)		N/A		
Asbestos Type:		NAD		
Condition:	N/A	Surface Treatment:	N/A

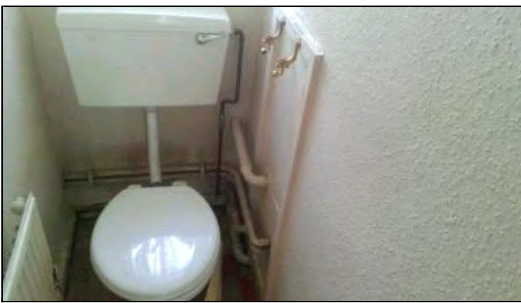
Item No:	000099	Laboratory sample no:	CF009210	
Accessibility:		Easy		
Installation:		Boarding (2)		
Approx extent (m² unless stated)		<1		
Asbestos Type:		Chrysotile + Amosite (2)		
Condition:	Low damage (1)	Surface Treatment:	Surface sealed (1)

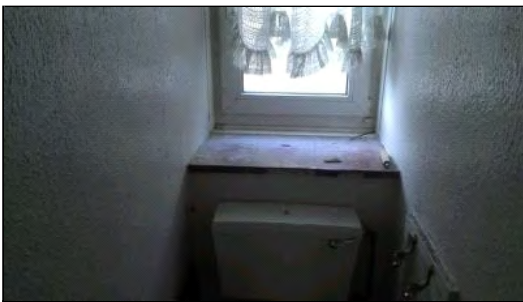
Item No:	000107	Laboratory sample no:	CF009219	
Accessibility:		Easy		
Installation:		Floor tile(s) (1)		
Approx extent (m² unless stated)		<1		
Asbestos Type:		Chrysotile (1)		
Condition:	Low damage (1)	Surface Treatment:	Completely sealed (0)

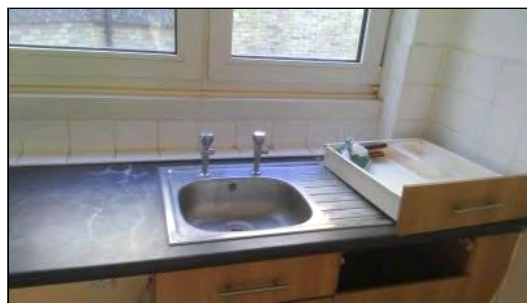
Item No:	000111	Laboratory sample no:	CF009220	
Accessibility:		N/A		
Installation:		Sink pad		
Approx extent (m² unless stated)		N/A		
Asbestos Type:		NAD		
Condition:	N/A		Surface Treatment:	N/A

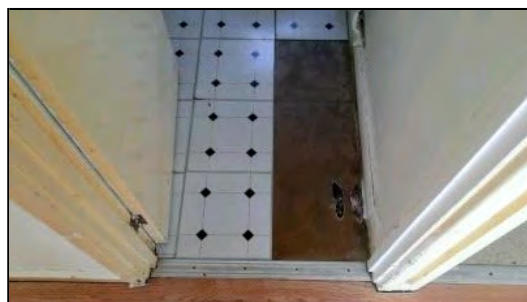
Item No:	000112	Laboratory sample no:	CF009221	
Accessibility:		Easy		
Installation:		Bitumen (1)		
Approx extent (m² unless stated)		5		
Asbestos Type:		Chrysotile (1)		
Condition:	Low damage (1)	Surface Treatment:	Completely sealed (0)

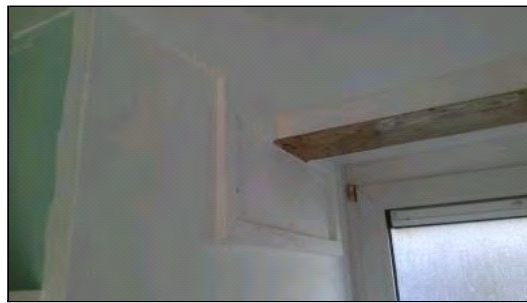
Item No:	000113	Laboratory sample no:	CF009222	
Accessibility:		Moderate		
Installation:		Boarding (2)		
Approx extent (m² unless stated)		<1		
Asbestos Type:		Chrysotile + Amosite (2)		
Condition:	Low damage (1)	Surface Treatment:	Surface sealed (1)

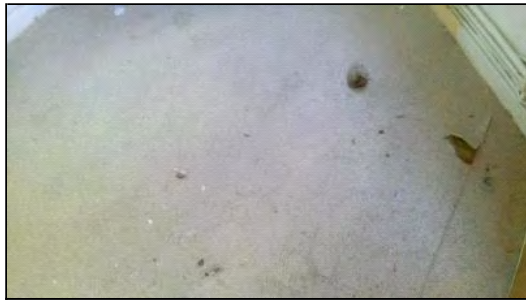
Item No:	000115	Laboratory sample no:	CF009224	
Accessibility:	Easy			
Installation:	Floor tile(s) & bitumen (1)			
Approx extent (m² unless stated)	10			
Asbestos Type:	Chrysotile (1)			
Condition:	Low damage (1)	Surface Treatment:	Completely sealed (0)

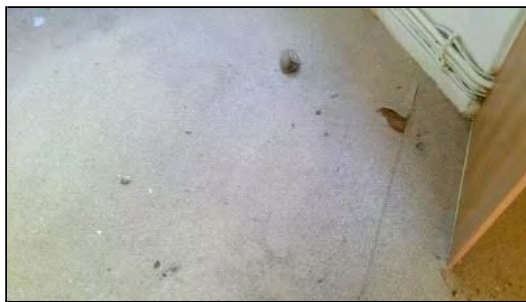
Item No:	000116	Laboratory sample no:	CF009225	
Accessibility:	Easy			
Installation:	Floor tile(s) & bitumen (1)			
Approx extent (m² unless stated)	10			
Asbestos Type:	Chrysotile (1)			
Condition:	Low damage (1)	Surface Treatment:	Completely sealed (0)

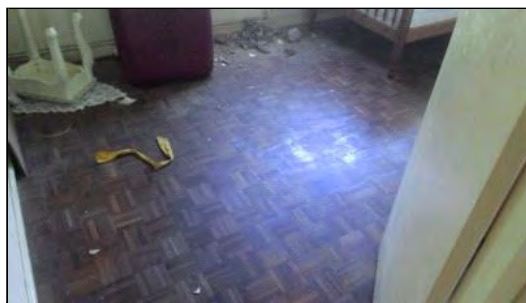
Item No:	000125	Laboratory sample no:	CF009230	
Accessibility:		Easy		
Installation:		Bitumen (1)		
Approx extent (m² unless stated)		16		
Asbestos Type:		Chrysotile (1)		
Condition:	Low damage (1)	Surface Treatment:	Completely sealed (0)

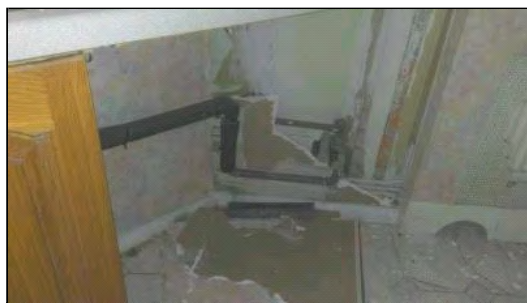
Item No:	000129	Laboratory sample no:	CF009234	
Accessibility:		Easy		
Installation:		Boarding (2)		
Approx extent (m² unless stated)		<1		
Asbestos Type:		Chrysotile + Amosite (2)		
Condition:	Low damage (1)		Surface Treatment:	
Surface sealed (1)

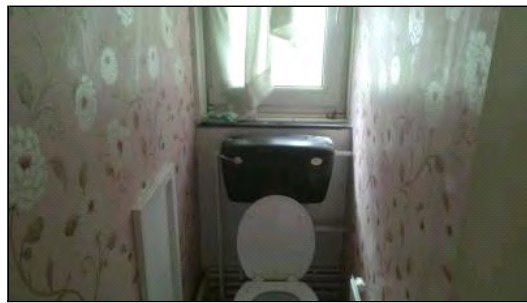
Item No:	000133	Laboratory sample no:	CF009238	
Accessibility:		Easy		
Installation:		Toilet cistern(s) (1)		
Approx extent (m² unless stated)		1no.		
Asbestos Type:		Chrysotile + Amosite (2)		
Condition:	Low damage (1)		Surface Treatment:

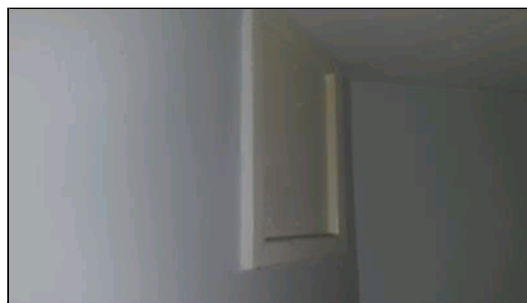
Item No:	000139	Laboratory sample no:	CF009240	
Accessibility:		Moderate		
Installation:		Boarding (2)		
Approx extent (m² unless stated)		<1		
Asbestos Type:		Chrysotile + Amosite (2)		
Condition:	Low damage (1)		Surface Treatment:

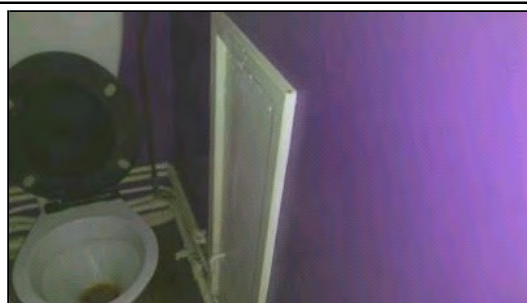
Item No:	000140	Laboratory sample no:	CF009241	
Accessibility:		Easy		
Installation:		Boarding (2)		
Approx extent (m² unless stated)		1		
Asbestos Type:		Chrysotile + Amosite (2)		
Condition:	Low damage (1)	Surface Treatment:	Surface sealed (1)

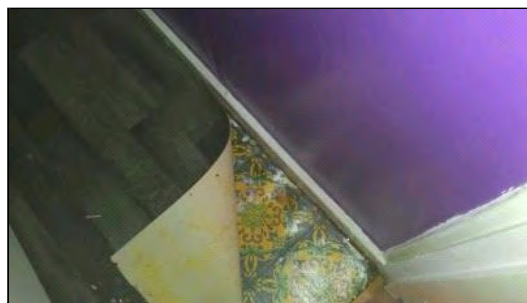
Item No:	000141	Laboratory sample no:	CF009242	
Accessibility:		N/A		
Installation:		Linoleum		
Approx extent (m² unless stated)		N/A		
Asbestos Type:		NAD		
Condition:	N/A	Surface Treatment:	N/A

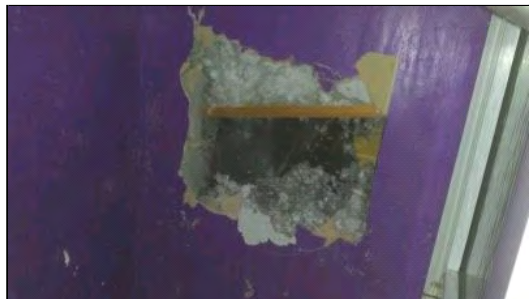
Item No:	000143	Laboratory sample no:	SP CF009239	
Accessibility:		N/A		
Installation:		Felt		
Approx extent (m² unless stated)		N/A		
Asbestos Type:		NAD		
Condition:	N/A	Surface Treatment:	N/A

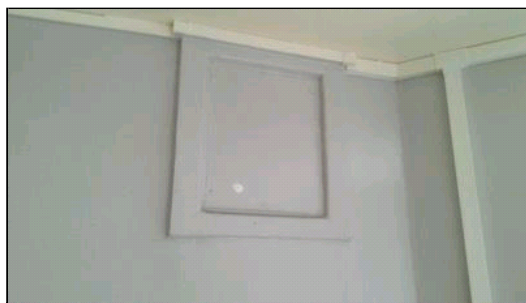
Item No:	000147	Laboratory sample no:	CF009246	
Accessibility:		Moderate		
Installation:		Boarding (2)		
Approx extent (m² unless stated)		1		
Asbestos Type:		Chrysotile + Amosite (2)		
Condition:	Low damage (1)		Surface Treatment:	Surface sealed (1)

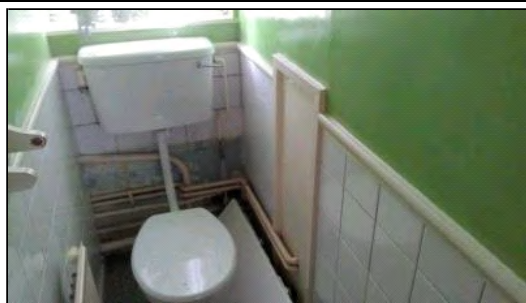
Item No:	000148	Laboratory sample no:	CF009247	
Accessibility:		N/A		
Installation:		Boarding		
Approx extent (m² unless stated)		N/A		
Asbestos Type:		NAD		
Condition:	N/A	Surface Treatment:	N/A

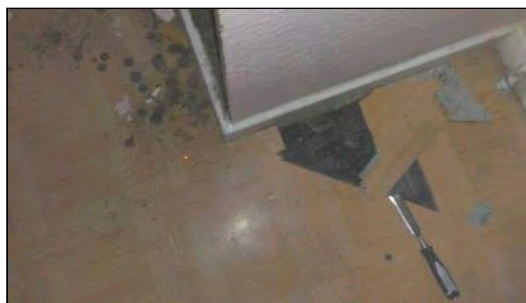
Item No:	000157	Laboratory sample no:	CF009251	
Accessibility:		Easy		
Installation:		Bitumen (1)		
Approx extent (m² unless stated)		10		
Asbestos Type:		Chrysotile (1)		
Condition:	Low damage (1)		Surface Treatment:	Completely sealed (0)

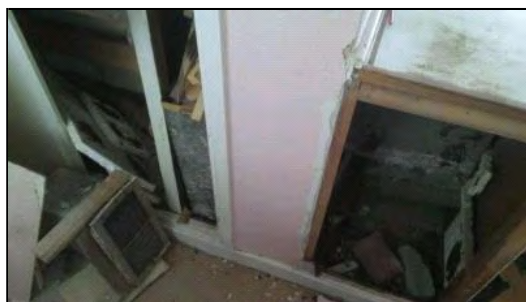
Item No:	000158	Laboratory sample no:	CF009252	
Accessibility:		N/A		
Installation:		Bitumen		
Approx extent (m² unless stated)		N/A		
Asbestos Type:		NAD		
Condition:	N/A	Surface Treatment:	N/A

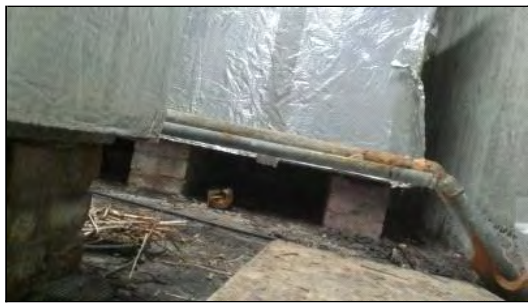
Item No:	000169	Laboratory sample no:	CF009258	
Accessibility:	N/A			
Installation:	Boarding			
Approx extent (m <sup>2</sup> unless stated)	N/A			
Asbestos Type:	NAD			
Condition:	N/A	Surface Treatment:	N/A
