MANAGEMENT ASBESTOS SURVEY WITH A
LOCALISED REFURBISHMENT AND DEMOLITION
ASBESTOS SURVEY REPORT TO

SHERBORNE
AGAR GROVE
LONDON

APRIL 2018

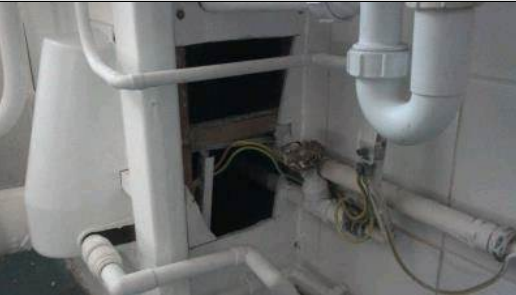
Location:		6 Sherborne, Agar Grove, London, NW1 9TB - First floor - Bathroom - Insulation board and debris to right hand low level panel to boxing behind toilet

Item No:	000001	Laboratory sample no:	CX001707	
Accessibility:		Easy		
Installation:		Boarding (2)		
Approx extent (m² unless stated)		<1		
Asbestos Type:		Chrysotile + Amosite (2)		
Condition:		High damage (3)	Surface Treatment:	
				Unsealed AIB/encapsulated lagging (2)

Material Risk Assessment	9	Priority Risk Assessment (PA)	N/A	Total Risk	N/A
Recommendation:	Restrict access to area until ACM has been repaired or removed				
Comments:	Boarding has a hole cut out leaving debris to timber ledge and inside boxing

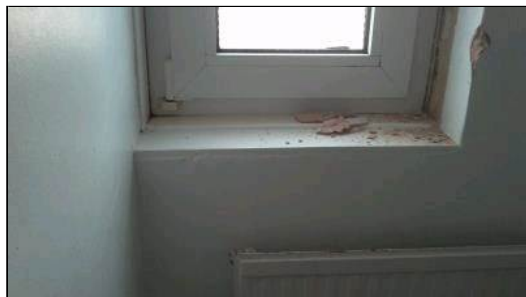
Location:		6 Sherborne, Agar Grove, London, NW1 9TB - First floor - Bathroom - Cement window sill

Item No:	000002	Laboratory sample no:	CX001708	
Accessibility:		Easy		
Installation:		Cement (1)		
Approx extent (m² unless stated)		1		
Asbestos Type:		Chrysotile (1)		
Condition:	Low damage (1)	Surface Treatment:	Surface sealed (1)

Material Risk Assessment	4	Priority Risk Assessment (PA)	N/A	Total Risk	N/A
Recommendation:	Remove if affected by refurbishment works. Manage in-situ otherwise				
Comments:

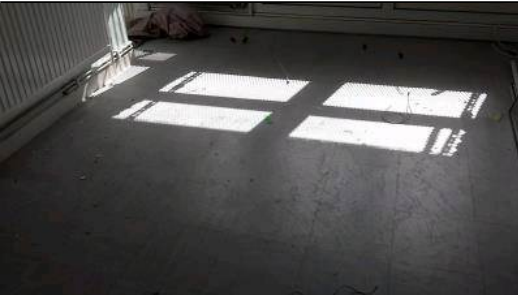
Location:		6 Sherborne, Agar Grove, London, NW1 9TB - First floor - Lounge - Vinyl floor tile and bitumen adhesive below (Blue) to floor

Item No:	000003	Laboratory sample no:	CX001709	
Accessibility:		Easy		
Installation:		Floor tile(s) & bitumen (1)		
Approx extent (m² unless stated)		20		
Asbestos Type:		Chrysotile (1)		
Condition:	Low damage (1)		Surface Treatment:

Material Risk Assessment	3	Priority Risk Assessment (PA)	N/A	Total Risk	N/A
Recommendation:	Remove if affected by refurbishment works. Manage in-situ otherwise				
Comments:

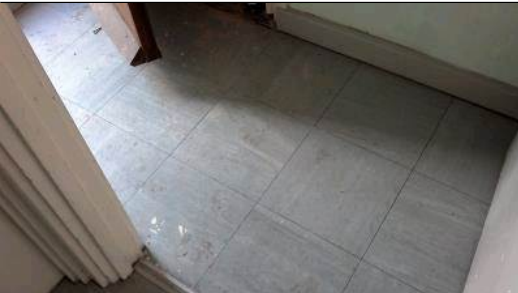
Location:		6 Sherborne, Agar Grove, London, NW1 9TB - First floor - Hall way - Vinyl floor tile and bitumen adhesive below (Blue) to floor

Item No:	000004	Laboratory sample no:	SP CX001709	
Accessibility:		Easy		
Installation:		Floor tile(s) & bitumen (1)		
Approx extent (m² unless stated)		2		
Asbestos Type:		Chrysotile (1)		
Condition:		Low damage (1)	Surface Treatment:

Material Risk Assessment	3	Priority Risk Assessment (PA)	N/A	Total Risk	N/A
Recommendation:	Remove if affected by refurbishment works. Manage in-situ otherwise				
Comments:

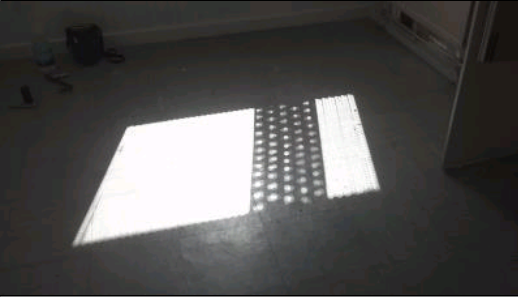
Location:		6 Sherborne, Agar Grove, London, NW1 9TB - First floor - Bedroom - Vinyl floor tile and bitumen adhesive below (Blue) to floor

Item No:	000005	Laboratory sample no:	SP CX001709	
Accessibility:		Easy		
Installation:		Floor tile(s) & bitumen (1)		
Approx extent (m² unless stated)		16		
Asbestos Type:		Chrysotile (1)		
Condition:	Low damage (1)		Surface Treatment:

Material Risk Assessment	3	Priority Risk Assessment (PA)	N/A	Total Risk	N/A
Recommendation:	Remove if affected by refurbishment works. Manage in-situ otherwise				
Comments:

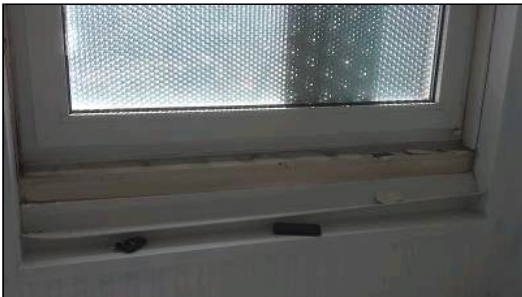
Location:		6 Sherborne, Agar Grove, London, NW1 9TB - First floor - Bedroom - Cement window sill

Item No:	000006	Laboratory sample no:	SP CX001708	
Accessibility:		Easy		
Installation:		Cement (1)		
Approx extent (m² unless stated)		1no.		
Asbestos Type:		Chrysotile (1)		
Condition:	Low damage (1)		Surface Treatment:

Material Risk Assessment	4	Priority Risk Assessment (PA)	N/A	Total Risk	N/A
Recommendation:	Remove if affected by refurbishment works. Manage in-situ otherwise				
Comments:

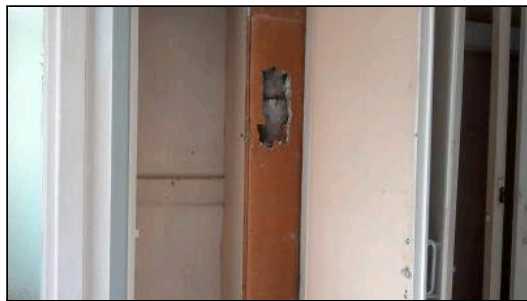
Location:		6 Sherborne, Agar Grove, London, NW1 9TB - First floor - Bedroom - Cement pipe within timber and plasterboard boxing

Item No:	000007	Laboratory sample no:	CX001710	
Accessibility:		Easy		
Installation:		Cement (1)		
Approx extent (m² unless stated)		6lm		
Asbestos Type:		Chrysotile + Amosite (2)		
Condition:	Low damage (1)	Surface Treatment:	Surface sealed (1)

Material Risk Assessment	5	Priority Risk Assessment (PA)	N/A	Total Risk	N/A
Recommendation:	Remove if affected by refurbishment works. Manage in-situ otherwise				
Comments: Cement pipe in bedroom goes through plasterboard ceiling with timber panels in front - in previous properties there is known insulation lining between the pipes - without causing damage and high possibility of disturbing this product, it must be presumed it is present

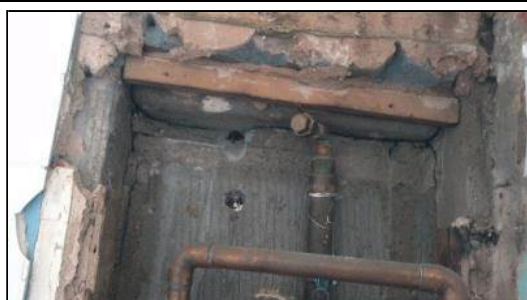
Location:		6 Sherborne, Agar Grove, London, NW1 9TB - First floor - Kitchen - Cement paneling within wall

Item No:	000008	Laboratory sample no:	CX001711	
Accessibility:		Easy		
Installation:		Cement (1)		
Approx extent (m² unless stated)		1		
Asbestos Type:		Chrysotile + Crocidolite (3)		
Condition:	Low damage (1)	Surface Treatment:	Surface sealed (1)

Material Risk Assessment	6	Priority Risk Assessment (PA)	N/A	Total Risk	N/A
Recommendation:	Remove if affected by refurbishment works. Manage in-situ otherwise				
Comments: (This can be seen in the external brick work)

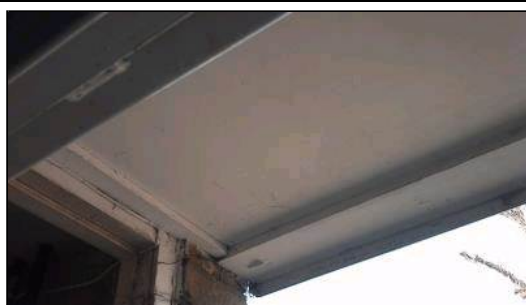
Location:		6 Sherborne, Agar Grove, London, NW1 9TB - External - External - Insulation board to porch

Item No:	000010	Laboratory sample no:	CX001713	
Accessibility:		Moderate		
Installation:		Boarding (2)		
Approx extent (m² unless stated)		1		
Asbestos Type:		Chrysotile + Amosite (2)		
Condition:	Low damage (1)	Surface Treatment:	Surface sealed (1)

Material Risk Assessment	6	Priority Risk Assessment (PA)	N/A	Total Risk	N/A
Recommendation:	Remove if affected by refurbishment works. Manage in-situ otherwise				
Comments:

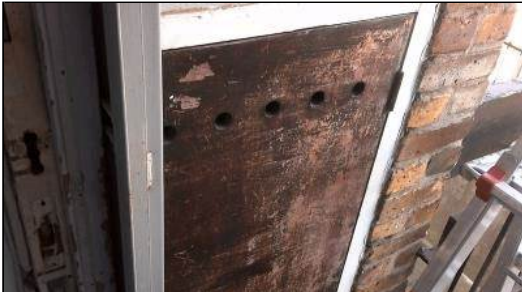
Location:		6 Sherborne, Agar Grove, London, NW1 9TB - External - External - No access gained within bottom store cupboard

Item No:	000012	Laboratory sample no:	Not sampled	
Accessibility:		No access gained		
Installation:		Unknown (3)		
Approx extent (m² unless stated)		Unknown		
Asbestos Type:		Presumed asbestos (3)		
Condition:		High damage (3)	Surface Treatment:	
			Unsealed (3)

Material Risk Assessment	12	Priority Risk Assessment (PA)	N/A	Total Risk	12
Recommendation:	Presume ACMs are present until area has been surveyed				
Comments:	Due to metal security door blocking access

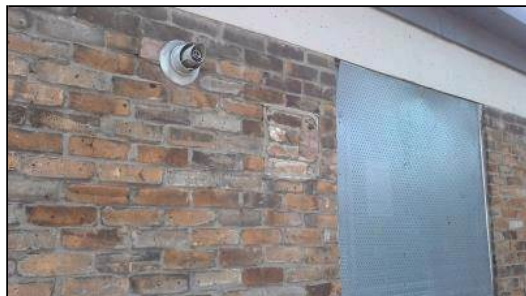
Location:		6 Sherborne, Agar Grove, London, NW1 9TB - External - External - Cement paneling within wall

Item No:	000013	Laboratory sample no:	SP CX001711	
Accessibility:		Easy		
Installation:		Cement (1)		
Approx extent (m² unless stated)		1		
Asbestos Type:		Chrysotile + Crocidolite (3)		
Condition:	Low damage (1)		Surface Treatment:

Material Risk Assessment	6	Priority Risk Assessment (PA)	N/A	Total Risk	N/A
Recommendation:	Remove if affected by refurbishment works. Manage in-situ otherwise				
Comments:	(This is the other side of the kitchen cement panel)
