MANAGEMENT ASBESTOS SURVEY WITH A  
LOCALISED REFURBISHMENT AND DEMOLITION  
ASBESTOS SURVEY REPORT TO

STURMINSTER  
AGAR GROVE  
LONDON

APRIL 2018

Report prepared for:	Hill Holdings (Essex) Ltd The Power House Gunpowder Mill Powdermill Lane Waltham Abbey Essex EN9 1BN
Report reference:	J113685
Issue date:	April 2018
Survey completed by: Richard Watts Senior Surveyor	 
Approved by: Laurence Stear Project Manager

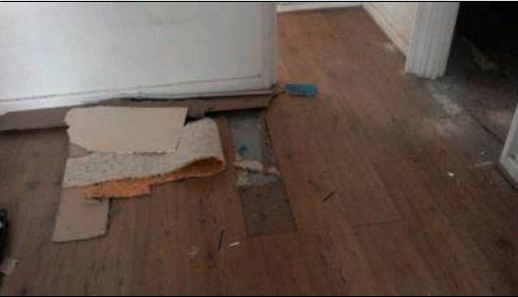
Location:		3 Sturminster, Agar Grove, London, NW1 9TA - Ground floor - Lounge - Vinyl floor tile and bitumen adhesive below under wood flooring and carpet

Item No:	000001	Laboratory sample no:	CX001679	
Accessibility:		Easy		
Installation:		Floor tile(s) & bitumen (1)		
Approx extent (m² unless stated)		20		
Asbestos Type:		Chrysotile (1)		
Condition:	Low damage (1)	Surface Treatment:	Completely sealed (0)

Material Risk Assessment	3	Priority Risk Assessment (PA)	N/A	Total Risk	N/A
Recommendation:	Remove if affected by refurbishment works. Manage in-situ otherwise				
Comments:

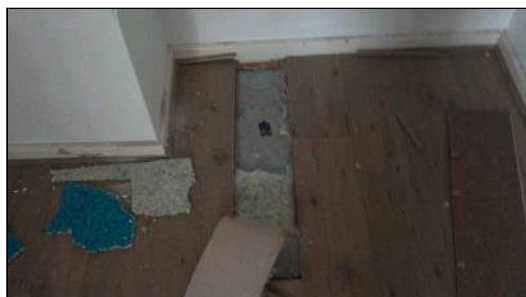
Item No:	000002	Laboratory sample no:	SP CX001679	
Accessibility:		Easy		
Installation:		Floor tile(s) & bitumen (1)		
Approx extent (m² unless stated)		15		
Asbestos Type:		Chrysotile (1)		
Condition:	Low damage (1)		Surface Treatment:	
				Completely sealed (0)

Material Risk Assessment	3	Priority Risk Assessment (PA)	N/A	Total Risk	N/A
Recommendation:	Remove if affected by refurbishment works. Manage in-situ otherwise				
Comments:

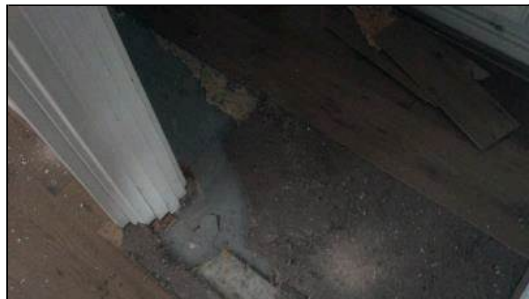
Item No:	000003	Laboratory sample no:	SP CX001679	
Accessibility:		Easy		
Installation:		Floor tile(s) & bitumen (1)		
Approx extent (m² unless stated)		2		
Asbestos Type:		Chrysotile (1)		
Condition:	Low damage (1)		Surface Treatment:

Material Risk Assessment	3	Priority Risk Assessment (PA)	N/A	Total Risk	N/A
Recommendation:	Remove if affected by refurbishment works. Manage in-situ otherwise				
Comments:

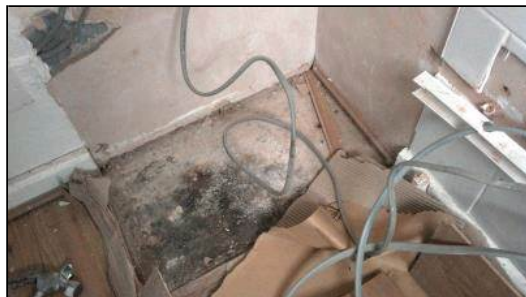
Item No:	000005	Laboratory sample no:	CX001681	
Accessibility:	Easy			
Installation:	Bitumen (1)			
Approx extent (m² unless stated)	6			
Asbestos Type:	Chrysotile (1)			
Condition:	Low damage (1)	Surface Treatment:	Completely sealed (0)

Material Risk Assessment	3	Priority Risk Assessment (PA)	N/A	Total Risk	N/A
Recommendation:	Remove if affected by refurbishment works. Manage in-situ otherwise				
Comments:

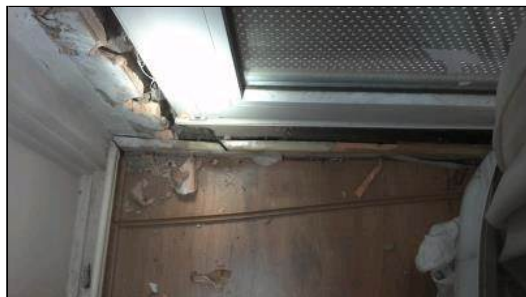
Item No:	000006	Laboratory sample no:	CX001682	
Accessibility:		Moderate		
Installation:		Bitumen (1)		
Approx extent (m² unless stated)		6lm		
Asbestos Type:		Chrysotile (1)		
Condition:	Low damage (1)	Surface Treatment:	Completely sealed (0)

Material Risk Assessment	3	Priority Risk Assessment (PA)	N/A	Total Risk	N/A
Recommendation:	Remove if affected by refurbishment works. Manage in-situ otherwise				
Comments:	To all external walls throughout

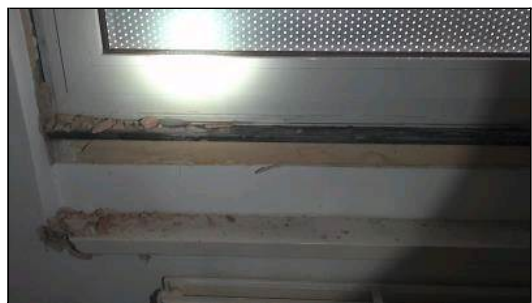
Item No:	000007	Laboratory sample no:	CX001683	
Accessibility:		Easy		
Installation:		Cement (1)		
Approx extent (m² unless stated)		1no.		
Asbestos Type:		Chrysotile (1)		
Condition:	Low damage (1)		Surface Treatment:

Material Risk Assessment	4	Priority Risk Assessment (PA)	N/A	Total Risk	N/A
Recommendation:	Remove if affected by refurbishment works. Manage in-situ otherwise				
Comments:

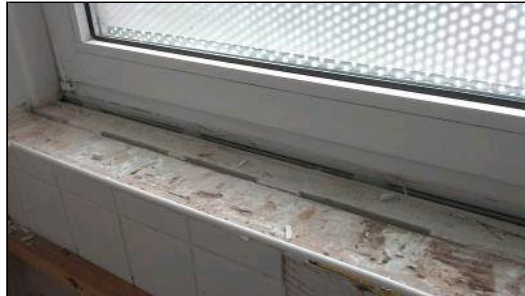
Item No:	000008	Laboratory sample no:	SP CX001683	
Accessibility:		Easy		
Installation:		Cement (1)		
Approx extent (m² unless stated)		1no.		
Asbestos Type:		Chrysotile (1)		
Condition:	Low damage (1)		Surface Treatment:	
				Surface sealed (1)

Material Risk Assessment	4	Priority Risk Assessment (PA)	N/A	Total Risk	N/A
Recommendation:	Remove if affected by refurbishment works. Manage in-situ otherwise				
Comments:

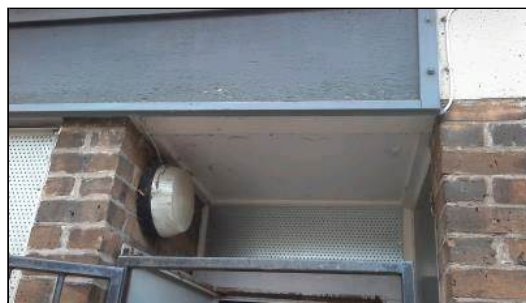
Item No:	000009	Laboratory sample no:	CX001684	
Accessibility:		Moderate		
Installation:		Boarding (2)		
Approx extent (m² unless stated)		1		
Asbestos Type:		Chrysotile + Amosite (2)		
Condition:	Low damage (1)		Surface Treatment:	Surface sealed (1)

Material Risk Assessment	6	Priority Risk Assessment (PA)	N/A	Total Risk	N/A
Recommendation:	Remove if affected by refurbishment works. Manage in-situ otherwise				
Comments:	Hole in boarding has been sealed up

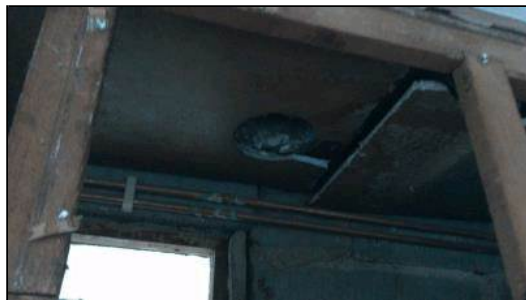
Item No:	000011	Laboratory sample no:	CX001686	
Accessibility:		Moderate		
Installation:		Insulation (3)		
Approx extent (m² unless stated)		1lm		
Asbestos Type:		Amosite (2)		
Condition:	Low damage (1)	Surface Treatment:	Unsealed (3)

Material Risk Assessment	9	Priority Risk Assessment (PA)	N/A	Total Risk	N/A
Recommendation:	Remove if affected by refurbishment works. Manage in-situ otherwise				
Comments:	Full extent unknown unit roof void is accessed

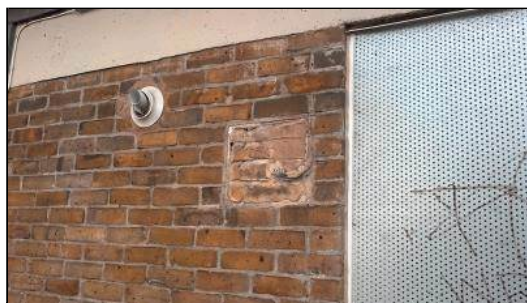
Item No:	000013	Laboratory sample no:	CX001688	
Accessibility:		Easy		
Installation:		Cement (1)		
Approx extent (m² unless stated)		1		
Asbestos Type:		Chrysotile (1)		
Condition:	Low damage (1)	Surface Treatment:	Surface sealed (1)

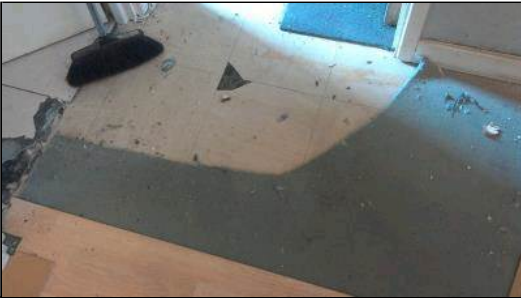
Item No:	000014	Laboratory sample no:	CX001689	
Accessibility:		Easy		
Installation:		Floor tile(s) & bitumen (1)		
Approx extent (m² unless stated)		20		
Asbestos Type:		Chrysotile (1)		
Condition:	Low damage (1)	Surface Treatment:	Completely sealed (0)

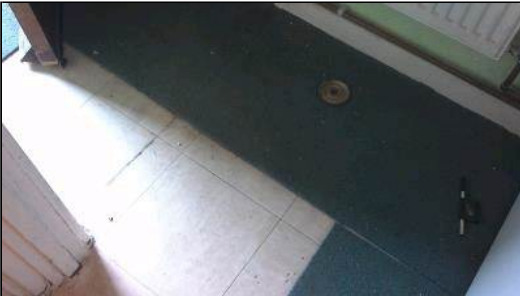
Item No:	000015	Laboratory sample no:	SP CX001689	
Accessibility:		Easy		
Installation:		Floor tile(s) & bitumen (1)		
Approx extent (m <sup>2</sup> unless stated)		2		
Asbestos Type:		Chrysotile (1)		
Condition:	Low damage (1)		Surface Treatment:	Completely sealed (0)

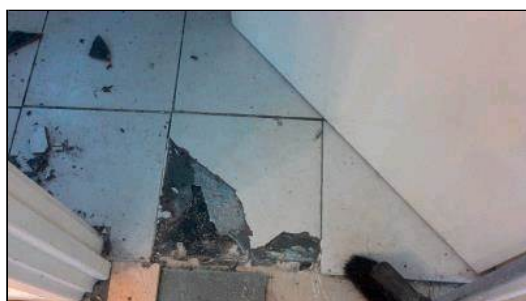
Item No:	000016	Laboratory sample no:	CX001690	
Accessibility:		Easy		
Installation:		Floor tile(s) & bitumen (1)		
Approx extent (m² unless stated)		6		
Asbestos Type:		Chrysotile (1)		
Condition:	Low damage (1)		Surface Treatment:	Completely sealed (0)

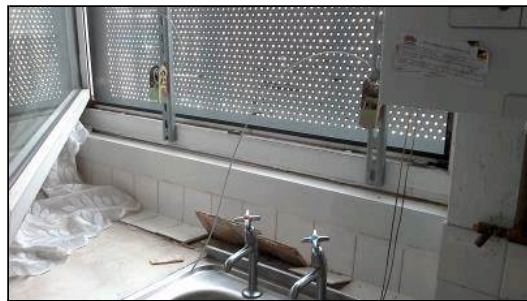
Item No:	000017	Laboratory sample no:	CX001691	
Accessibility:		Easy		
Installation:		Cement (1)		
Approx extent (m² unless stated)		<2lm		
Asbestos Type:		Chrysotile (1)		
Condition:	Low damage (1)		Surface Treatment:	Surface sealed (1)

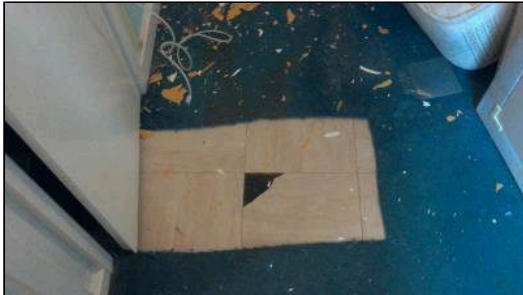
Item No:	000018	Laboratory sample no:	SP CX001689	
Accessibility:		Easy		
Installation:		Floor tile(s) & bitumen (1)		
Approx extent (m² unless stated)		16		
Asbestos Type:		Chrysotile (1)		
Condition:	Low damage (1)		Surface Treatment:

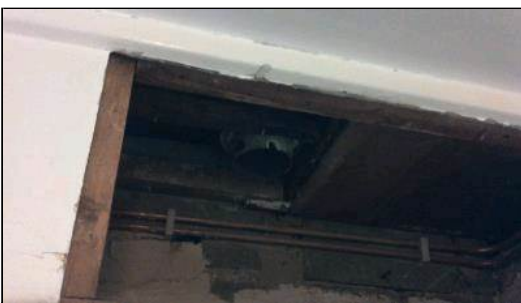
Item No:	000019	Laboratory sample no:	CX001692	
Accessibility:		Moderate		
Installation:		Cement (1)		
Approx extent (m² unless stated)		3lm		
Asbestos Type:		Chrysotile + Amosite (2)		
Condition:	Low damage (1)	Surface Treatment:	Surface sealed (1)

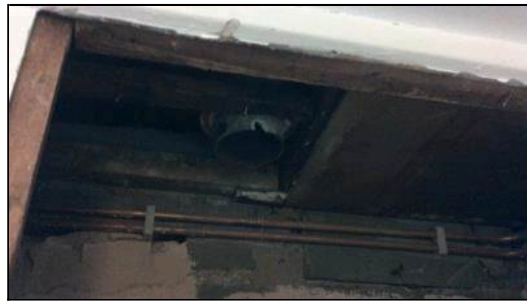
Item No:	000020	Laboratory sample no:	CX001693	
Accessibility:		Moderate		
Installation:		Insulation (3)		
Approx extent (m² unless stated)		3lm		
Asbestos Type:		Chrysotile (1)		
Condition:	Low damage (1)	Surface Treatment:	Unsealed (3)

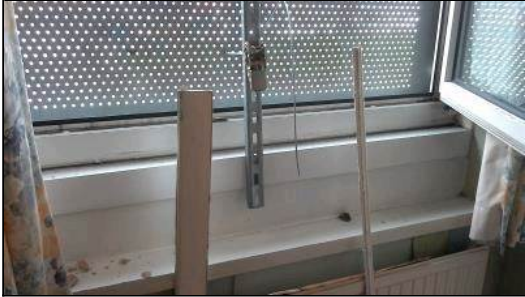
Item No:	000023	Laboratory sample no:	SP CX001691	
Accessibility:		Easy		
Installation:		Cement (1)		
Approx extent (m² unless stated)		1no.		
Asbestos Type:		Chrysotile (1)		
Condition:	Low damage (1)		Surface Treatment:	
				Surface sealed (1)

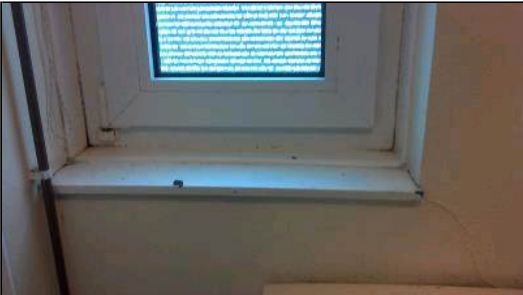
Item No:	000024	Laboratory sample no:	SP CX001691	
Accessibility:		Easy		
Installation:		Cement (1)		
Approx extent (m² unless stated)		1no.		
Asbestos Type:		Chrysotile (1)		
Condition:	Low damage (1)		Surface Treatment:

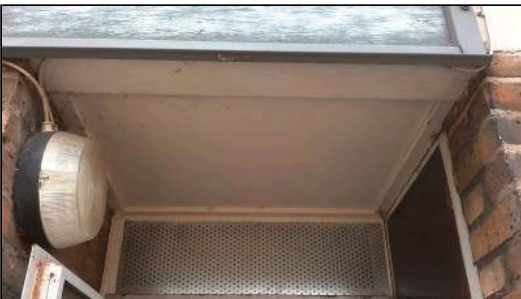
Item No:	000026	Laboratory sample no:	CX001698	
Accessibility:		Easy		
Installation:		Boarding (2)		
Approx extent (m² unless stated)		1		
Asbestos Type:		Chrysotile + Amosite (2)		
Condition:		Low damage (1)	Surface Treatment:

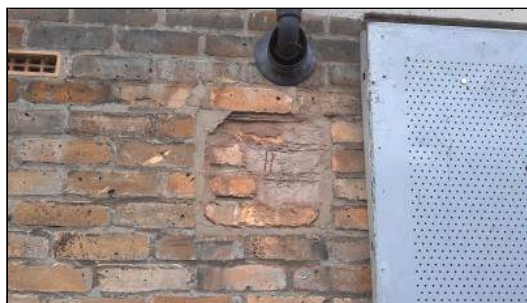
Item No:	000027	Laboratory sample no:	CX001699	
Accessibility:		Easy		
Installation:		Cement (1)		
Approx extent (m² unless stated)		1		
Asbestos Type:		Chrysotile (1)		
Condition:	Low damage (1)	Surface Treatment:	Surface sealed (1)

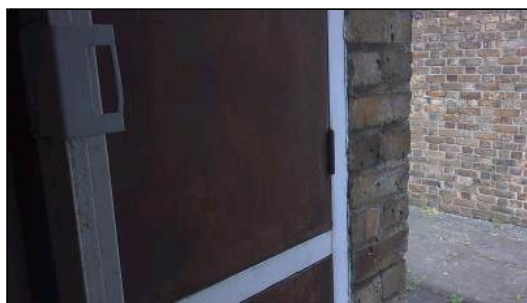
Item No:	000028	Laboratory sample no:	CX001700	
Accessibility:		Easy		
Installation:		Mastic (1)		
Approx extent (m² unless stated)		4lm		
Asbestos Type:		Chrysotile (1)		
Condition:	Low damage (1)	Surface Treatment:	Surface sealed (1)

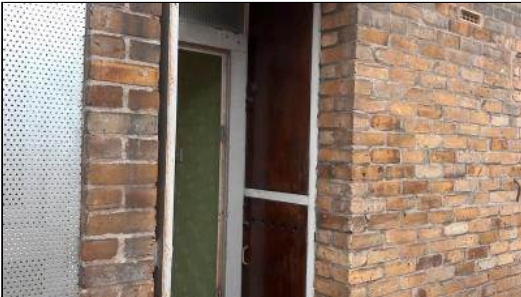
Item No:	000029	Laboratory sample no:	Not sampled	
Accessibility:		No access gained		
Installation:		Unknown (3)		
Approx extent (m² unless stated)		Unknown		
Asbestos Type:		Presumed asbestos (3)		
Condition:	High damage (3)	Surface Treatment:	Unsealed (3)

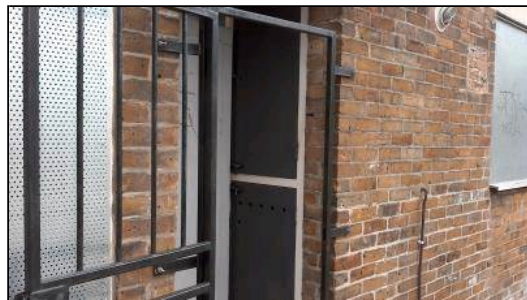
Item No:	000031	Laboratory sample no:	Not sampled	
Accessibility:		No access gained		
Installation:		Unknown (3)		
Approx extent (m² unless stated)		Unknown		
Asbestos Type:		Presumed asbestos (3)		
Condition:		High damage (3)	Surface Treatment:

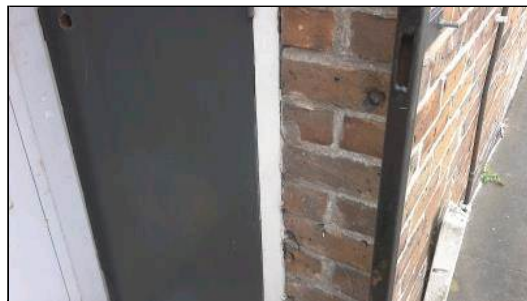
Item No:	000032	Laboratory sample no:	CX001702	
Accessibility:		Easy		
Installation:		Mastic (1)		
Approx extent (m² unless stated)		4lm		
Asbestos Type:		Chrysotile (1)		
Condition:	Low damage (1)		Surface Treatment:	Completely sealed (0)

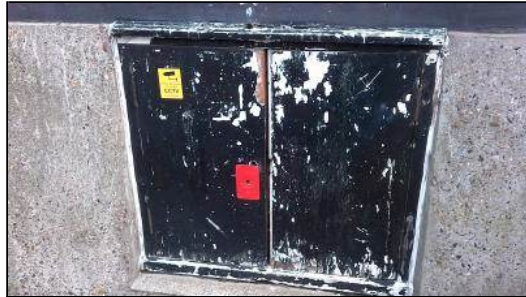
Item No:	000037	Laboratory sample no:	Not sampled	
Accessibility:		No access gained		
Installation:		Unknown (3)		
Approx extent (m² unless stated)		Unknown		
Asbestos Type:		Presumed asbestos (3)		
Condition:		High damage (3)	Surface Treatment:

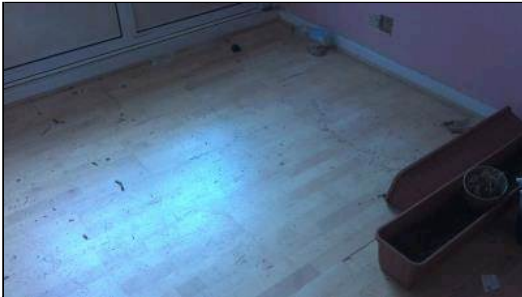
Item No:	000038	Laboratory sample no:	CX001715	
Accessibility:	Easy			
Installation:	Floor tile(s) & bitumen (1)			
Approx extent (m <sup>2</sup> unless stated)		20		
Asbestos Type:	Chrysotile (1)			
Condition:	Low damage (1)	Surface Treatment:	Completely sealed (0)

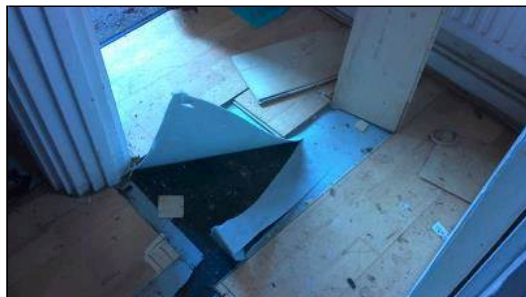
Item No:	000039	Laboratory sample no:	SP CX001715	
Accessibility:		Easy		
Installation:		Floor tile(s) & bitumen (1)		
Approx extent (m² unless stated)		2		
Asbestos Type:		Chrysotile (1)		
Condition:		Low damage (1)	Surface Treatment:

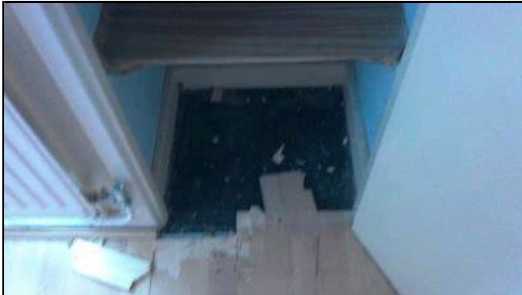
Item No:	000040	Laboratory sample no:	SP CX001715	
Accessibility:		Easy		
Installation:		Floor tile(s) & bitumen (1)		
Approx extent (m² unless stated)		16		
Asbestos Type:		Chrysotile (1)		
Condition:	Low damage (1)	Surface Treatment:	Completely sealed (0)

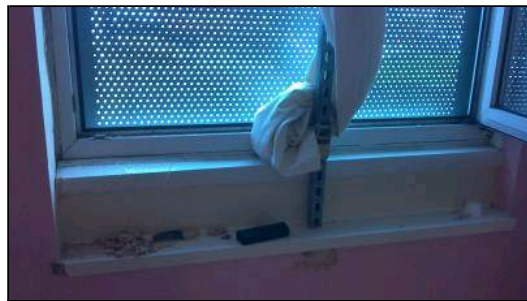
Item No:	000041	Laboratory sample no:	CX001716	
Accessibility:		Easy		
Installation:		Cement (1)		
Approx extent (m² unless stated)		1no.		
Asbestos Type:		Chrysotile (1)		
Condition:	Low damage (1)		Surface Treatment:

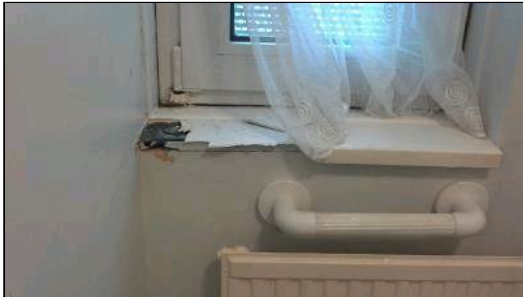
Item No:	000042	Laboratory sample no:	SP CX001716	
Accessibility:		Easy		
Installation:		Cement (1)		
Approx extent (m² unless stated)		1no.		
Asbestos Type:		Chrysotile (1)		
Condition:	Low damage (1)	Surface Treatment:	Surface sealed (1)

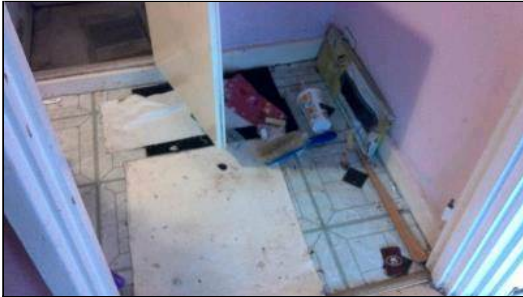
Item No:	000043	Laboratory sample no:	CX001717	
Accessibility:		Easy		
Installation:		Floor tile(s) & bitumen (1)		
Approx extent (m² unless stated)		6		
Asbestos Type:		Chrysotile (1)		
Condition:	Low damage (1)		Surface Treatment:	Completely sealed (0)

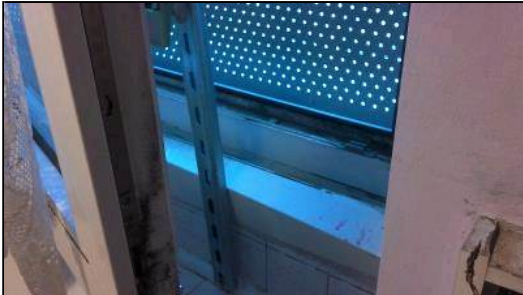
Item No:	000044	Laboratory sample no:	SP CX001716	
Accessibility:		Easy		
Installation:		Cement (1)		
Approx extent (m² unless stated)		1no.		
Asbestos Type:		Chrysotile (1)		
Condition:	Low damage (1)		Surface Treatment:

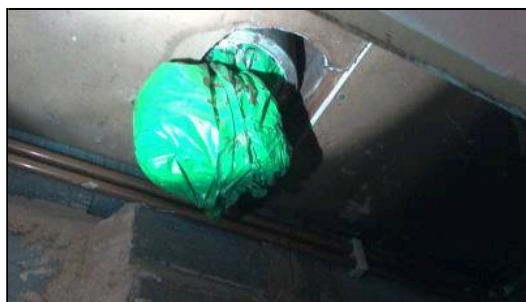
Item No:	000046	Laboratory sample no:	CX001719	
Accessibility:		Easy		
Installation:		Insulation (3)		
Approx extent (m² unless stated)		3lm		
Asbestos Type:		Chrysotile (1)		
Condition:	Medium damage (2)	Surface Treatment:	Unsealed (3)

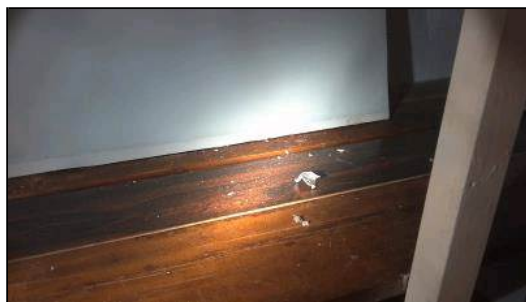
Item No:	000047	Laboratory sample no:	SP CX001719	
Accessibility:		Easy		
Installation:		Insulation (3)		
Approx extent (m² unless stated)		2		
Asbestos Type:		Chrysotile (1)		
Condition:	High damage (3)		Surface Treatment:

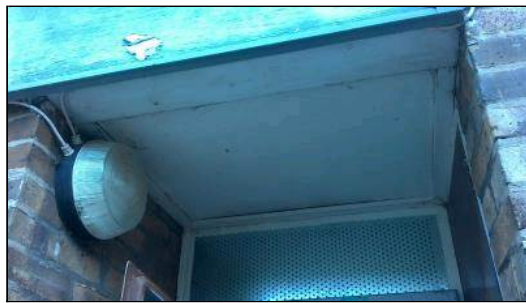
Item No:	000048	Laboratory sample no:	CX001720	
Accessibility:		Moderate		
Installation:		Boarding (2)		
Approx extent (m² unless stated)		1		
Asbestos Type:		Amosite (2)		
Condition:	Low damage (1)		Surface Treatment:	Surface sealed (1)

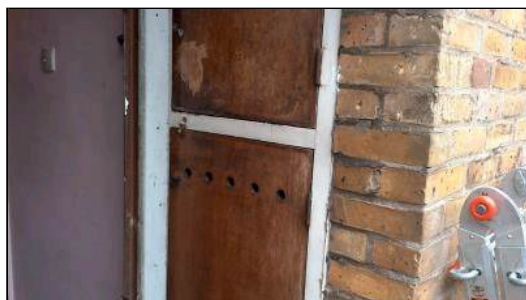
Item No:	000049	Laboratory sample no:	CX001721	
Accessibility:		Easy		
Installation:		Mastic (1)		
Approx extent (m² unless stated)		4lm		
Asbestos Type:		Chrysotile (1)		
Condition:	Low damage (1)	Surface Treatment:	Completely sealed (0)

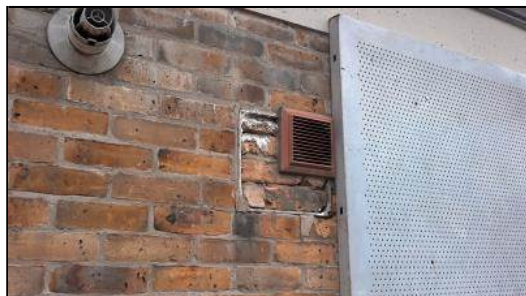
Item No:	000050	Laboratory sample no:	CX001722	
Accessibility:		Easy		
Installation:		Cement (1)		
Approx extent (m² unless stated)		1		
Asbestos Type:		Chrysotile (1)		
Condition:	Low damage (1)	Surface Treatment:	Surface sealed (1)

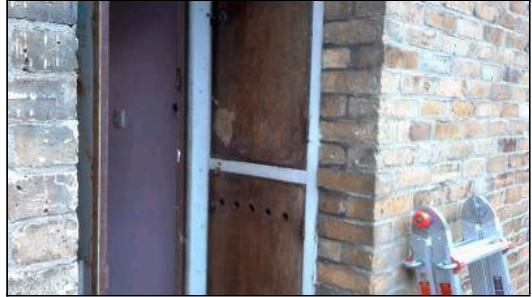
Item No:	000051	Laboratory sample no:	Not sampled	
Accessibility:		No access gained		
Installation:		Unknown (3)		
Approx extent (m² unless stated)		Unknown		
Asbestos Type:		Presumed asbestos (3)		
Condition:	High damage (3)	Surface Treatment:	Unsealed (3)
