REFURBISHMENT SURVEY
AGAR GROVE (SHOPS/CAFE)
LONDON
NW1 0RJ
APRIL 2018

Report prepared for:	Hill Holdings (Essex) Ltd The Power House Gunpowder Mill Powdermill Lane Waltham Abbey Essex EN9 1BN
Report reference:	J114426
Issue date:	May 2018
Survey completed by: Craig Auty Senior Surveyor	 
Approved by: Chris Frost Project Manager

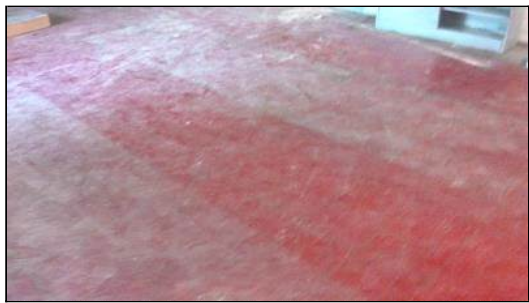
Location:	26-28 Agar Grove - Ground floor - 0.001 - Shop - Shop Area - Red tiles to floor

Item No:	000001	Laboratory sample no:	EA001755	
Accessibility:	N/A			
Installation:	Floor tile(s)			
Approx extent (m² unless stated)	N/A			
Asbestos Type:	NAD			
Condition:	N/A	Surface Treatment:	N/A

Material Risk Assessment	0	Priority Risk Assessment (PA)	N/A	Total Risk	
Recommendation:	None				
Comments:

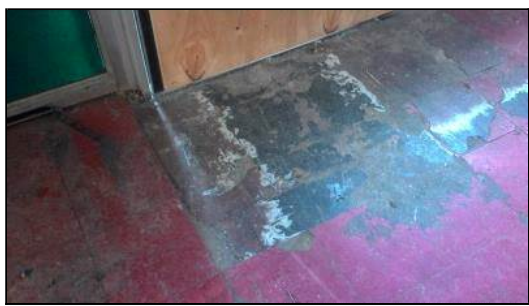
Location:	26-28 Agar Grove - Ground floor - 0.001 - Shop - Shop Area - Black tiles to floor near entrance

Item No:	000002	Laboratory sample no:	EA001756	
Accessibility:	N/A			
Installation:	Floor tile(s)			
Approx extent (m² unless stated)	N/A			
Asbestos Type:	NAD			
Condition:	N/A	Surface Treatment:	N/A

Material Risk Assessment	0	Priority Risk Assessment (PA)	N/A	Total Risk	
Recommendation:	None				
Comments:

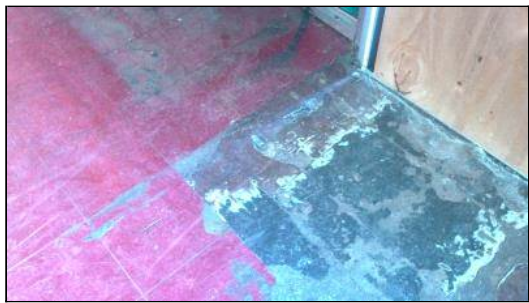
Location:	26-28 Agar Grove - Ground floor - 0.001 - Shop - Shop Area - Brown tiles to floor near entrance

Item No:	000003	Laboratory sample no:	EA001757	
Accessibility:	N/A			
Installation:	Floor tile(s)			
Approx extent (m ² unless stated)	N/A			
Asbestos Type:	NAD			
Condition:	N/A	Surface Treatment:	N/A

Material Risk Assessment	0	Priority Risk Assessment (PA)	N/A	Total Risk	
Recommendation:	None				
Comments:

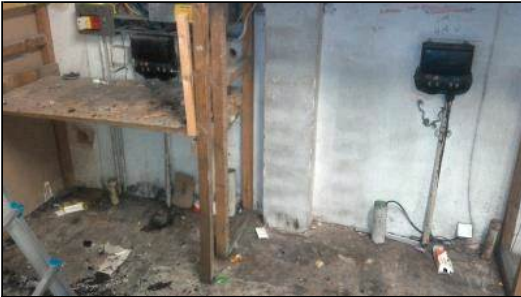
Location:		26-28 Agar Grove - Ground floor - 0.002 - Shop - Store Room - Bitumen based textile wraps to two electrical intake cables

Item No:	000005	Laboratory sample no:	EA001759	
Accessibility:		N/A		
Installation:		Textile		
Approx extent (m² unless stated)		N/A		
Asbestos Type:		NAD		
Condition:	N/A	Surface Treatment:	N/A

Material Risk Assessment	0	Priority Risk Assessment (PA)	N/A	Total Risk	
Recommendation:	None				
Comments:

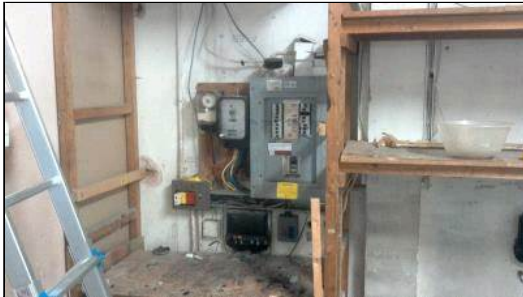
Location:		26-28 Agar Grove - Ground floor - 0.002 - Shop - Store Room - Inaccessible - No access to internal aspects of electrical units

Item No:	000006	Laboratory sample no:	Not sampled	
Accessibility:		No access gained		
Installation:		Unknown (3)		
Approx extent (m² unless stated)		Unknown		
Asbestos Type:		Presumed asbestos (3)		
Condition:		High damage (3)	Surface Treatment:

Material Risk Assessment	12	Priority Risk Assessment (PA)	N/A	Total Risk	12
Recommendation:	Presume ACMs are present until area has been surveyed				
Comments:	Electrics live at time of survey

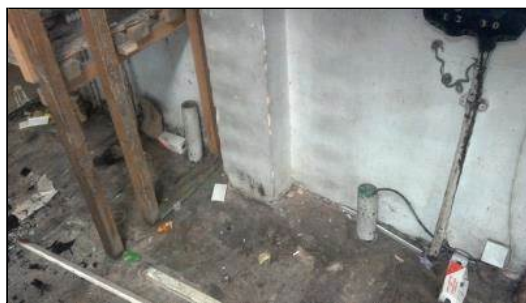
Location:		26-28 Agar Grove - Ground floor - 0.002 - Shop - Store Room - Cement pipes/cable surrounds at low level

Item No:	000007	Laboratory sample no:	EA001760	
Accessibility:		Easy		
Installation:		Cement (1)		
Approx extent (m² unless stated)		2lm		
Asbestos Type:		Chrysotile (1)		
Condition:	Low damage (1)	Surface Treatment:	Surface sealed (1)

Material Risk Assessment	4	Priority Risk Assessment (PA)	N/A	Total Risk	N/A
Recommendation:	Remove				
Comments:	Two observed

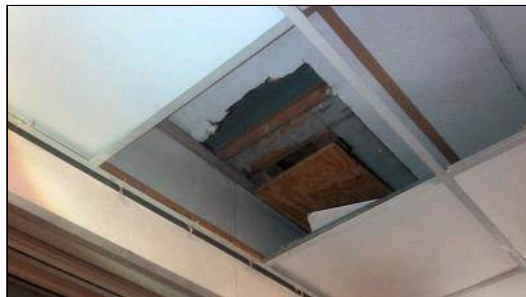
Location:		26-28 Agar Grove - Ground floor - 0.001 - Shop - Shop Area - Bitumen based adhesive to underside of roof and side panels within ceiling void

Item No:	000009	Laboratory sample no:	EA001762	
Accessibility:		N/A		
Installation:		Bitumen		
Approx extent (m² unless stated)		N/A		
Asbestos Type:		NAD		
Condition:	N/A	Surface Treatment:	N/A

Material Risk Assessment	0	Priority Risk Assessment (PA)	N/A	Total Risk	
Recommendation:	None				
Comments: Extent reflects all ceiling voids

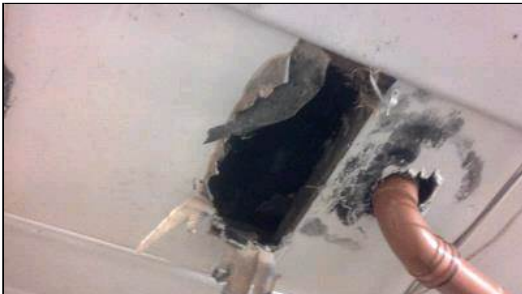
Location:		26-28 Agar Grove - Ground floor - 0.002 - Shop - Store Room - Felt lining within roof panels

Item No:	000010	Laboratory sample no:	EA001763	
Accessibility:		Moderate		
Installation:		Felt (1)		
Approx extent (m² unless stated)		140		
Asbestos Type:		Chrysotile (1)		
Condition:	Low damage (1)	Surface Treatment:	Completely sealed (0)

Material Risk Assessment	3	Priority Risk Assessment (PA)	N/A	Total Risk	N/A
Recommendation:	Remove				
Comments: Extent reflects whole roof

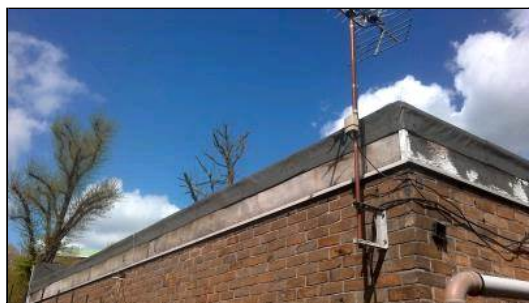
Location:		26-28 Agar Grove - External - Ex.001 - Shop - Flat Roof - Roofing felt to roof

Item No:	000011	Laboratory sample no:	EA001764	
Accessibility:		N/A		
Installation:		Roofing felt		
Approx extent (m² unless stated)		N/A		
Asbestos Type:		NAD		
Condition:	N/A	Surface Treatment:	N/A

Material Risk Assessment	0	Priority Risk Assessment (PA)	N/A	Total Risk	
Recommendation:	None				
Comments:

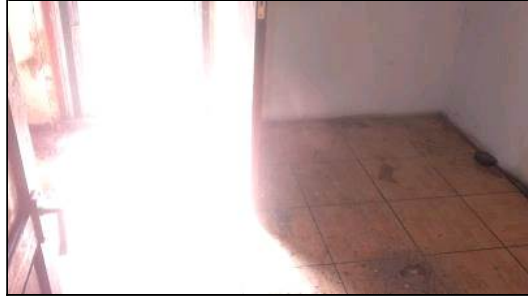
Location:		26-28 Agar Grove - Ground floor - 0.005 - Cafe - Store - No suspect materials

Item No:	000013	Laboratory sample no:	Not sampled	
Accessibility:		N/A		
Installation:		Unknown		
Approx extent (m² unless stated)		N/A		
Asbestos Type:		NAD		
Condition:	N/A	Surface Treatment:	N/A

Material Risk Assessment	0	Priority Risk Assessment (PA)	N/A	Total Risk	
Recommendation:	None				
Comments:

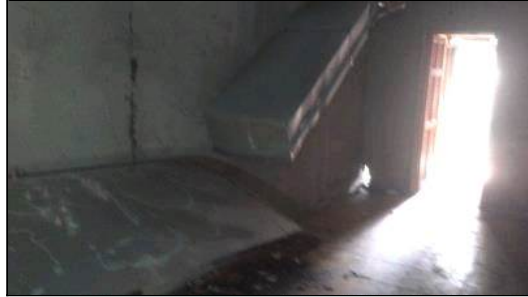
Location:		26-28 Agar Grove - Ground floor - 0.006 - Cafe - Kitchen - Mastic sealant to ventilation ductwork

Item No:	000014	Laboratory sample no:	EA001765	
Accessibility:		N/A		
Installation:		Mastic		
Approx extent (m² unless stated)		N/A		
Asbestos Type:		NAD		
Condition:	N/A	Surface Treatment:	N/A

Material Risk Assessment	0	Priority Risk Assessment (PA)	N/A	Total Risk	
Recommendation:	None				
Comments: Extent continues in to store

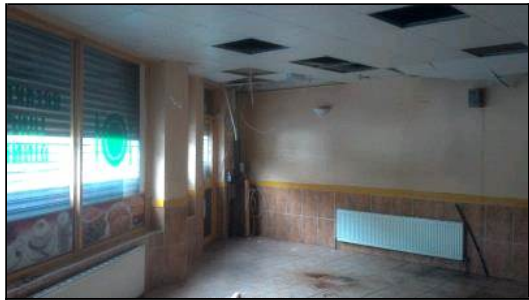
Location:		26-28 Agar Grove - Ground floor - 0.007 - Cafe - Cafe Area - No suspect materials

Item No:	000015	Laboratory sample no:	Not sampled	
Accessibility:		N/A		
Installation:		Unknown		
Approx extent (m² unless stated)		N/A		
Asbestos Type:		NAD		
Condition:	N/A	Surface Treatment:	N/A

Material Risk Assessment	0	Priority Risk Assessment (PA)	N/A	Total Risk	
Recommendation:	None				
Comments:

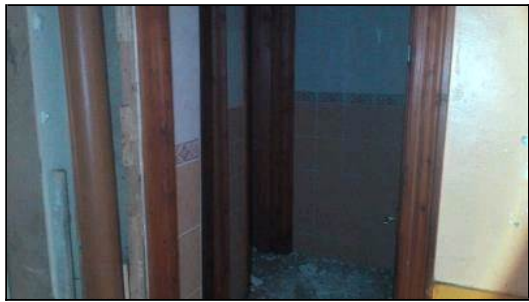
Location:		26-28 Agar Grove - Ground floor - 0.008 - Cafe - W.C. - No suspect materials

Item No:	000016	Laboratory sample no:	Not sampled	
Accessibility:		N/A		
Installation:		Unknown		
Approx extent (m² unless stated)		N/A		
Asbestos Type:		NAD		
Condition:	N/A	Surface Treatment:	N/A

Material Risk Assessment	0	Priority Risk Assessment (PA)	N/A	Total Risk	
Recommendation:	None				
Comments:

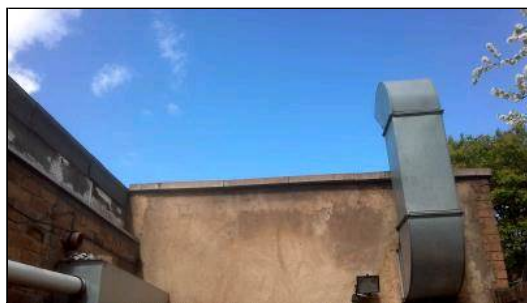
Location:		26-28 Agar Grove - External - Ex.002 - Cafe - Flat roof - Roofing felt to flat roof

Item No:	000017	Laboratory sample no:	EA001766	
Accessibility:		N/A		
Installation:		Roofing felt		
Approx extent (m² unless stated)		N/A		
Asbestos Type:		NAD		
Condition:	N/A		Surface Treatment:

Material Risk Assessment	0	Priority Risk Assessment (PA)	N/A	Total Risk	
Recommendation:	None				
Comments:
