POLICYHOLDER: Mrs Jane Hoadley

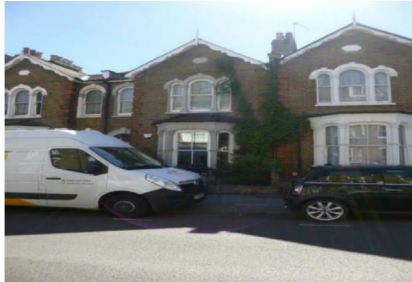
PHOTOGRAPH 01:

This photograph shows the front elevation.

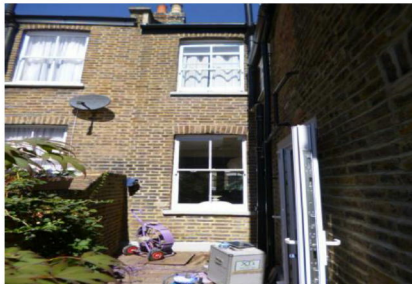
PHOTOGRAPH 02:

This photograph is a general view of the rear elevation of the main terrace.

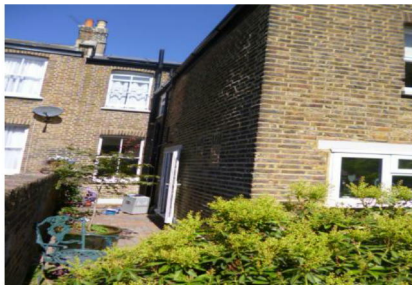
PHOTOGRAPH 03:

This photograph is a general view of the right hand flank wall of the rear projection.

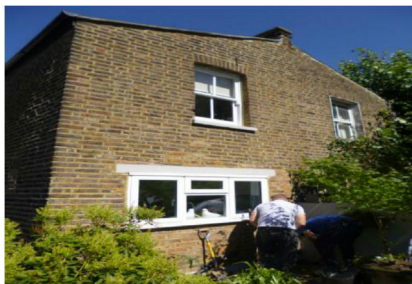
PHOTOGRAPH 04:

This photograph is a general view of the rear elevation of the rear projection.

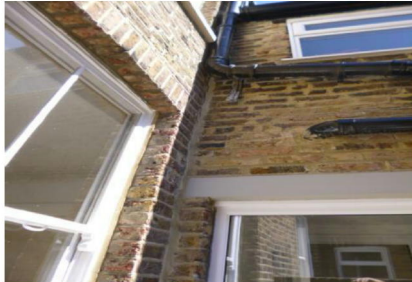
PHOTOGRAPH 05:

This photograph shows vertical junction between the rear projection and main terrace.

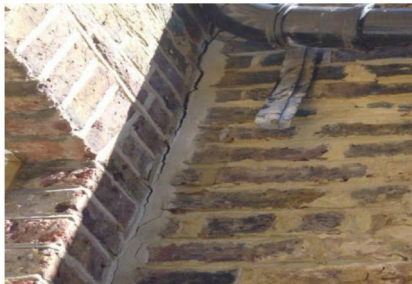
PHOTOGRAPH 06:

This photograph is a close up of the above showing separation cracking above the ground floor window.

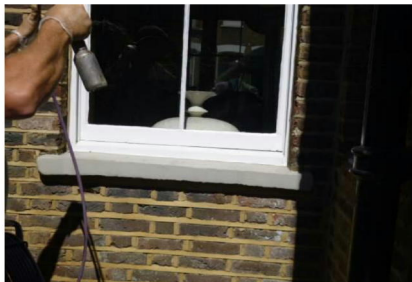
PHOTOGRAPH 07:

This photograph is a view of historic distortion to ground floor windowsill to the rear of the reception room.

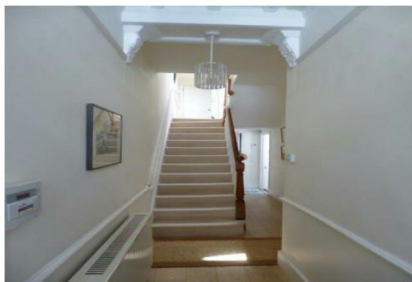
PHOTOGRAPH 08:

This photograph is a general view of the hallway.

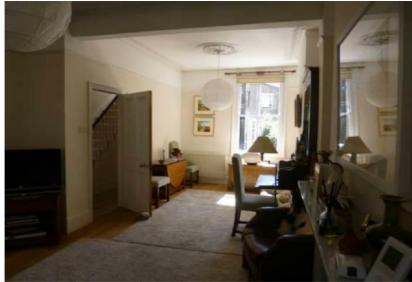
PHOTOGRAPH 09:

This photograph is a general view of the reception room looking towards the rear.

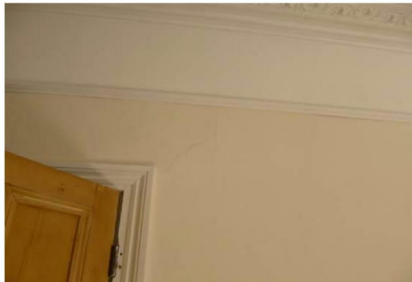
PHOTOGRAPH 10:

This photograph shows cracking to rear of the door opening from rear of reception room to hallway.

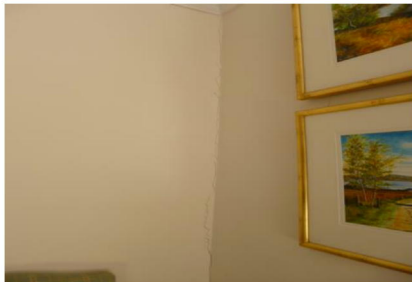
PHOTOGRAPH 11:

This photograph shows vertical cracking at junction of partition wall between hallway and rear elevation.

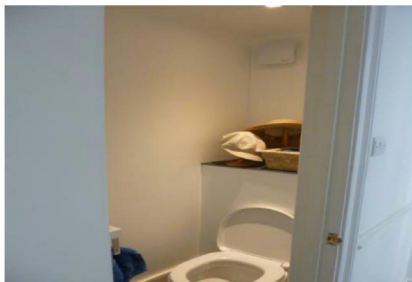
PHOTOGRAPH 12:

This photograph shows downstairs WC beneath the stairs.

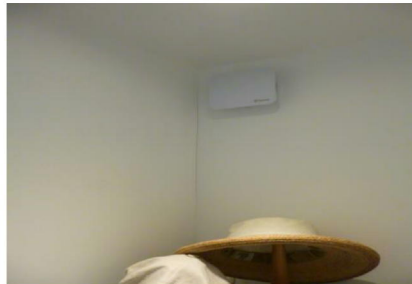
PHOTOGRAPH 13:

This photograph shows vertical cracking to stud partition between WC and back of kitchen (probable old door opening).

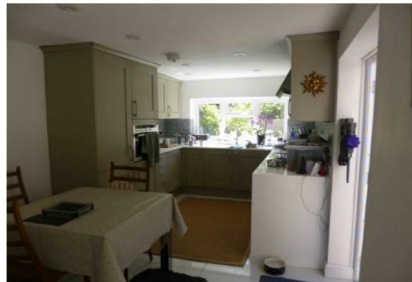
PHOTOGRAPH 14:

This photograph is a general view of the kitchen looking towards the rear.

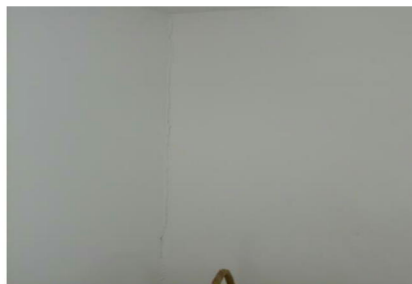
PHOTOGRAPH 15:

This photograph shows vertical cracking on partition with WC from kitchen (as photograph 13).

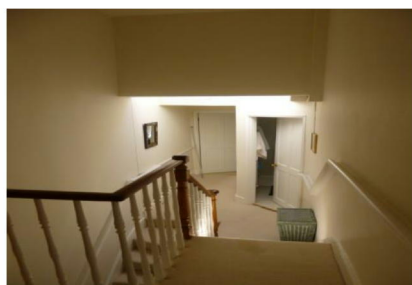
PHOTOGRAPH 16:

This photograph is a general view of the landing looking towards the rear.

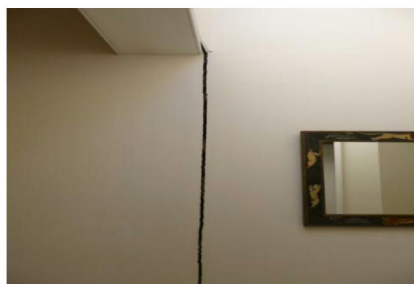
PHOTOGRAPH 17:

This photograph shows vertical movement joint on left hand party wall at junction of rear projection.

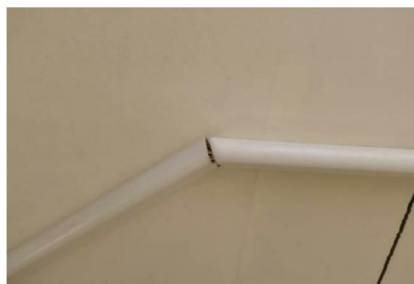
PHOTOGRAPH 18:

This photograph shows opening of handrail at top of stairs.

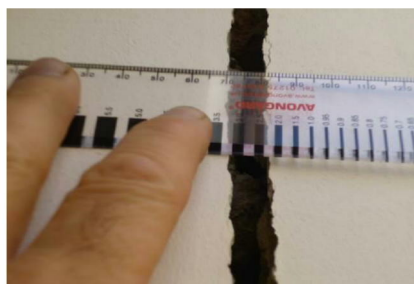
PHOTOGRAPH 19:

This photograph is a close up showing width of cracking at high level.

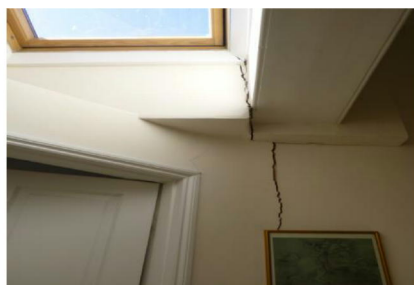
PHOTOGRAPH 20:

This photograph is a view of cracking to right hand junction of main terrace and partition wall to bathroom at top of stairs extending up to a Velux window.

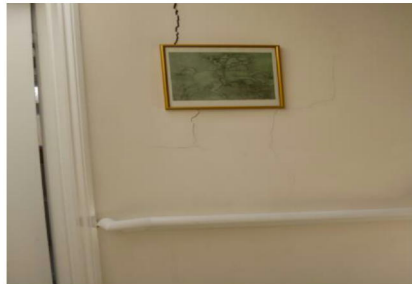
PHOTOGRAPH 21:

This photograph shows above cracking tapering out to mid-height.

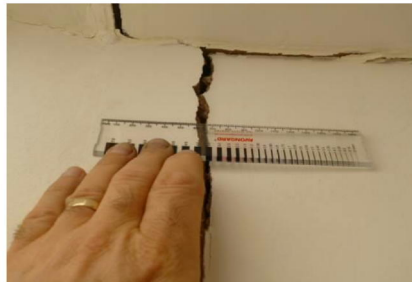
PHOTOGRAPH 22:

This photograph is a close up showing width of cracking at high level.

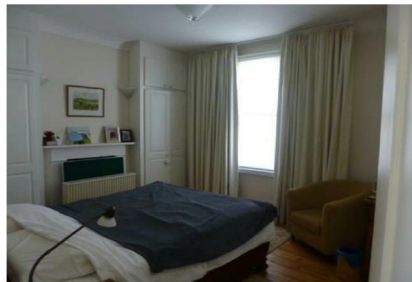
PHOTOGRAPH 23:

This photograph is a general view of front bedroom 01.

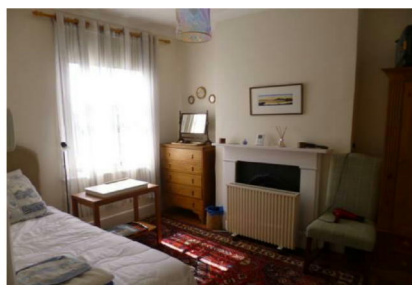
PHOTOGRAPH 24:

This photograph is a general view of bedroom 02.

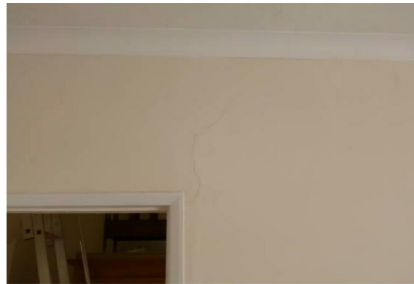
PHOTOGRAPH 25:

This photograph shows cracking to partition wall between bedroom 02 and landing over door head.

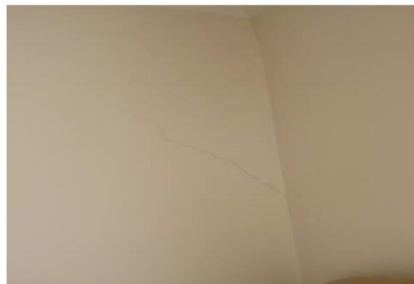
PHOTOGRAPH 26:

This photograph shows vertical cracking to landing partition and rear elevation wall.

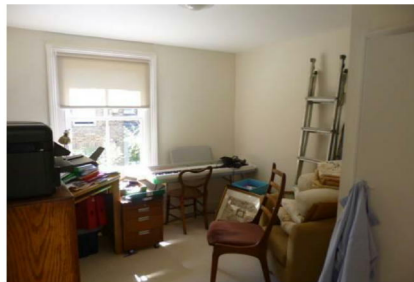
PHOTOGRAPH 27:

This photograph is a general view of bedroom 03 in the rear projection.

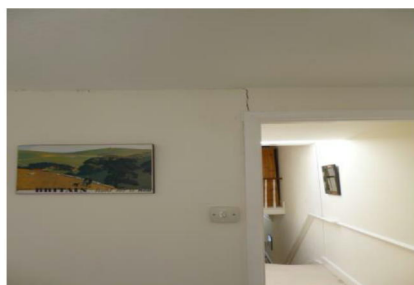
PHOTOGRAPH 28:

This photograph shows cracking to the stud partition between bedroom 03 and bathroom.

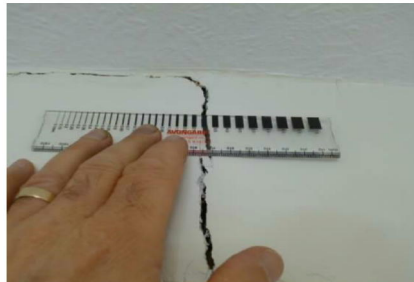
PHOTOGRAPH 29:

This photograph is a close up showing width of above cracking.

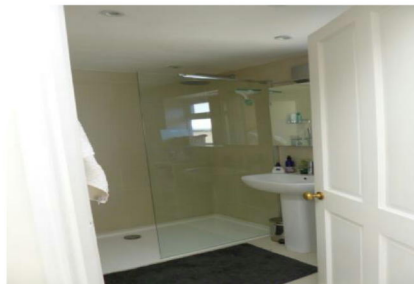
PHOTOGRAPH 30:

This photograph is a general view of shower room.

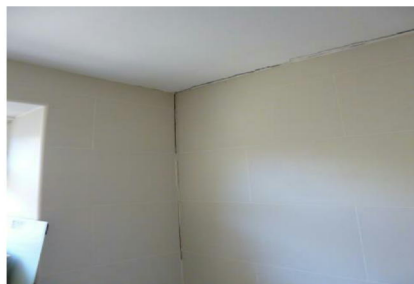
PHOTOGRAPH 31:

This photograph shows cracking at junction of rear projection and main rear elevation to right hand side of bathroom.

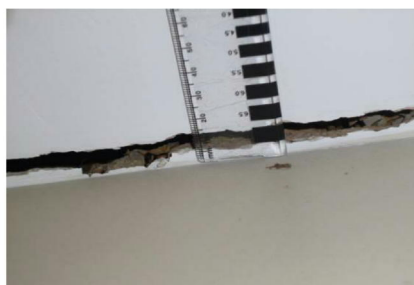
PHOTOGRAPH 32:

This photograph is a close up showing width of ceiling cracking.

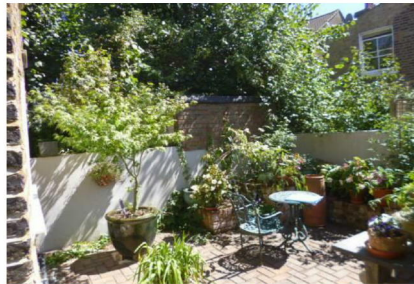
PHOTOGRAPH 33:

This photograph shows a general view of vegetation on left hand neighbours property behind outhouse.

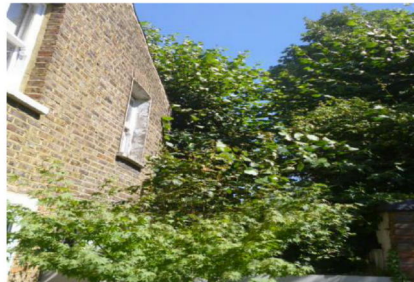
PHOTOGRAPH 34:

This photograph shows Lime tree in very close proximity to rear corner of neighbouring rear projection.

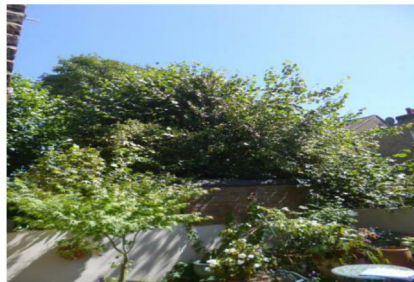
PHOTOGRAPH 35:

This photograph shows a further view of Lime and Holly trees on immediate neighbours property, with taller Sycamore tree on distant neighbours.

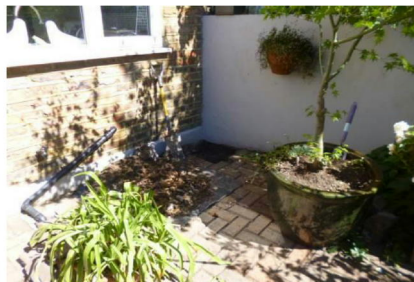
PHOTOGRAPH 36:

This photograph shows location of trial hole at rear party wall area.

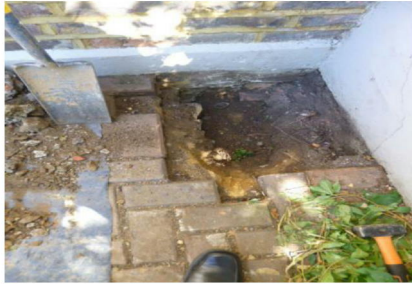
PHOTOGRAPH 37:

This photograph shows a close-up of trial hole.
