## SITE INVESTIGATION FACTUAL REPORT

Report No: 526420  
Client: Graham High Group Limited  
Site: 24 Chetwynd Road  
Client Ref: [REDACTED]  
Date of Visit: 02/08/18

Home Emergency Response - Subsidence Investigation - Drainage Services – Crack & Level Monitoring – Property Video Surveys

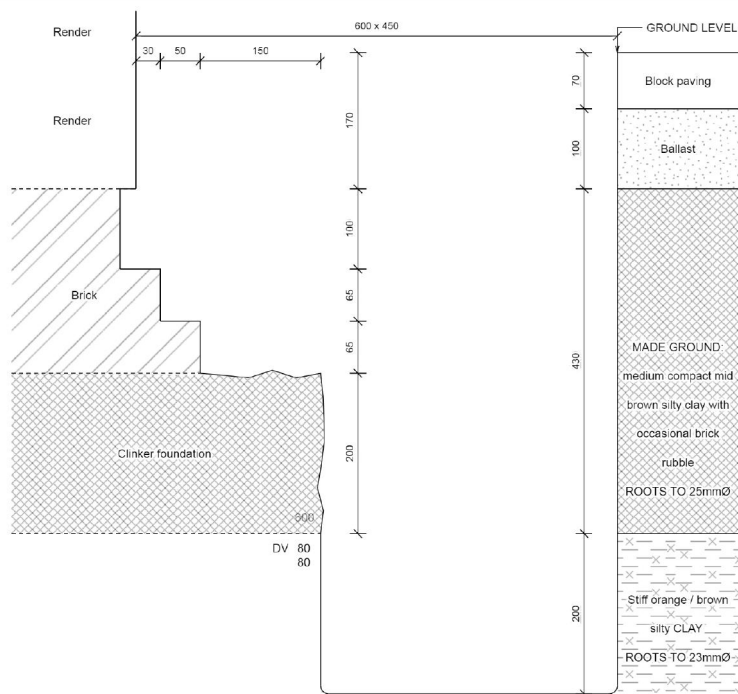
TRIAL PIT REF: TP1

For Strata below 800mm see Bore Hole log
