Schedule of Remaining Fabric 25A Chalcot Crescent

And proposals for repair and reinstatement

Jim Howett 3 Fournier Street London E1 6 QE  
jim@mariannakennedy.com

25 Chalcot Crescent is one of a group of grade 2 listed buildings Nos. 19- 27. This house is divided into 4 flats and this report concerns the condition of the basement flat, number 25a.

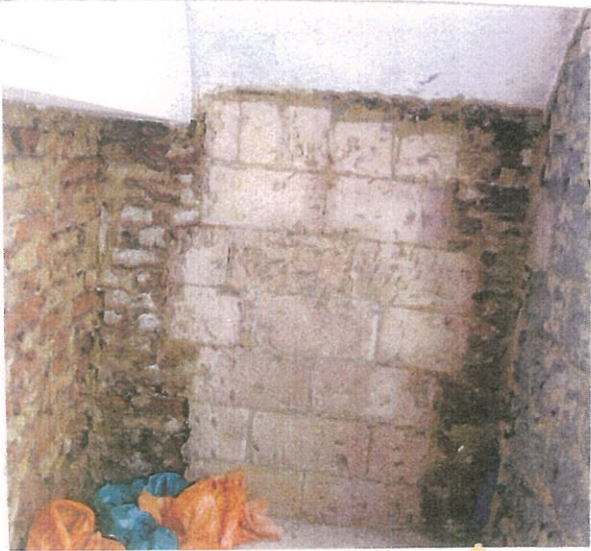
Storage Area beneath front steps seen from entry lobby basement flat

Within the flat, the storage area beneath the external rising steps to the front door of the house is closed with breezeblocks.

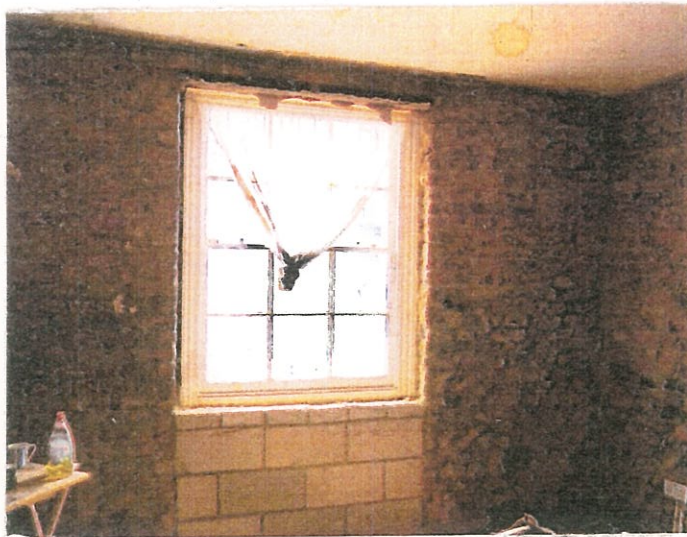
Basement flat window front room to open area

The sash window frame work of original form is packed with plywood, the cill sits onto a breeze block base, cut into the older brick opening, and is of 1960s make.

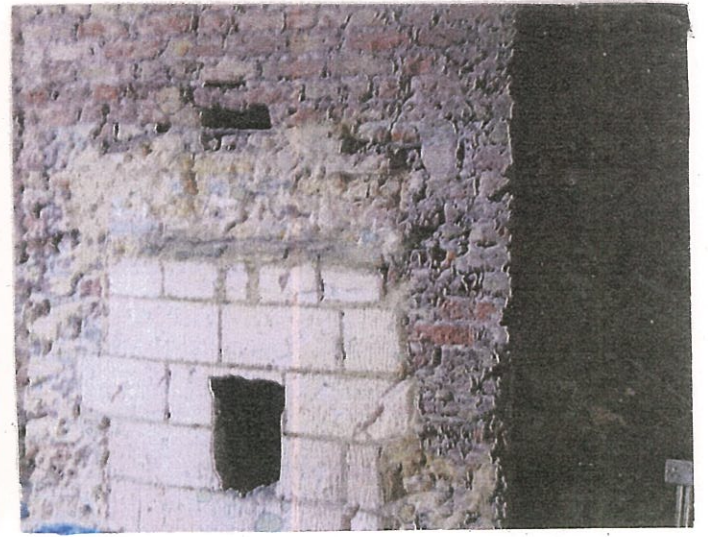
front room fireplace

The fire place of this front room is closed with breeze block, the door with fanlight is removed.

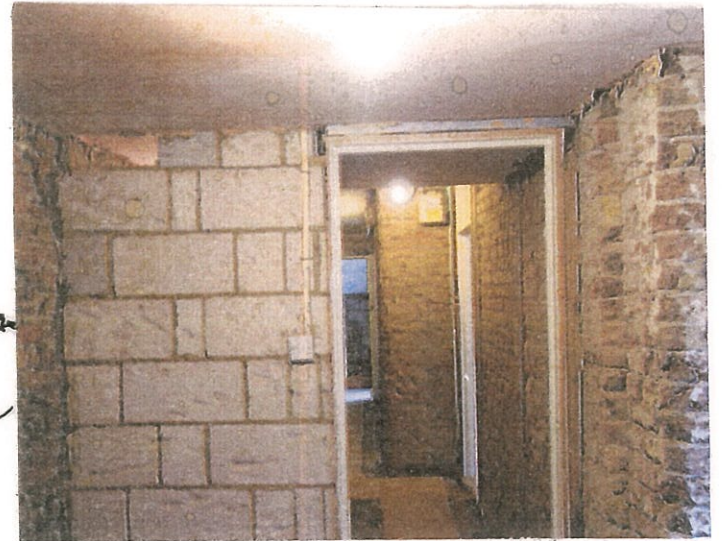
There is a small toilet/shower within the space formerly occupied by the staircase between ground and basement in breezeblock. All fixtures have been removed.

former staircase enclosure for WC/shower

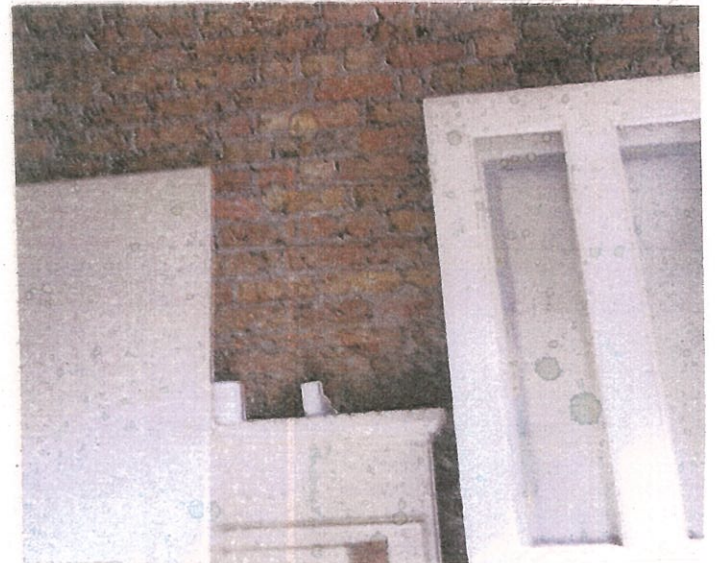
The door frame and fanlight are of recent make, the door and is stacked with other internal doors which are also of mid 20<sup>th</sup> century make and of hardboard and comb construction with one framed and paneled exception, which is not old, but will be re-used

Assorted joinery dismantled and stacked back room

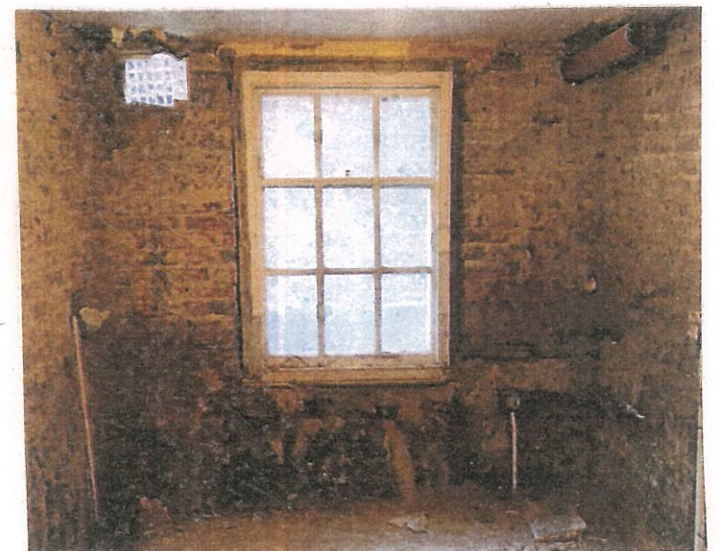
This was a kitchen, but all fixtures have been removed. The sash window has some original fabric. The door to the garden is of modern make the

View to garden from closet back

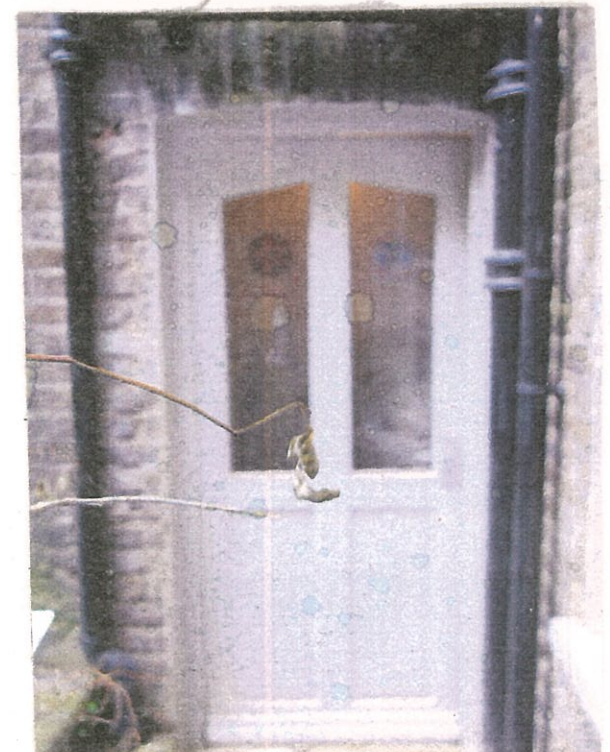
external door to yard at back

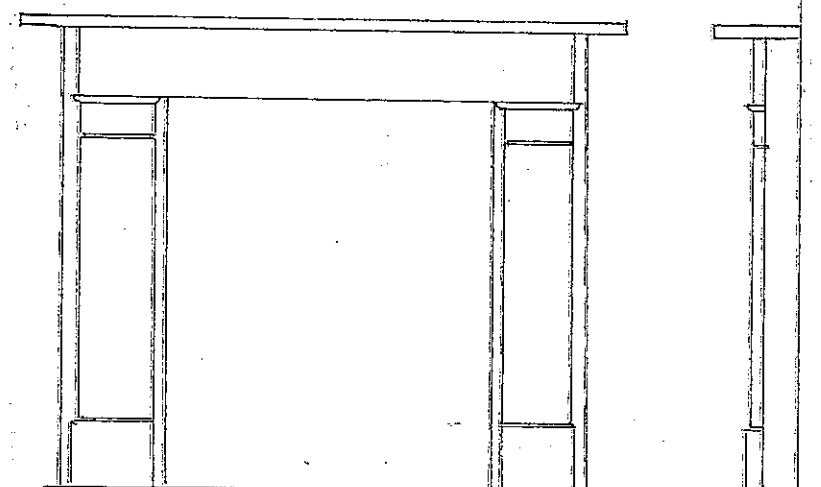
There is no remnant of the previous surround to the front room and in the back room there is a surface mounted cast iron surround.

Back room fire surround

It is intended to duplicate the stone surround from the same position in No. 23 and to install a simpler version in the Front Room

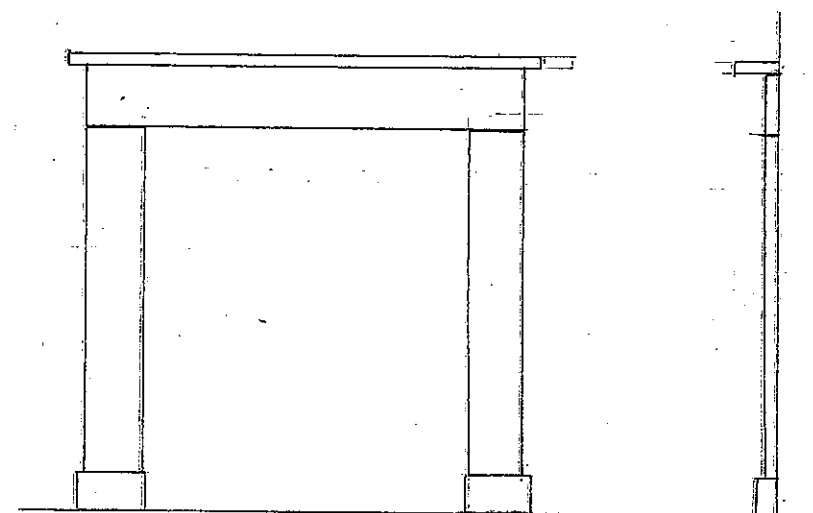
Front room fire surround
