**Tree and Shrub Survey @ 25 Marquis Road
Camden, London NW1 9UD**

April 2018

DKS/589

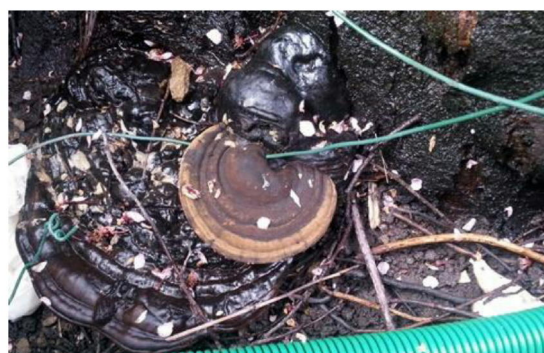
Fig 1: Fruiting bodies @ tree base on eastern side

Due to the purple plum being located in a self-contained planting area with poor rooting medium existing outside of the area it is highly unlikely that it would have had a deleterious impact on any surrounding built-form. Cracking and some movement is present in boundary walls and whilst the tree cannot be entirely discounted other causal factors are more likely including; seasonal movement on moderate – high plasticity soils and potential faulty drainage. It would be prudent to check drains to ensure that faulty drains are not resulting in poor soil structure and resulting ground movement causing cracking and movement in boundary walls. Nevertheless the removal of the purple plum tree and any replacement planting conducted as recommended (Section 2.1.) will help to prevent future plant related built-form structural movement. **There are no indicators of structural movement to the front of the property dwelling and neither are there concerns of future plant related movement.**

The Local Planning Authority (LPA) may require replacement planting for the removal of the purple plum tree. It is recommended that new planting should be placed in an extended self-contained planting area; at a level 300 – 600mm higher than surrounding ground levels, lined with a root barrier and providing at least 12m² root medium area. The tree should be planted at least 1.75m distant from the boundary walls to prevent potential future structural root pressure. Recommended replacement species (Table 2).

Remove the Lawson cypress adjacent to the rear garden studio building and, remove the purple plum with replacement planting in extended self-contained planting area as recommended (Section 2).
