# Supporting Information for External Repairs and Cleaning

This document is to support an application for listed building consent to carry out repairs and maintenance to the Grade II listed façade, formally a Church, to Aviation House, 125 Kingsway. The listed façade of Aviation House is utilised as the main entrance for the commercial office space currently undergoing refurbishment prior to occupation by We Work. This façade is of Portland stone construction with ornate features including the semi-circular portico supported by fluted columns with scroll head carvings, some carved statuette inlay panels, and the original church bell tower. Windows have leaded glazing and are of circular porthole type. The entrance doors are original panelled timber doors.

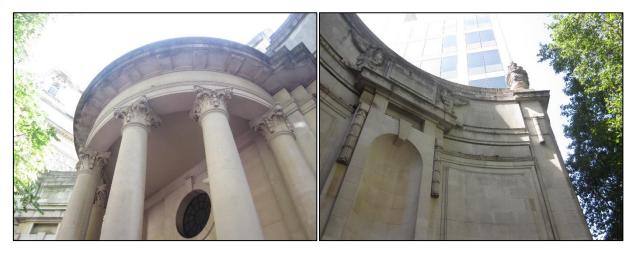
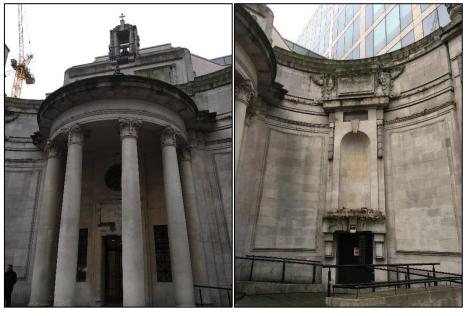
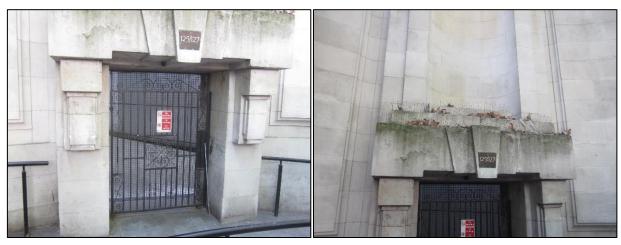
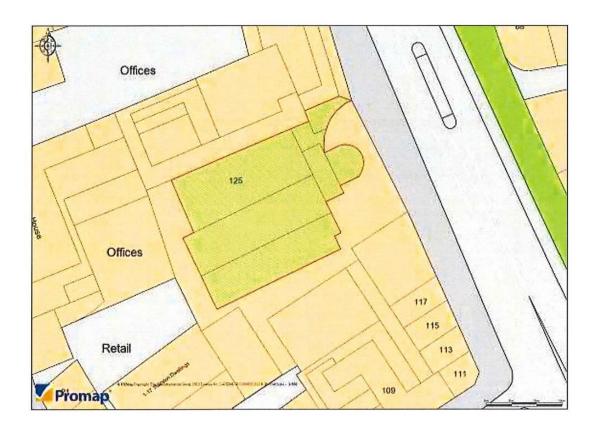
The rationale behind the proposed works is that the Portland stone facade has become stained from airborne pollution and moss growth. Whilst the Listed status of the stone facade brings with it a legal obligation to maintain in satisfactory repair, there are no major defects but some general maintenance is now due to prevent further cosmetic deterioration, such as painting the corroding metalwork, removal of heavy moss growth and general cleaning. The stone is discoloured, particularly at high level and some minor repairs are needed to isolated cracked mortar joints between the stonework.

To carefully clean the Portland lime stone using the nebulous water spray method and DOFF or TORK system where necessary, to remove vegetation and detritus from the façade.

To carefully rake out loose lime mortar pointing between the stone block work and repoint with lime mortar which will be as closely colour-matched with the existing mortar as possible.
