45059
45059
06/07/2016 10:03:05

Site Details
THE HOPE PROJECT
CAMDEN HIGH STREET
LONDON
NW1 7JE

CCTV SURVEY REPORT

Drawing Title: UNDERGROUND DRAINAGE LAYOUT DRAWING
BASEMENT PLAN

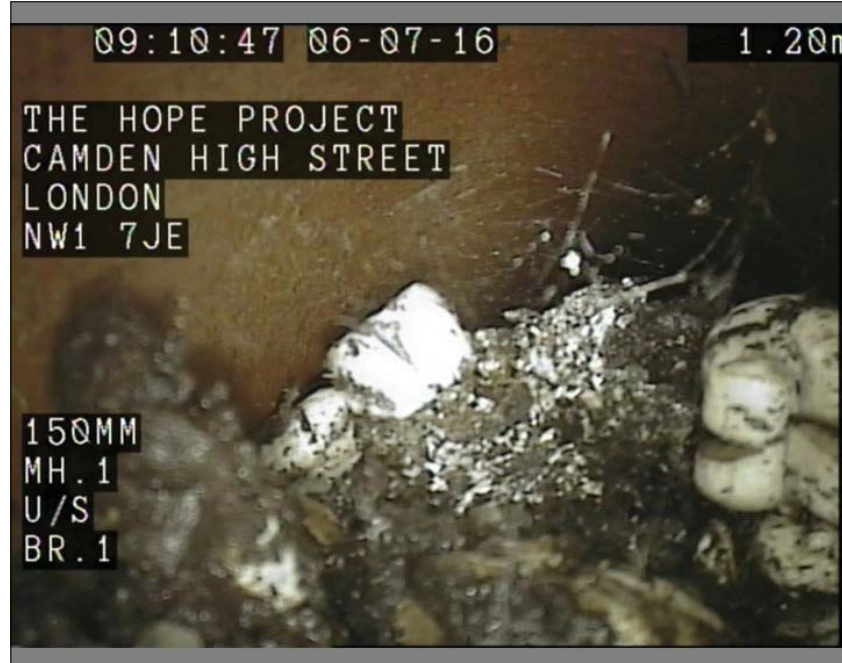
Photo: 1_1_5_A.JPG
1.2m, Settled deposits, fine, 80% cross-sectional area loss

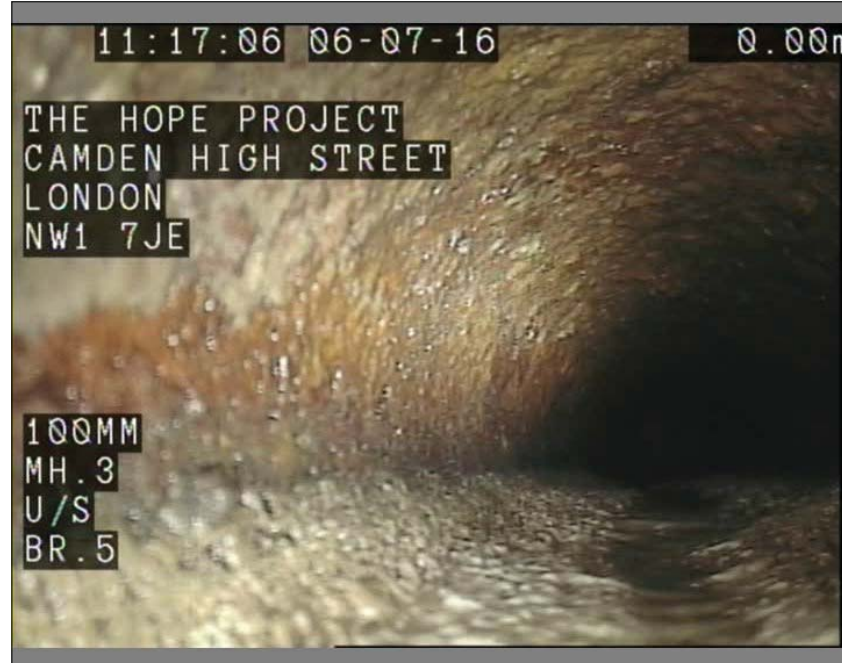
<p>Photo: 11_11_52_A.JPG 0m, Attached deposits, encrustation, from 3 to 8 o'clock, 30% cross-sectional area loss</p>

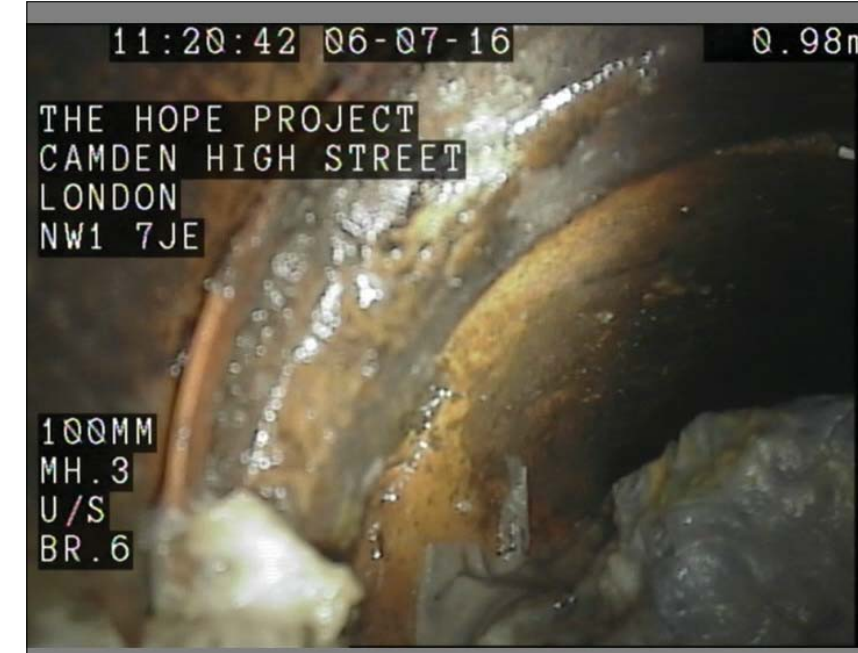
Photo: 11_1_5_18072016_124455_A.jpg
0.98m, Joint displaced, medium

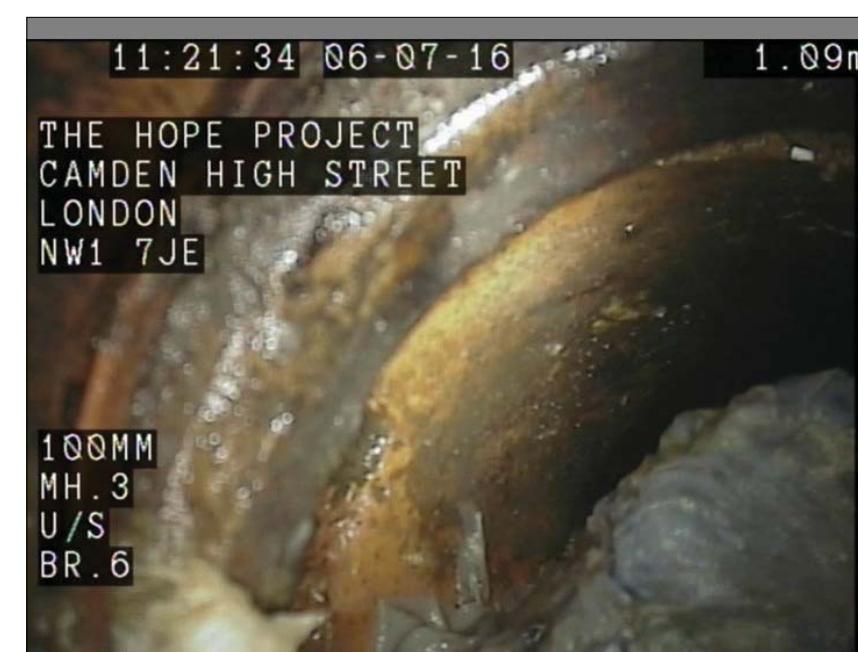
Photo: 12_12_59_A.JPG
1.09m, Settled deposits, coarse, 60% cross-sectional area loss

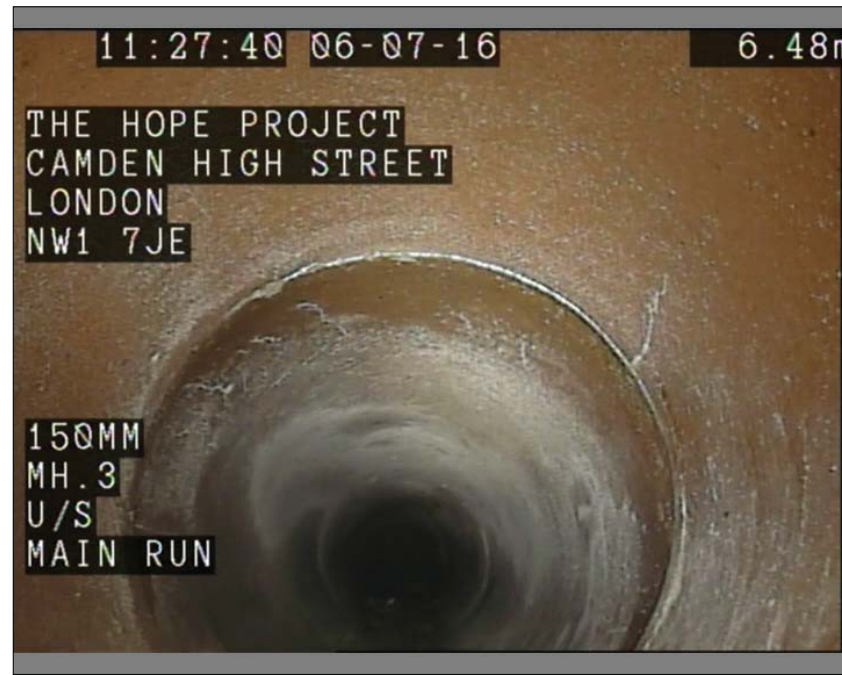
Photo: 12_1_9_18072016_124627_A.jpg
6.48m, Crack, longitudinal at joint, at 2 o'clock

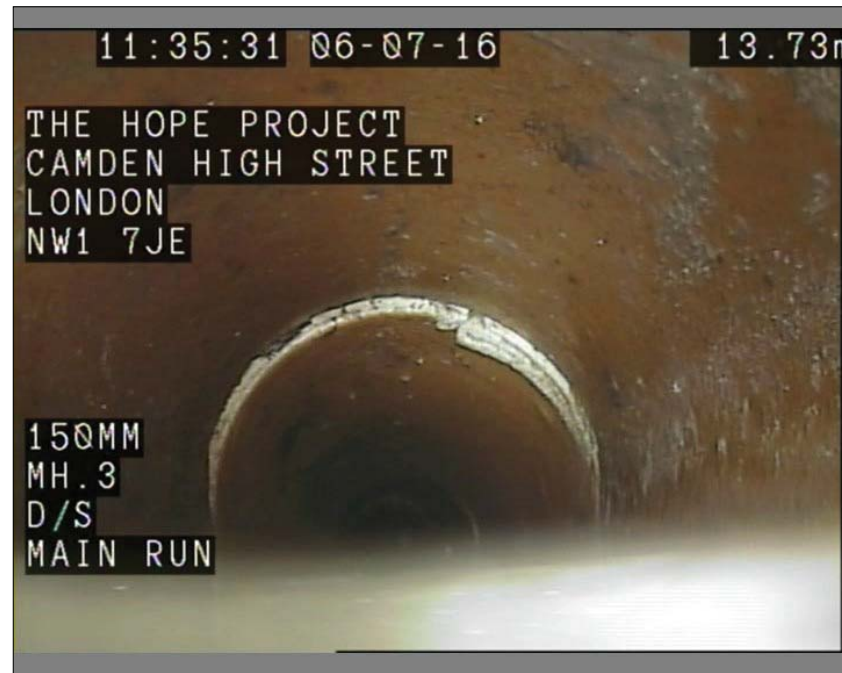
Structural defects			
Section	PLR	Grade	Fault description
13	MH3 X	4	Broken pipe at joint, from 1 to 3 o'clock
19	BR2 X	4	Broken pipe, from 10 to 12 o'clock

Photo: 14_14_82_A.JPG
13.84m, Broken pipe at joint, from 1 to 3 o'clock

Grade 4; Best practice suggests consideration be given to a repair to avoid potential collapse

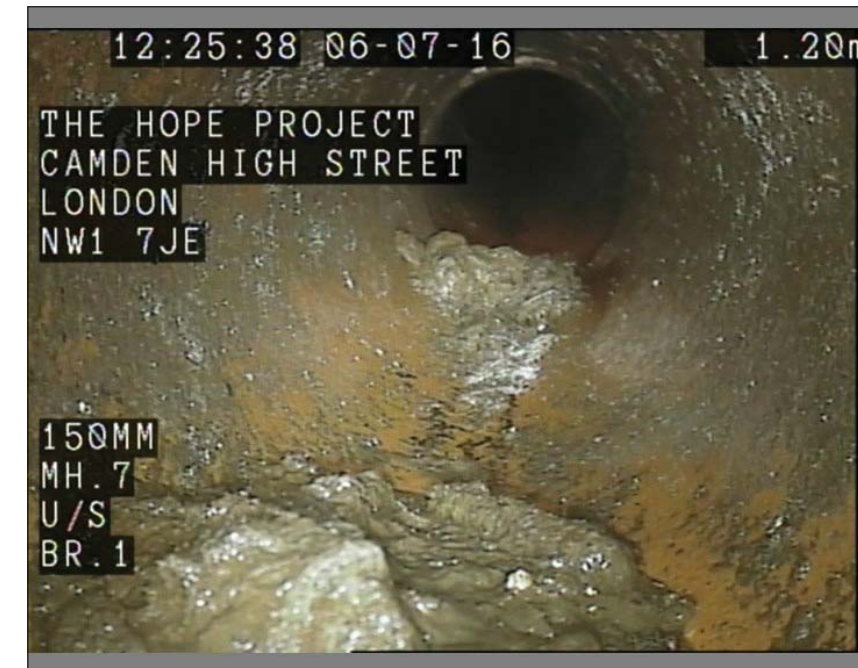
Photo: 19_19_120_A.JPG
 1.2m, Settled deposits, coarse, 10% cross-sectional area loss

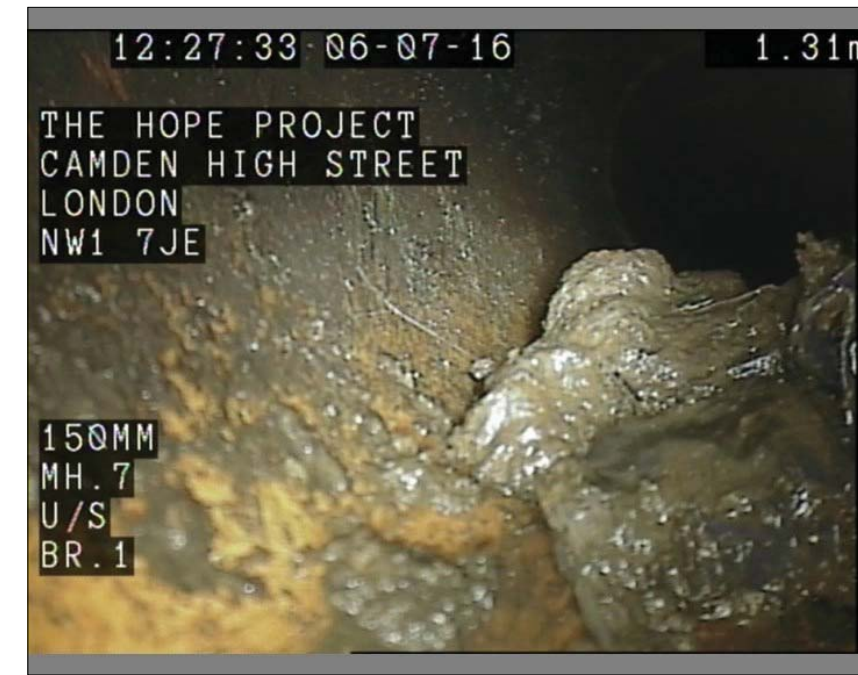
Photo: 19_19_121_A.JPG
 1.31m, Settled deposits, coarse, 10% cross-sectional area loss

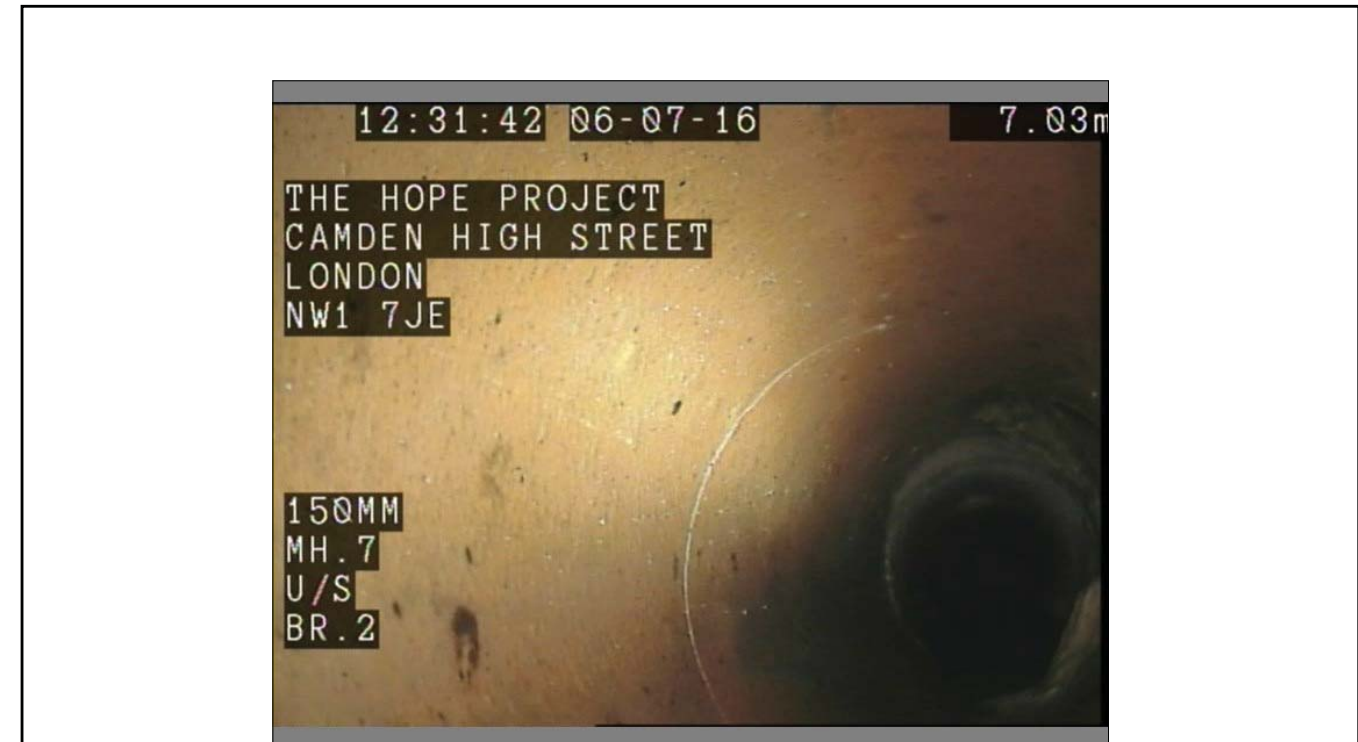
Photo: 20_20_129_A.JPG
7.03m, Crack, circumferential, from 7 to 11 o'clock

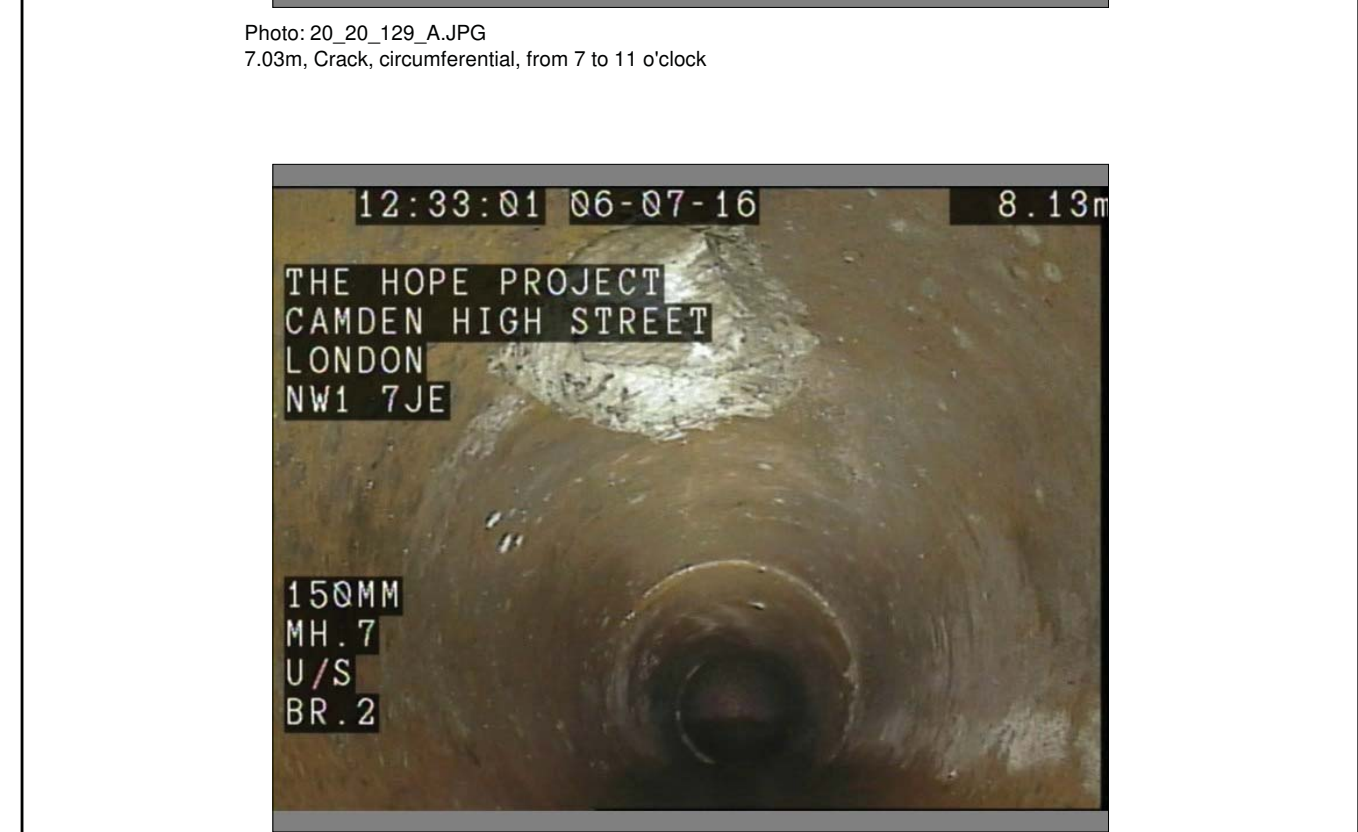
Photo: 20_20_131_A.JPG
8.13m, Broken pipe, from 10 to 12 o'clock

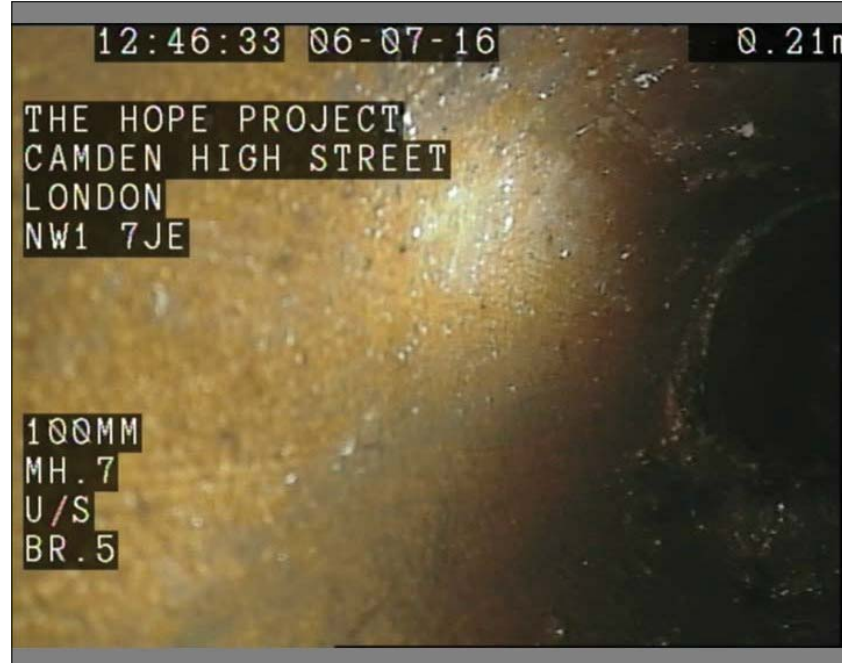
Photo: 23_23_147_A.JPG
0.21m, Attached deposits, encrustation at joint, from 4 to 7 o'clock, 20% cross-sectional area loss

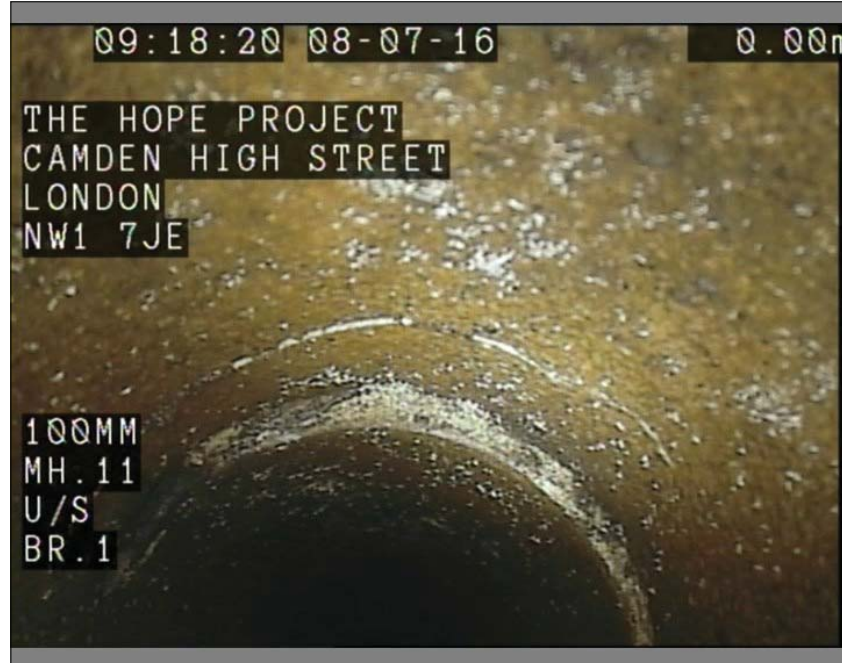
Photo: 25_25_155_A.JPG
0m, Crack, circumferential, from 10 to 2 o'clock

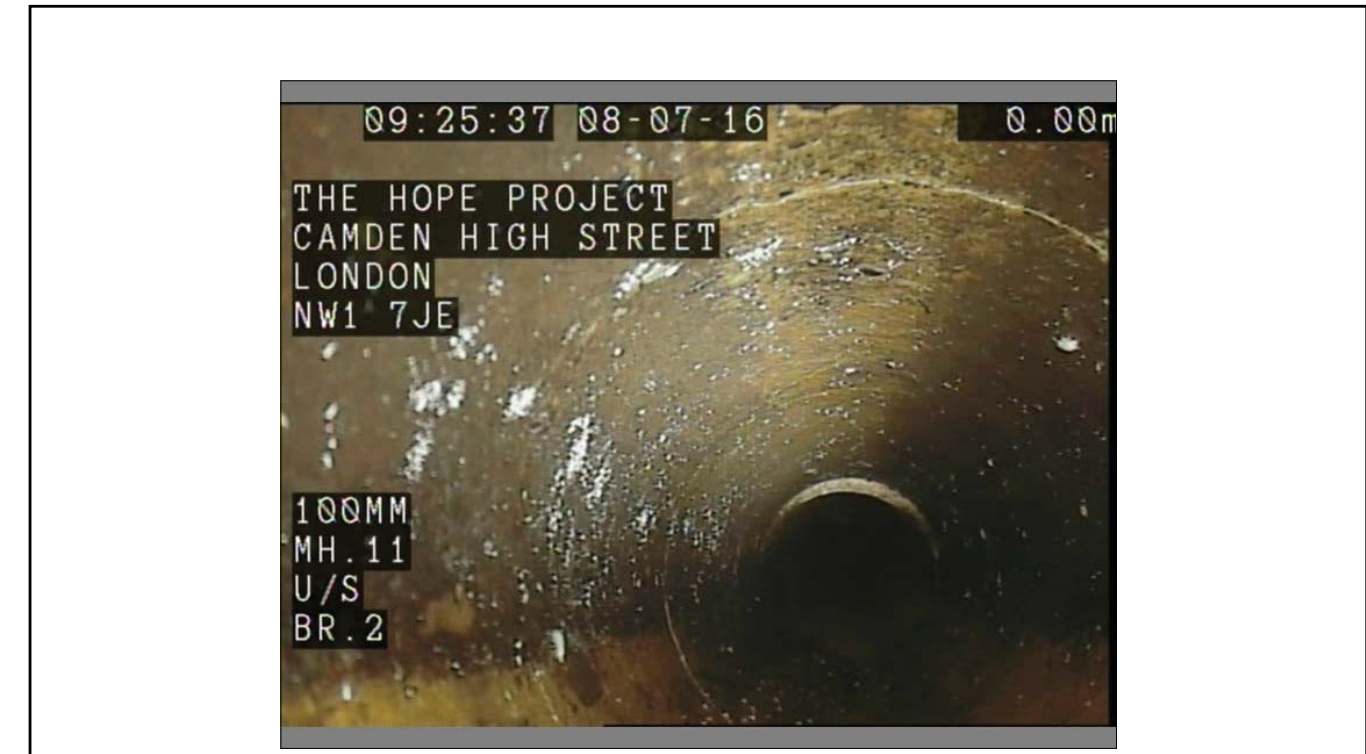
Photo: 26_26_161_A.JPG
0m, Crack, circumferential, from 7 to 4 o'clock

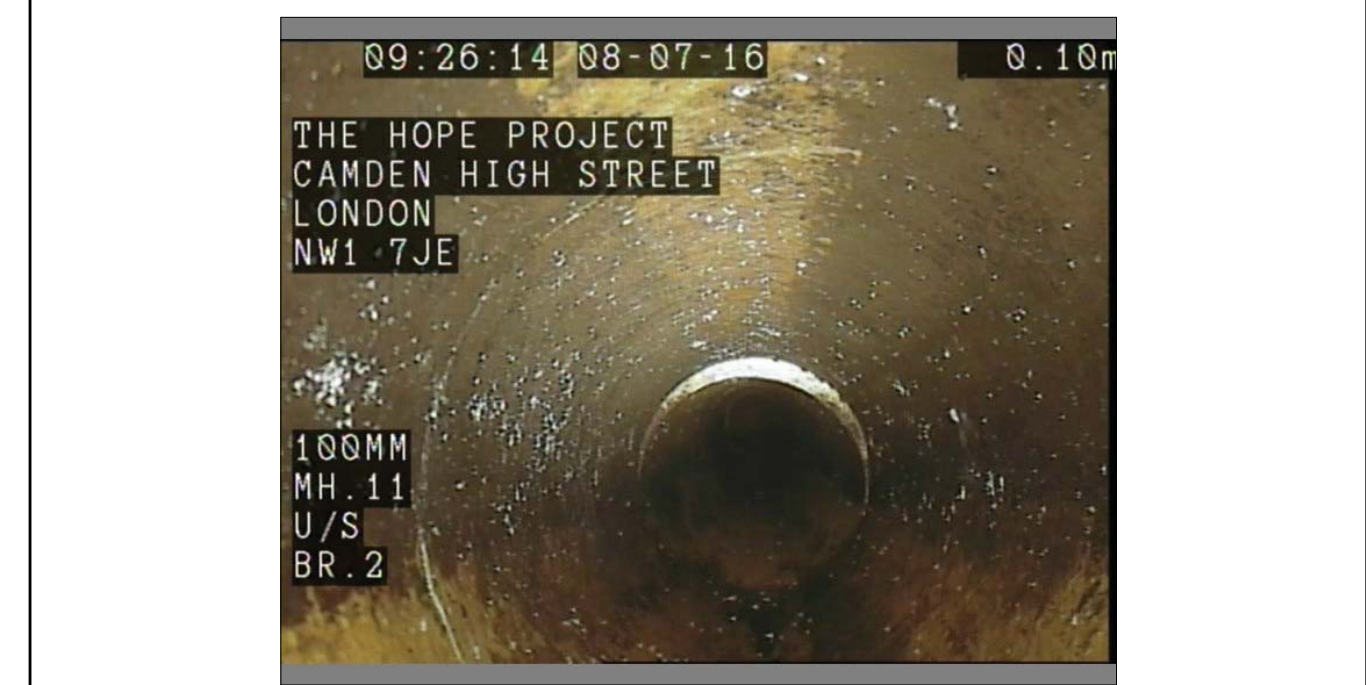
Photo: 26_26_162_A.JPG
0.1m, Crack, circumferential, from 7 to 12 o'clock

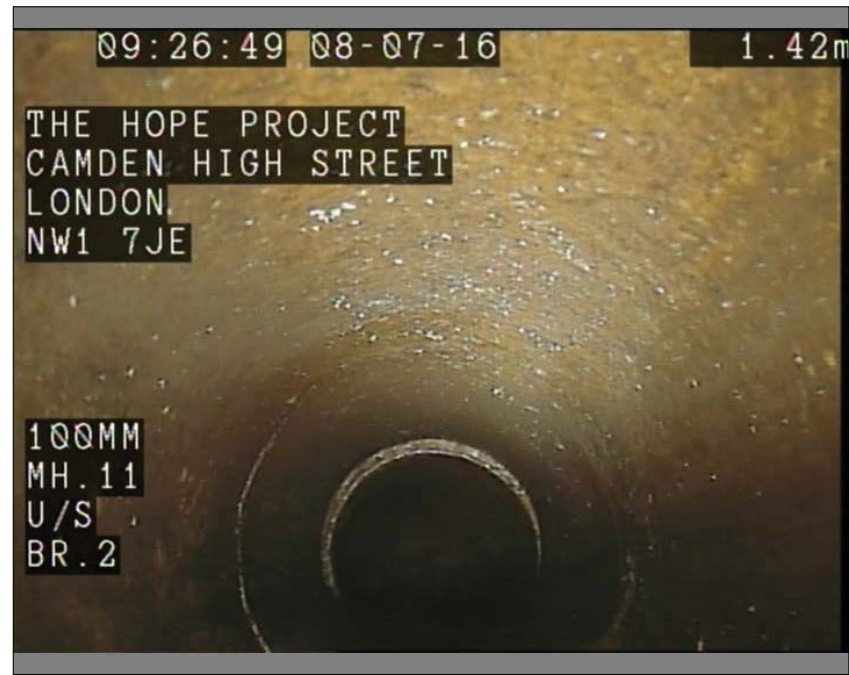
Photo: 26_26_163_A.JPG
1.42m, Crack, circumferential, from 7 to 5 o'clock

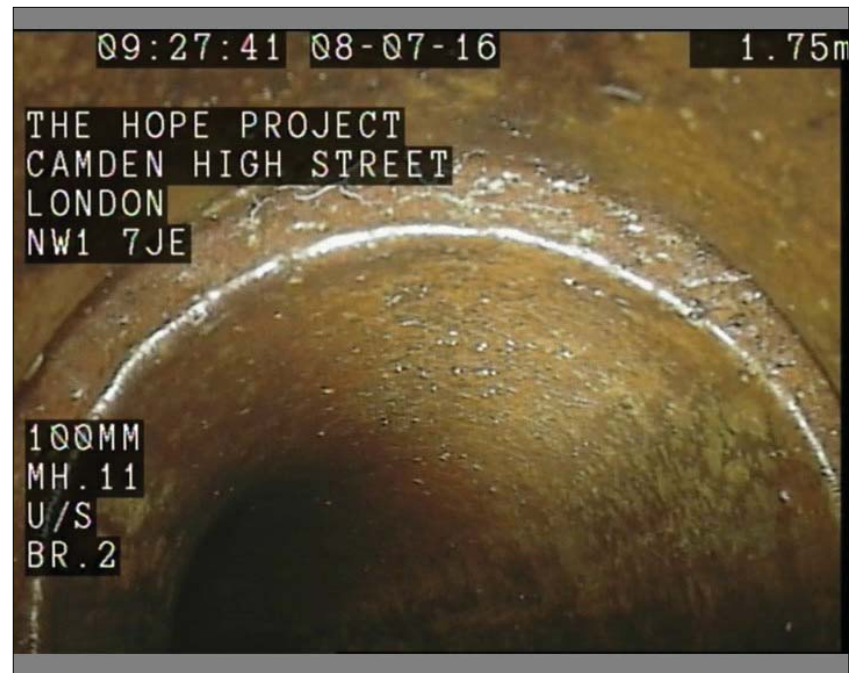
Photo: 26_26_164_A.JPG
1.75m, Crack, circumferential at joint, from 7 to 3 o'clock

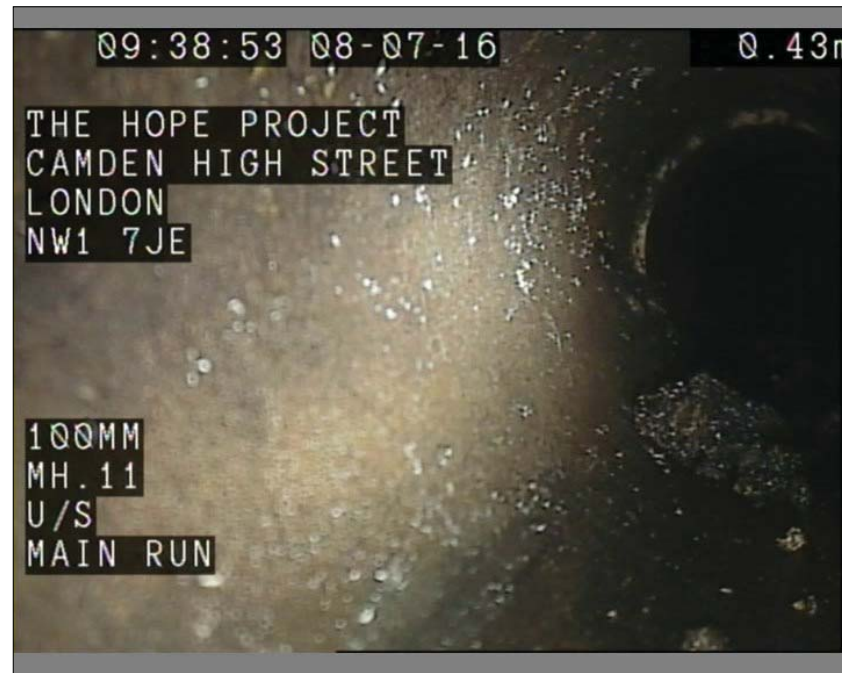
Photo: 27_27_178_A.JPG
0.43m, Settled deposits, coarse, 10% cross-sectional area loss

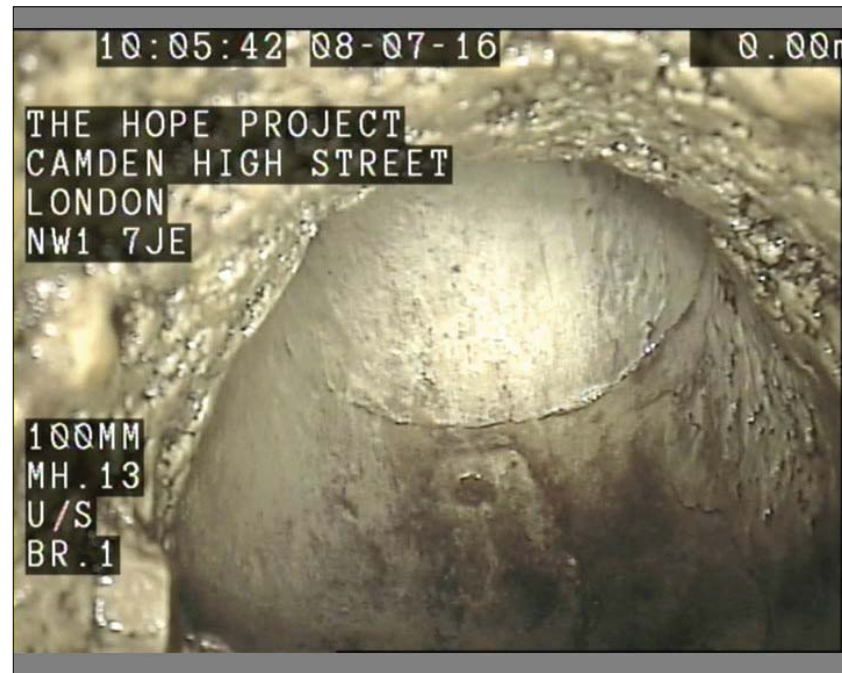
Photo: 29_29_193_A.JPG
 0m, Attached deposits, encrustation, from 9 to 2 o'clock, 10% cross-sectional area loss

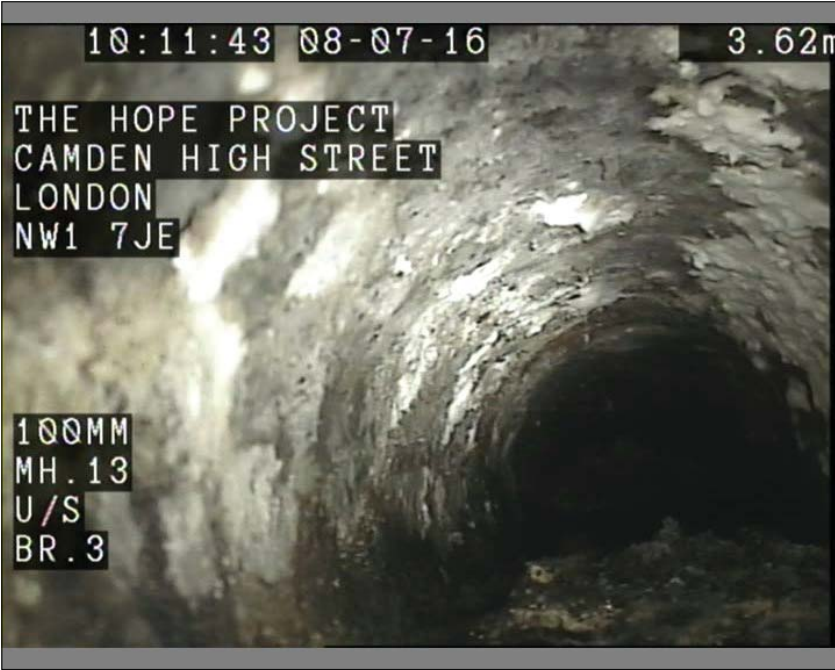
Photo: 31_31_205_A.JPG
3.62m, Settled deposits, coarse, 10% cross-sectional area loss

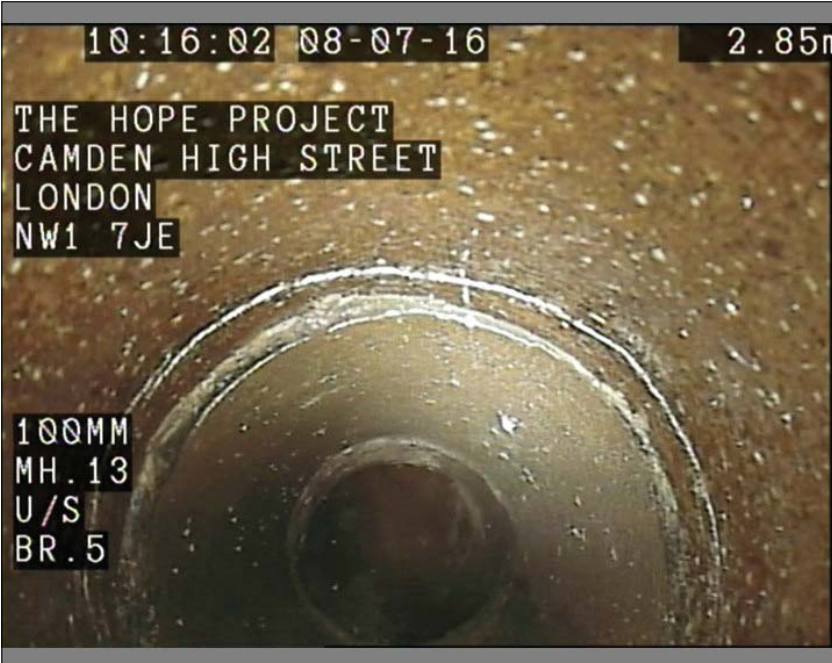
Photo: 32_32_211_A.JPG
2.85m, Crack, circumferential, from 9 to 3 o'clock

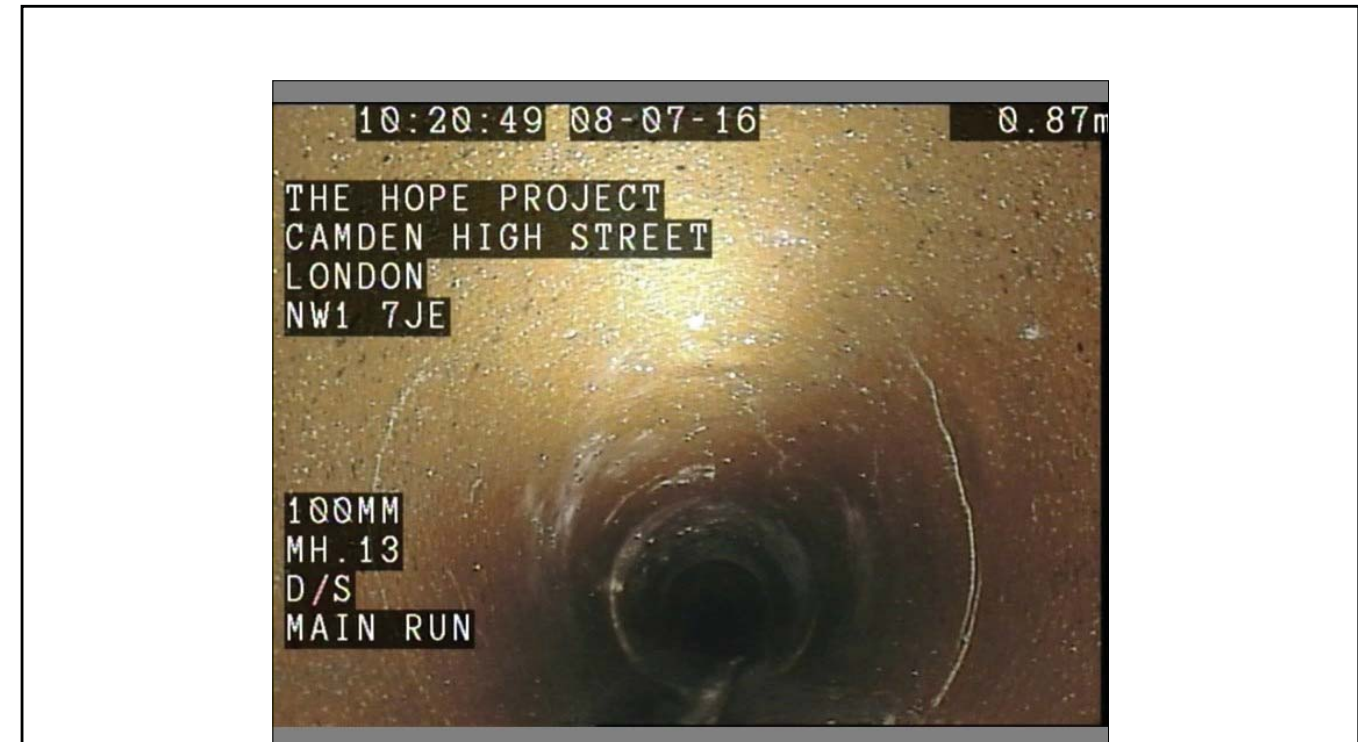
Photo: 33_33_218_A.JPG
0.87m, Crack, circumferential, from 7 to 10 o'clock
