Our Ref: AHD/RS/23450

12th September 2018

Re: Bentham House, 4 The Mount, Hampstead

Hurst Peirce & Malcolm were asked to visit site to inspect the leaning north gable wall and chimney at the above property

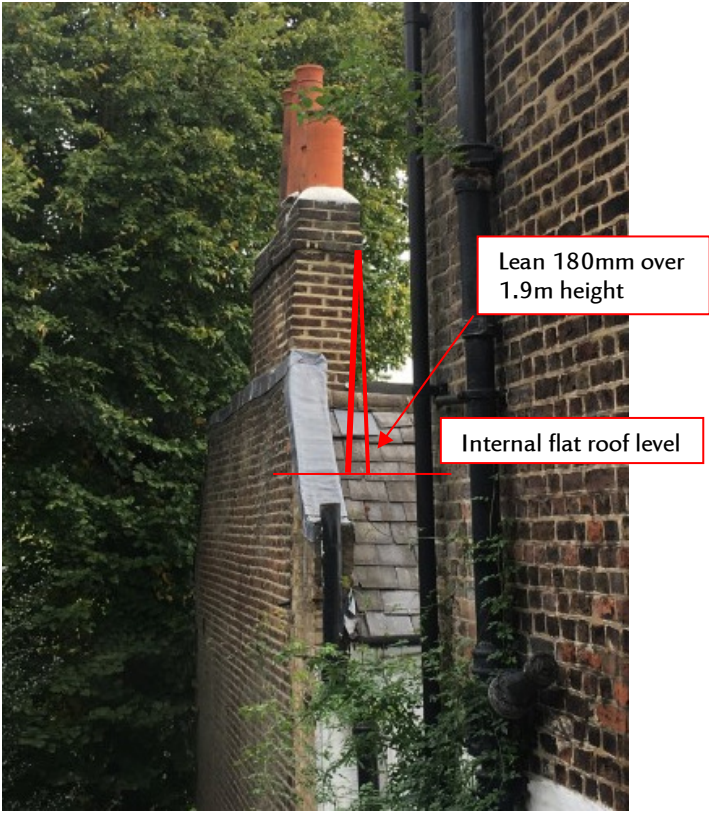
Both the top section of the north gable wall and north chimney stack are leaning fairly significantly. A plumb line dropped on the chimney stack measured 180mm out-of-plumb over 1900mm height of stack. It was not possible to measure the lean on the gable wall, but this is estimated at a further 100-150mm over the approximate 1500mm height from eaves level (where the lean appears to begin) up to parapet level. The term 'lean' may be misleading because the gable wall and chimney stacks are actually curved over.

The curvature is more exaggerated at the base of the stack. The kink visible in the second photograph below may indicate that the stack has been rebuilt in the distant past and has then continued to curve over further.

The stack had been fairly recently repointed in heavy cement ribbon pointing so gauging the condition of the brickwork was difficult, although there were no obvious signs of deterioration.

The plumb check on the stack alone reveals a lean of 180mm over a height of 1900mm, the overall stack is 300mm higher than this and has some tall clay pots on top.

Assuming that the stack works as a single entity 580mm wide, this puts the centre of gravity just inside the 'middle 1/3, which is considered to be stable for a static structure not subject to wind load. However, the stack and flues are subject to wind load and there is no guarantee that the stack does work as a single entity, as with the walls can be notoriously poorly bonded. In addition, there is already eccentricity at the base of the stack from the leaning gable wall below. There is also no provision for future increase of the lean.

We would therefore conclude that the stack should be treated as structurally unstable.

Therefore, rebuilding the stack vertically above the roof only (ie down to flashings level) might be an acceptable compromise, albeit one that leaves some eccentric loadings in the wall and structure generally, but only if a strutting system can be provided. Locating such a system inside the roof structure is unlikely to work, given the shallow depth of the roof voids, so the benefits would be minimal. It would really need some form of external strutting. Even if this were possible, we believe any such system would detract more from the listed building than a carefully rebuilt wall section & chimney stack. In addition, there is not really any solid internal structure below to bring struts down onto.

The stack should be rebuilt to match the existing, but true and vertical, in a suitable lime mortar, reusing as many existing bricks as possible and matching sound reclaims to make up any shortfall. The wythe walls should be adequately bonded in and flues should each be lime parged internally as work progresses.

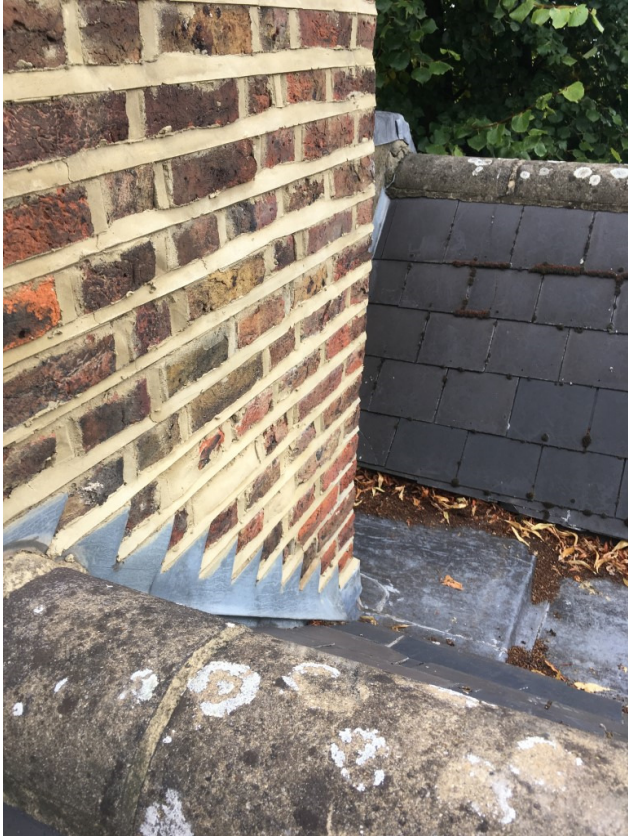
The factors causing the lean can be manyfold, but usually it is down to weathering loss of mortar and drying-out on the windward side, plus expansion of the lime mortar on the leeward side as salts from flue gasses are drawn towards that side by moisture migration where they crystallize and expand. This leads to the curvature and confirms that the process is long term and there will not have been any sudden change.

Repointing with cement mortar whilst not trying to deal with the other issues can accelerate the effects.
