## SITE INVESTIGATION FACTUAL REPORT

Report No: 505888  
Client: Cunningham Lindsey - Morley (Leeds)  
Site: 221 Goldhurst Terrace  
Client Ref: [REDACTED]  
Date of Visit: 25/04/18

Home Emergency Response - Subsidence Investigation - Drainage Services – Crack & Level Monitoring – Property Video Surveys

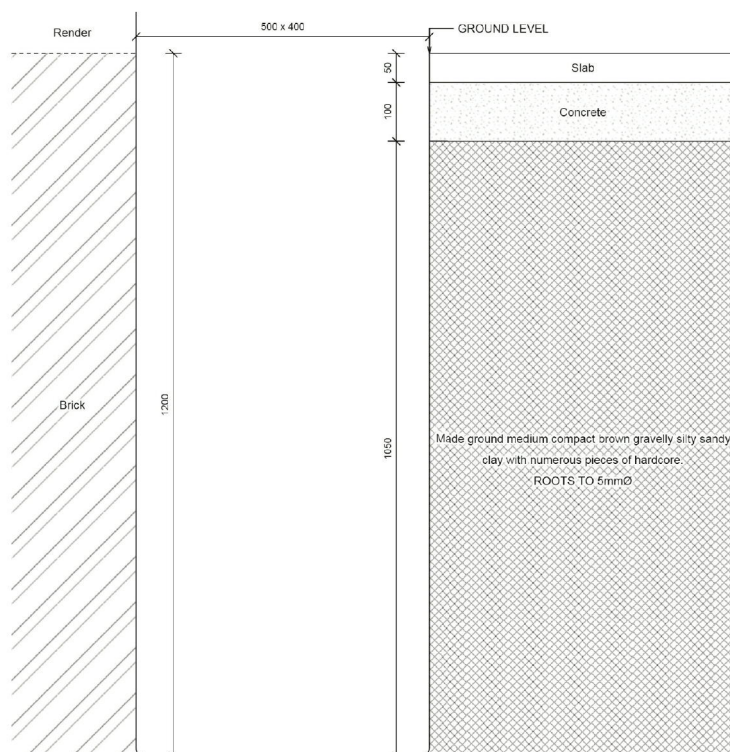
TRIAL PIT REF: Tp1 1of1

For Strata below 1200mm see Bore Hole log

TP abandoned at 1200mm due to depth. BH carried out in back of trial pit. u/s of foundation not found ,no soil sample taken.

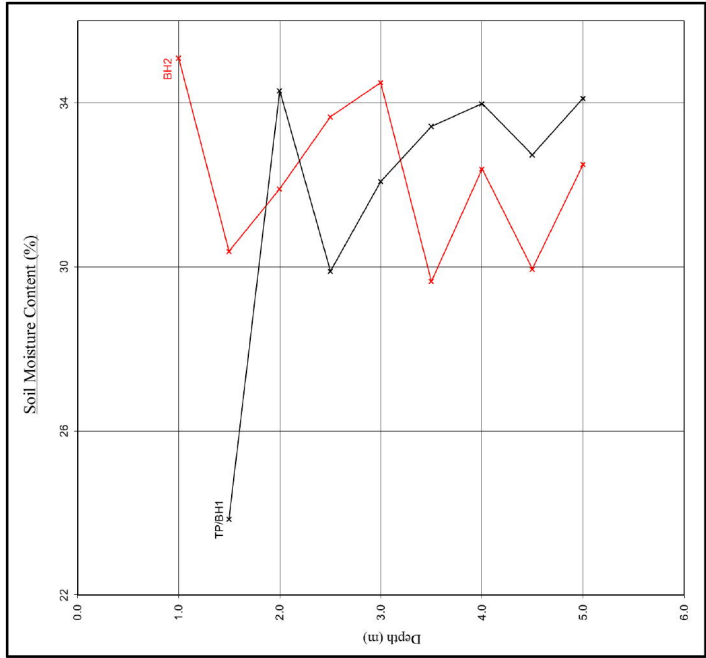
## Moisture Content Profiles

**Notes**  
1. If plotted, 0.4 LL and PI+2 (after Driscoll, 1983) should only be applied to London Clay ( and similarly overconsolidated clay) at shallow depths.  
2. Unless specifically noted the profiles have not been related to a site datum.

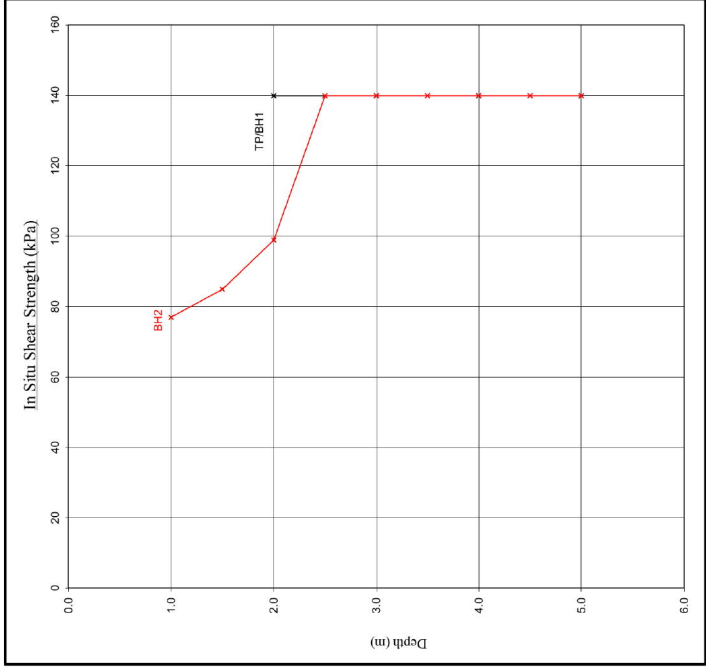
## Shear Strength Profiles

**Note**  
1. Unless otherwise stated, values of Shear Strength were determined in situ by CET using a Picon Hand Vane the calibration of which is limited to a maximum reading of 140 kPa.  
2. Unless specifically noted the profiles have not been related to a site datum.
