DAMP INVESTIGATION

113 ALBERT STREET, LONDON

JOB NO. 148.30

26 FEBRUARY 2018

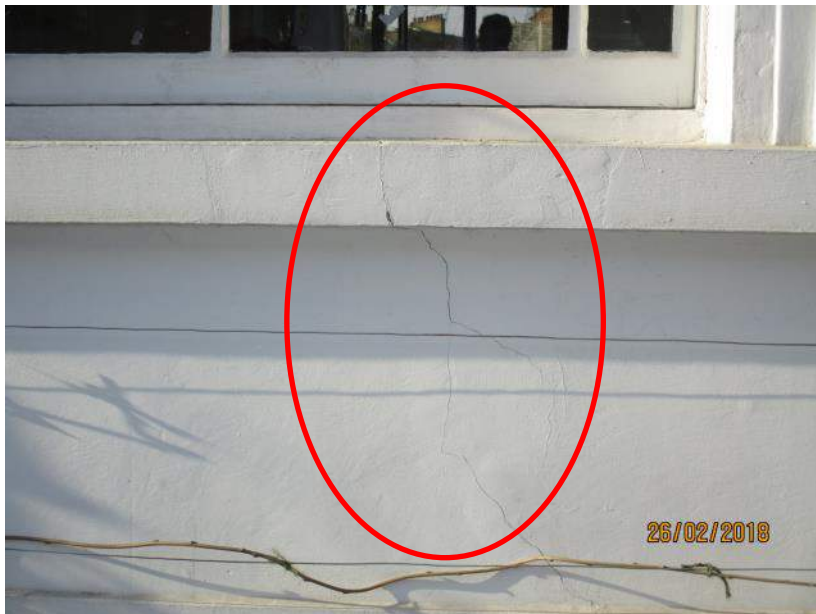
**Fig 1:**

East elevation, upper ground floor; showing vertical crack through render and decorative finishes, allowing water penetration into the structure

*Allowance should be made for patch repair in a flexible colour matched sealant to all cracks in the façade render and decorative finishes. Consideration should be given on future planned refurbishment and redecoration to specialist repair to the existing cracks, to reduce the risk of them opening up and admitting wind driven rainwater between normal redecoration cycles*

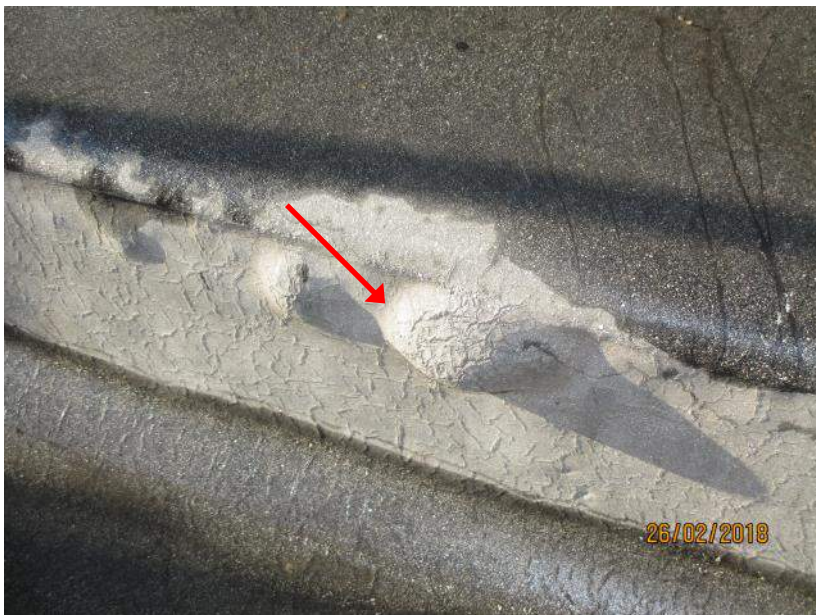
**Fig 2:**

East elevation, access stairs to upper ground floor; showing blistering to asphalt finishes indicating trapped moisture and a shortened service life

*Blisters or splits in the bituminous coatings should be repaired on planned refurbishment. Cracks in render at the sides of the steps should be repaired as described at 3.1.1(2) above*

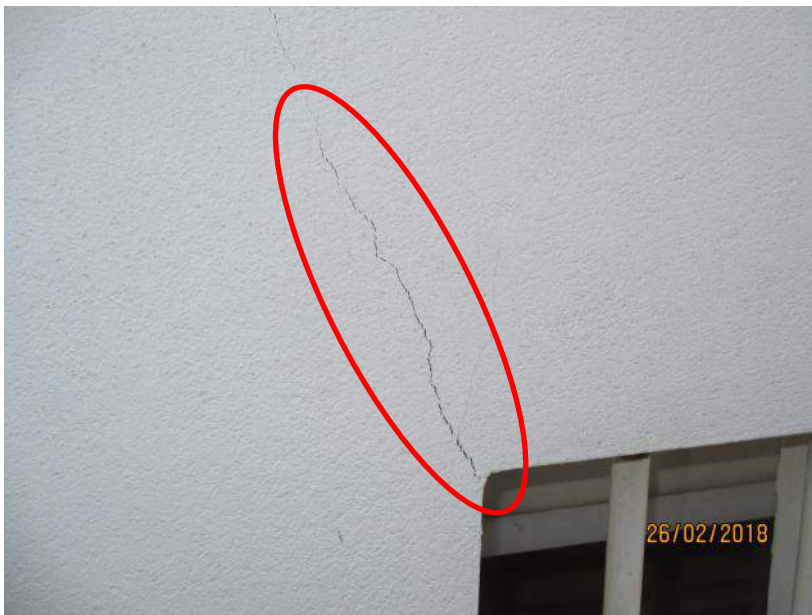
**Fig 4:**

East elevation, upper south side of lower ground floor window; showing diagonal crack in render and decorative finishes, increasing the risk of water penetration

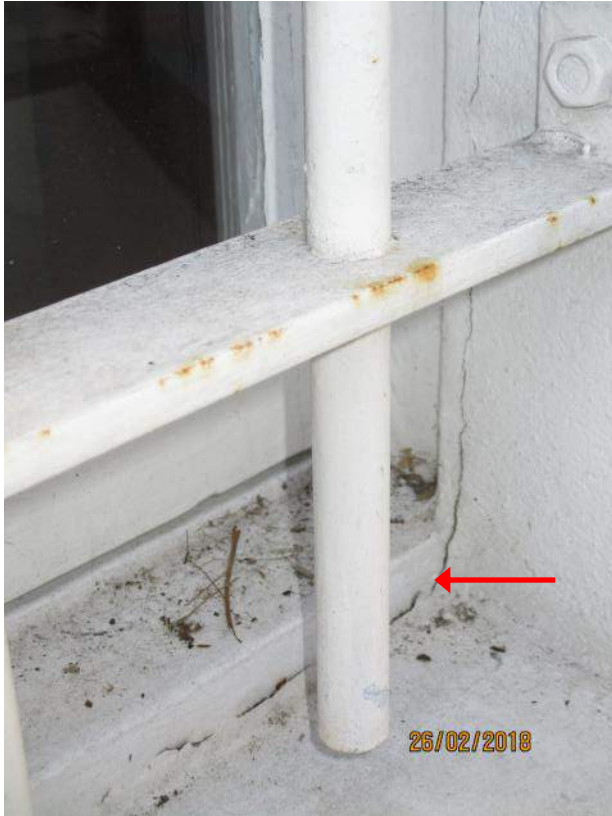
**Fig 5:**

East elevation, lower ground floor window; showing minor failure of sealants and decorative finishes around the window frame on the north side

*Defective sealants should be replaced around window frames and all external joinery should be subject to a programme of effective routine maintenance and redecoration, to maintain a vapour permeable but waterproof 'skin' over all external timber surfaces. Consideration should be given to stripping non-permeable or 'alkyd' paints from external joinery and replacing in a breathable micro-porous paint system on planned future refurbishment. H+R can provide further advice if required*

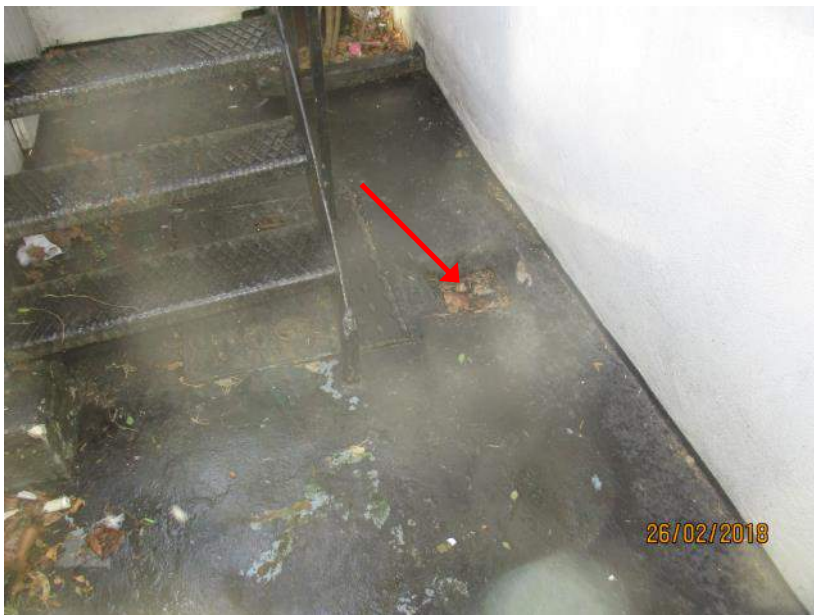
**Fig 6:**

East elevation, lightwell to lower ground floor; showing bituminous paint finishes to concrete hardstanding, laid to fall to a surface drainage gulley on the west side

*No urgent remedial works are required. Effective surface drainage should be maintained at all times and below ground pipework should be routinely inspected and cleaned or repaired as required, so as to direct surface water clear of the structure*

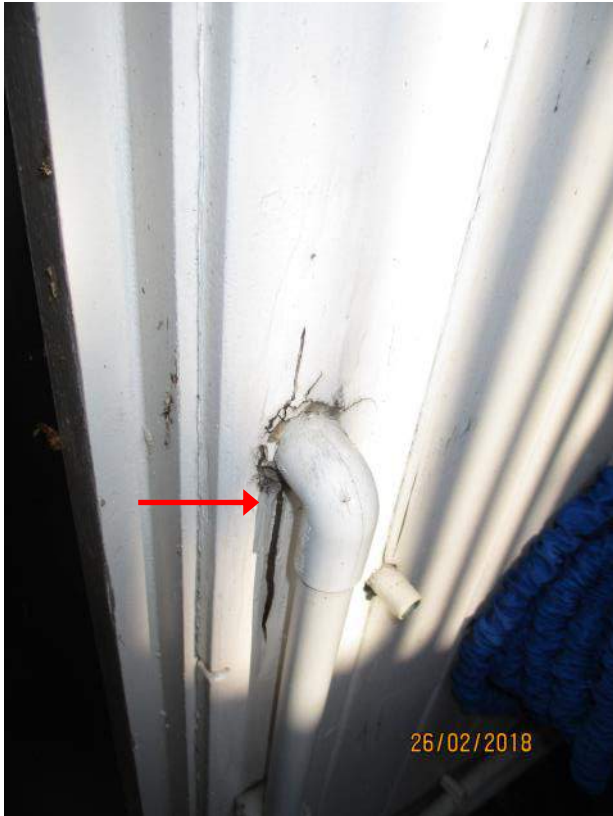
**Fig 7:**

East elevation, lower ground floor;  
showing minor decay to timber  
cladding on the south side of the  
access stair structure

*Allow for piece-in repair or wholesale replacement of decayed timbers and for improvements to waterproof detailing, to prevent surface water from draining into the structure and interior around pipe penetrations and at the upper and lower edges of the timber cladding. Consideration should be given in future refurbishment to replacing the timber cladding in a suitable moisture and decay resistant material*

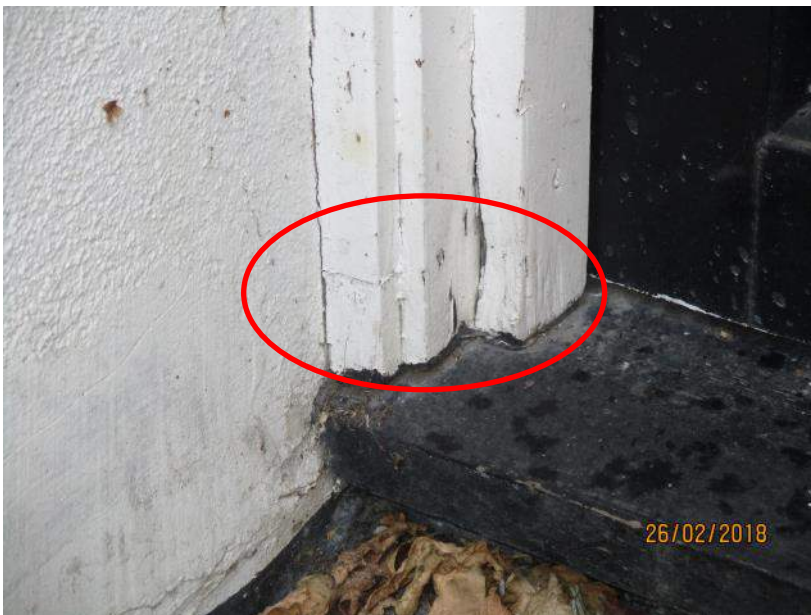
**Fig 8:**

East elevation, lower ground floor;  
showing evidence of decay and  
previous patch repair to the entry door  
frame on the west side

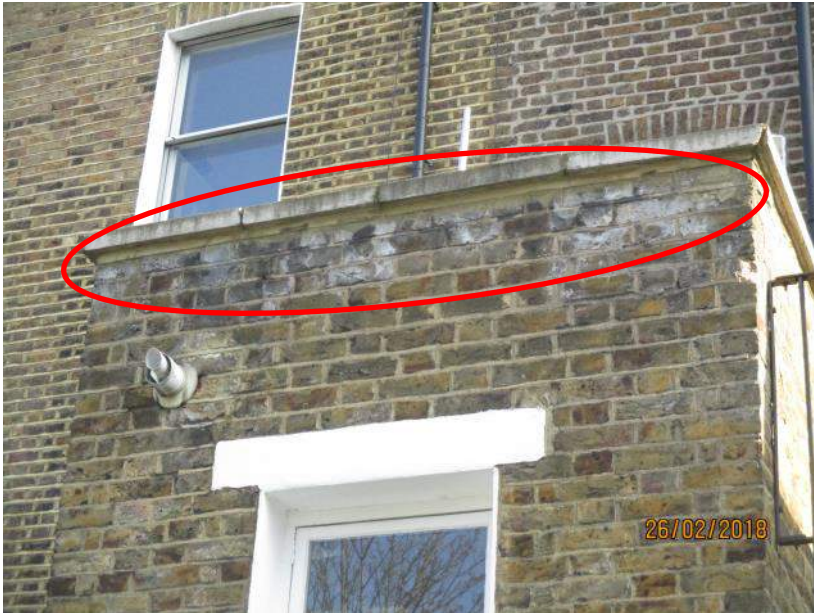
**Fig 9:**

West elevation, extension brickwork at upper ground floor level; showing salt efflorescence below coping stones, where pointing failure was allowing surface water to drain into the structures beneath. Flashings on the reverse may also require attention

*Allowance should be made for patch repair to pointing mortars around the parapet brickwork and copings of the extension roofs. Consideration should be given to lifting the existing copings and for replacement in new masonry slabs, with drip rebates on the undersides of the projecting edges. Copings should be laid over a suitable horizontal damp-proof course*

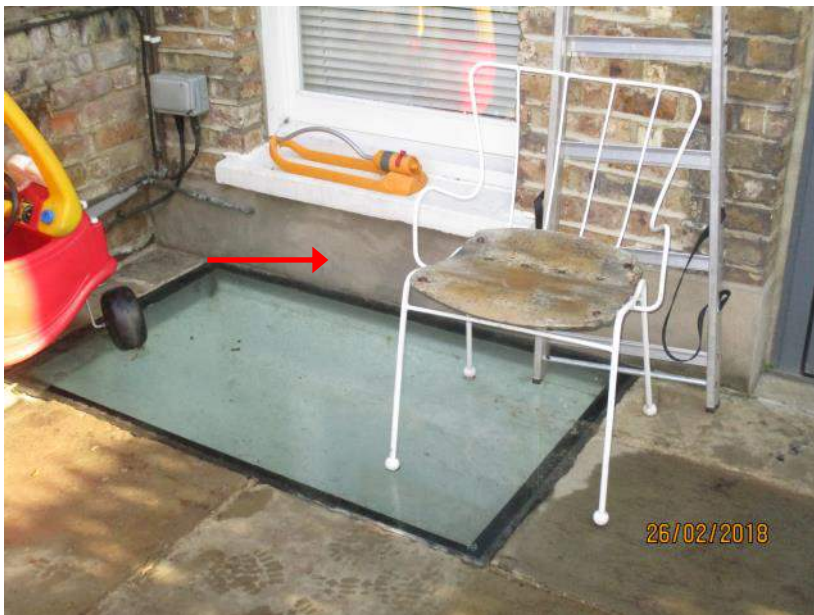
**Fig 10:**

West elevation, base of extension façade on north side; showing cementitious render skirting that was likely to have been encapsulating residual moisture within the structure and allowing surface water to drain behind

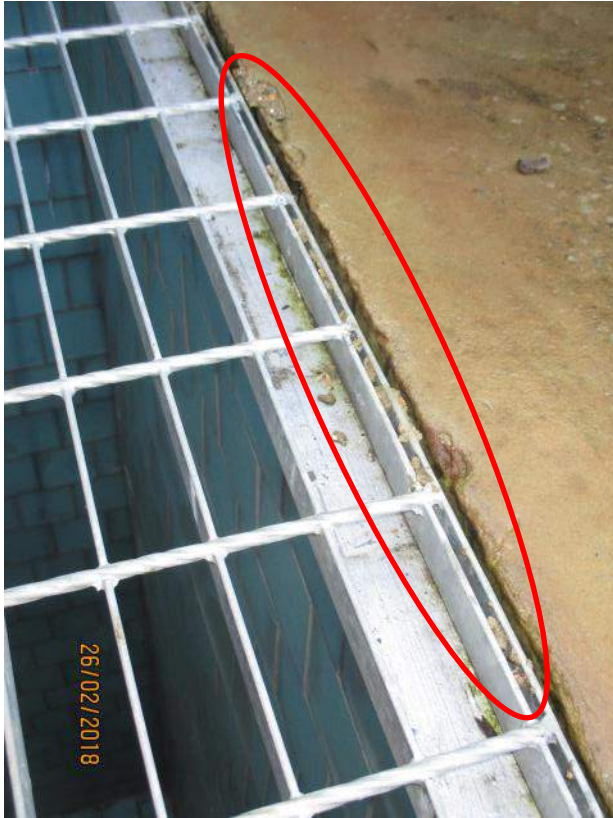
**Fig 11:**

West elevation, south side; showing failure of pointing between the lightwell cover and surrounding paving, allowing surface water to drain behind render and tiles applied to the lightwell wall beneath

*Open joints and other masonry defects allowing surface water penetration below the terrace paving and into the base of the west wall should be inspected in detail and repaired or replaced in new materials as required. Consideration should be given to reducing the level of the terrace generally and to improving the provision for horizontal damp proofing at the base of the west elevation and around the covered and open light wells serving the lower ground floor*

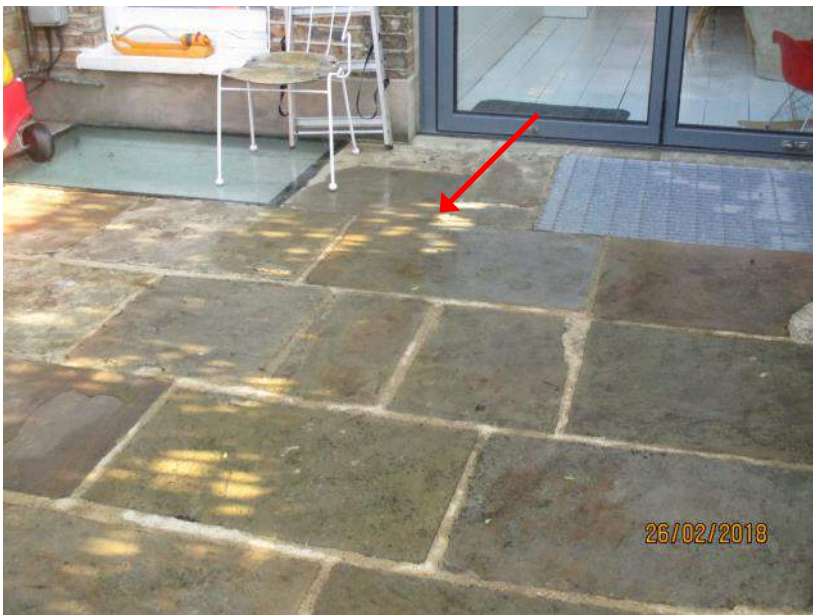
**Fig 12:**

West elevation; showing stone paving not laid to significant falls or detailed with surface drains which may allow ponding against the base of the façade by rain driven by prevailing winds from the west. Water would then be able to drain into the walls at the base of the west elevation through defects in the external masonry, affecting decorative finishes on the interior

*The junction between the external paving and the west elevation should be inspected in detail and modified as required, to effectively exclude surface water and wind driven rain. Damaged joints in paving should also be repaired in a suitable water resistant and flexible mortar mix. If extensive refurbishment works are anticipated consideration should be given to reducing the level of the external paving to between 150mm and 200mm below internal finished floor level and to installing a continuous horizontal damp-proof membrane, laid over a suitable screed or tapered insulation to a minimum fall of 1:60 away from the west elevation. The abutment with the façade should be detailed with a 150mm membrane upstand, with a cover flashing, from sheet lead or other suitable material, chased and sealed into the elevation brickwork. The horizontal membrane should be detailed around the light well openings to drain water passing through the terrace coverings outside the provision for vertical damp-proofing around the light-wells. It may be possible to improve the provision for damp-proofing whilst maintaining the terrace surface at the existing level. This will require careful detailing and improvements to surface drainage, including a liner drain across the base of the west elevation to interrupt surface water that would otherwise drain into the base of the wall. H+R can provide further advice on remedial detailing of required*

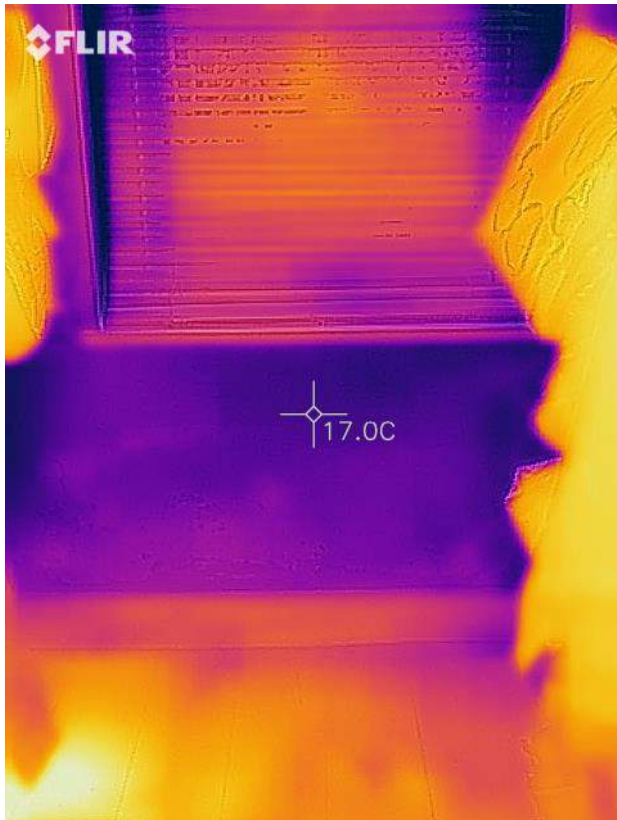
**Fig 13:**

Thermal image 1, upper ground floor cloakroom, base of wall on west side; showing surface temperatures significantly above dew point at time of inspection

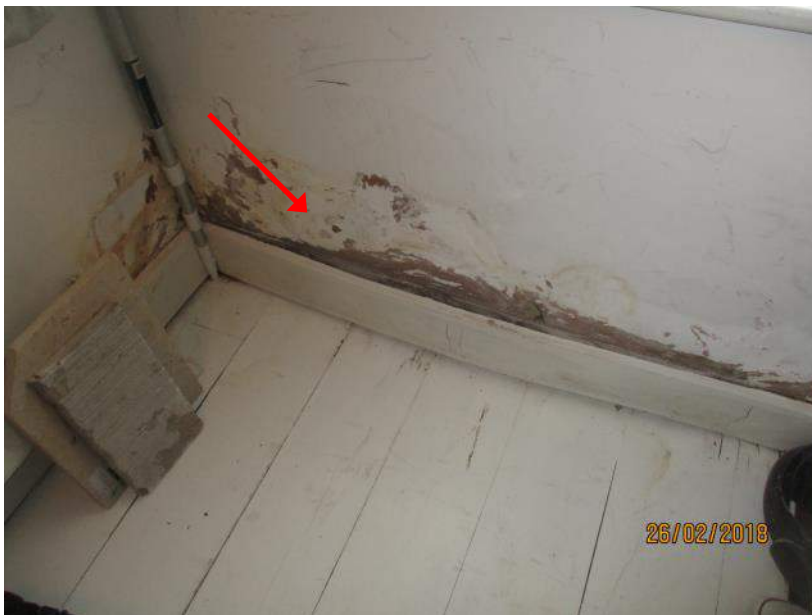
**Fig 14:**

- 1 Defects: Gypsum skim plaster was subject to failure across the full width of the west wall, typically extending to around 0.4m above floor level. Further detachment of skim coat plaster was noted in isolated locations up to 0.6m above floor level. External ground level was approximately 500mm above finished floor level increasing the risk of surface and ground water draining into the structure. Failure of decorative finishes and light brown 'tobacco' staining was consistent with the mobilisation of hygroscopic salts following water penetration from the exterior and intermittent efflorescence and deliquescence of salts driven by natural variations in internal humidity

Upper ground floor cloakroom ('boot room'), west side; showing damage to surface plaster and decorative finishes at low level, consistent with chronic damp penetration from the exterior and intermittent efflorescence and deliquescence of hygroscopic salts

*Allowance should be made for stripping the plaster of the west wall to level of the west window sill following removal of skirtings and other joinery at low level. The exposed area of brickwork should be extended a minimum of 1m from the north-west and south-west corners. Timber floor structure should be subject to detailed inspection and replacement or repair of decayed timber as required. New or retained timber should be fully isolated from masonry by a studded plastic vertical separating membrane, linked to membranes forming the cavity drain system at lower ground floor level; effectively extending the provision for lower ground floor damp-proofing up to around 1.0m above external ground level. The wall membranes should be closed in timber panelling or plasterboard dry lining as directed by the Architect, detailed with continuous ventilation slots at skirtings and 'dado level'. Wall membranes and dry linings should be extended across the exposed areas of brickwork on the north and south sides, to isolate timber and vulnerable materials from damp affected walls that abut the west elevation. Consideration should be given to extending the dry lining to the east to natural breaks in the wall surface, such as the vanity unit on the south side and the return wall adjacent to the WC to the north. This is likely to require adjustments to the central heating radiator on the south side*

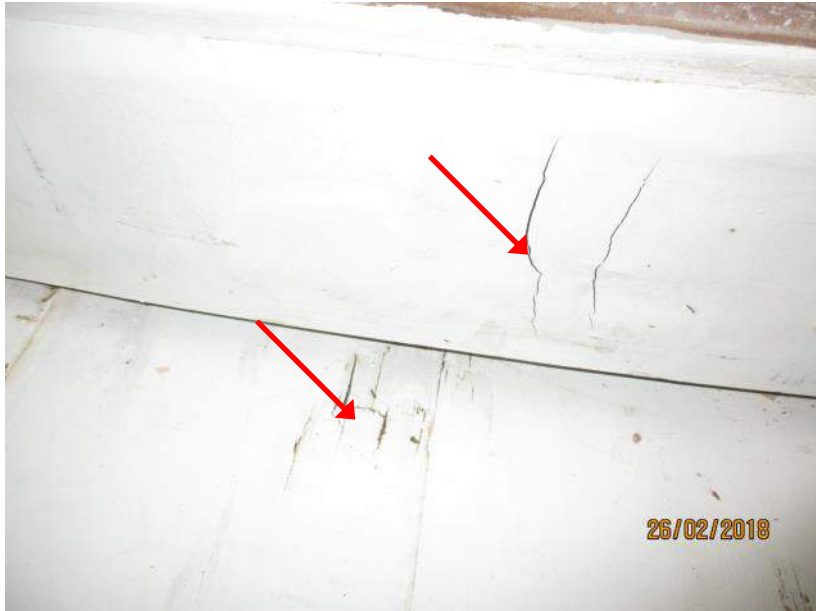
**Fig 15:**

- 2 Timber: The skirting board on the west side had bowed away from the wall and showed signs of decay at the centre and north ends. Decay was also noted in the west ends of the floorboards where these were assumed to be in contact with the damp affected structure of the west external wall. The shelf on the north side and the skirting on the south side were also likely to have been affected by damp and were at risk of decay. The indicative moisture contents of areas affected by historic decay were significantly above the decay threshold, indicating that further timber decay was probable. The skirting on the south side was saturated with moisture contents above 40 per cent up to 300mm from the south-west corner of the room. A corresponding section of skirting at the west end of the north dining room wall, on the reverse of the structure, had been replaced on previous refurbishment but the moisture content of this timber at time of survey was below the decay threshold

Upper ground floor cloakroom ('boot room'), west side; showing decay to the skirting board which had bowed away from the base of the wall and decay to the ends of the floorboards, which were assumed to be in direct contact with the damp affected external wall

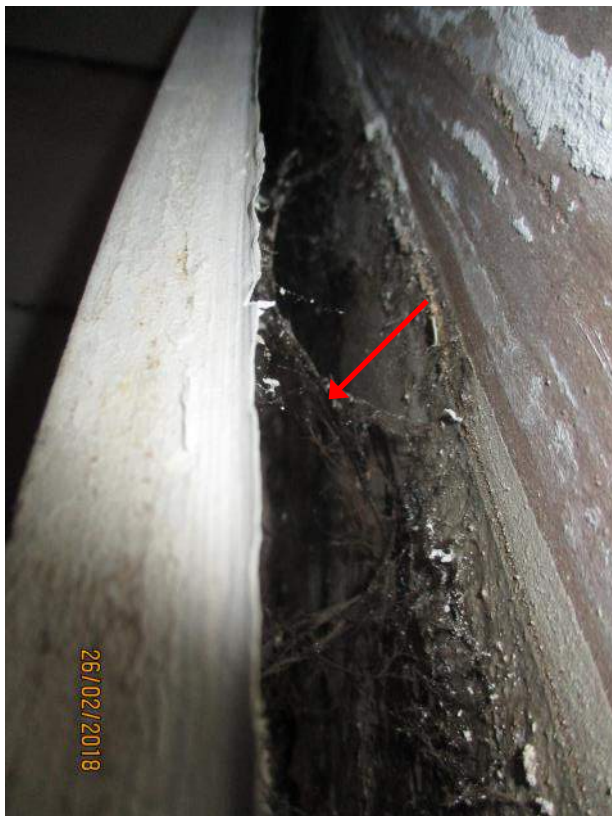
**Fig 16:**

Upper ground floor cloakroom ('boot room'), west side; showing the mycelium of a timber decay organism behind the skirting board which was vulnerable to damp penetration from the exterior and showed signs of historic decay

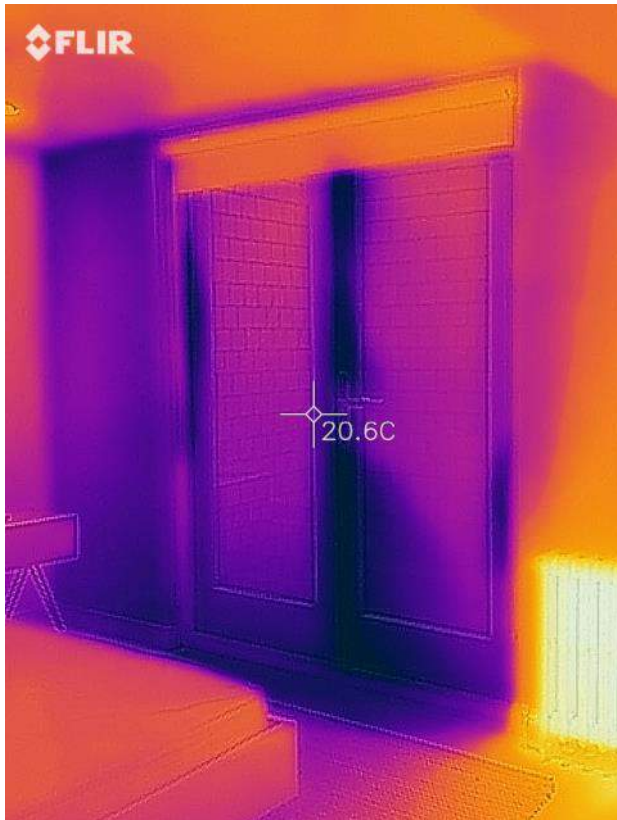
**Fig 17:**

Thermal image, lower ground floor, west bedroom; showing surface temperatures on south side of west wall with minimum 12°C above dew point at the time of inspection

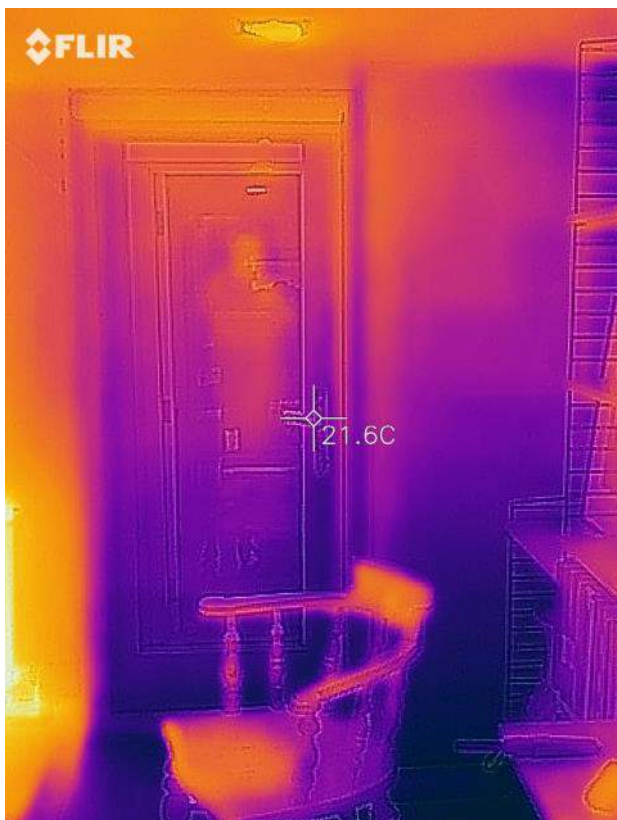
**Fig 18:**

Thermal image, lower ground floor, west bedroom; showing surfaces on north side of west wall minimum 12°C above dew point at time of inspection

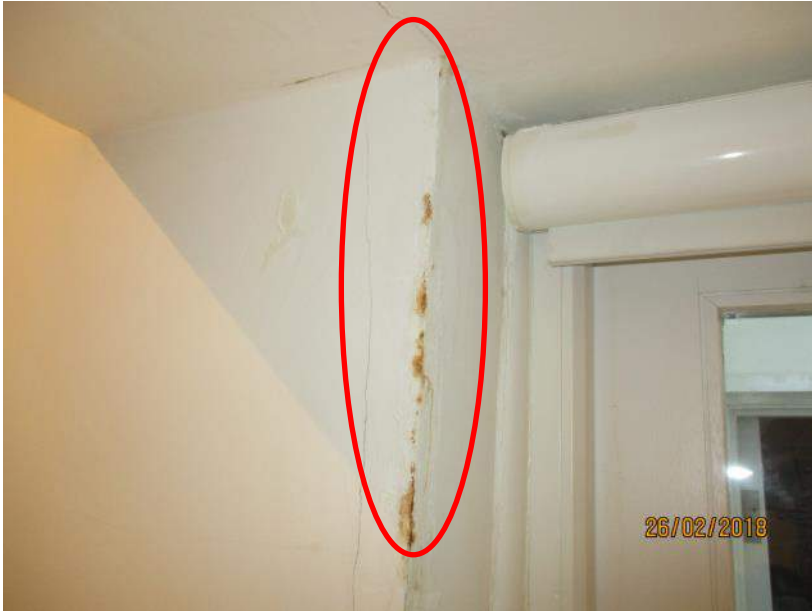
**Fig 19:**

Lower ground floor, west bedroom, west side; showing iron oxide staining to plaster beads, consistent with damp conditions in masonry behind and intermittent surface condensation

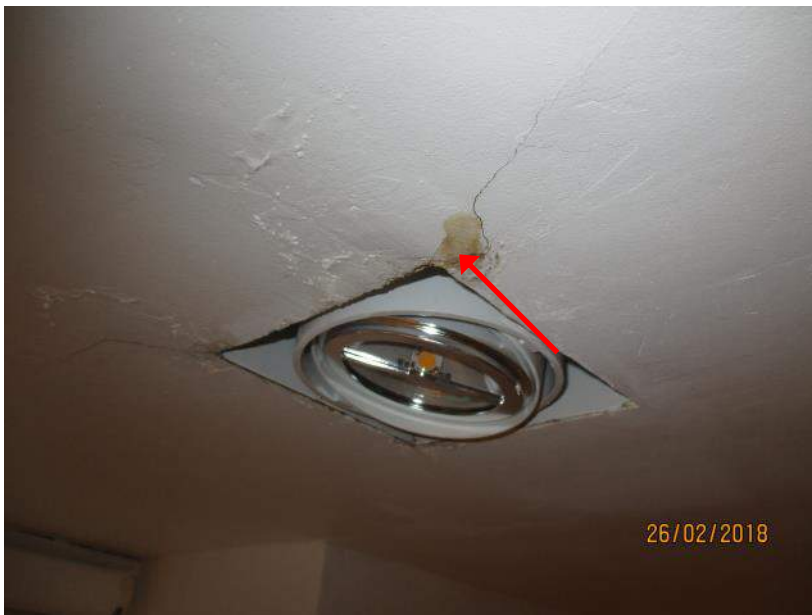
**Fig 20:**

Lower ground floor, west bedroom, ceiling towards north-west corner; showing moisture damage around recess light fittings, consistent with water draining over top surface of the ceiling boards, from the west wall

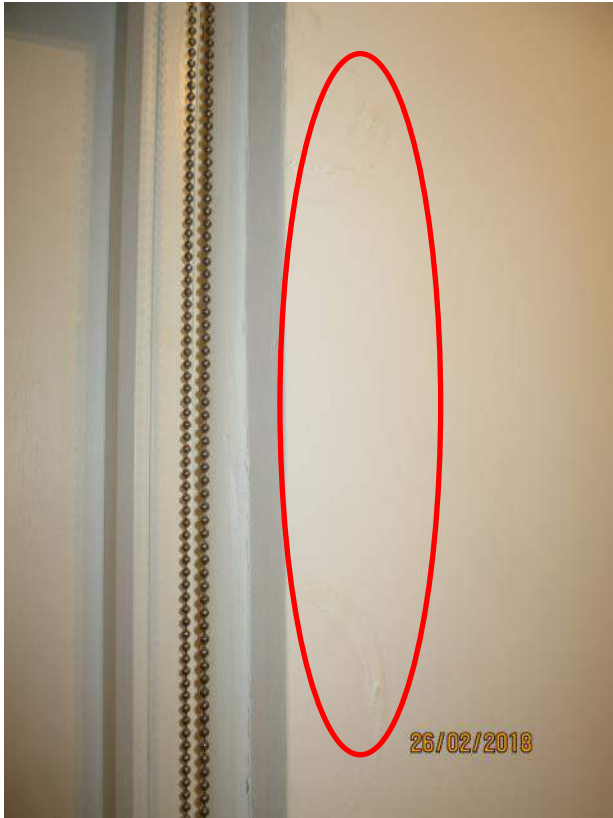
**Fig 21:**

Lower ground floor, west bedroom, upper north side of doorway to external lightwell; showing deformation of the wall surface, consistent with cyclical efflorescence and deliquescence of hygroscopic salts between the plaster skim and the paint coating. A cold-bridge was likely to exist around the door frame and the structure was vulnerable to damp penetration, where it was earth retaining and where surface water could drain into the structure from above

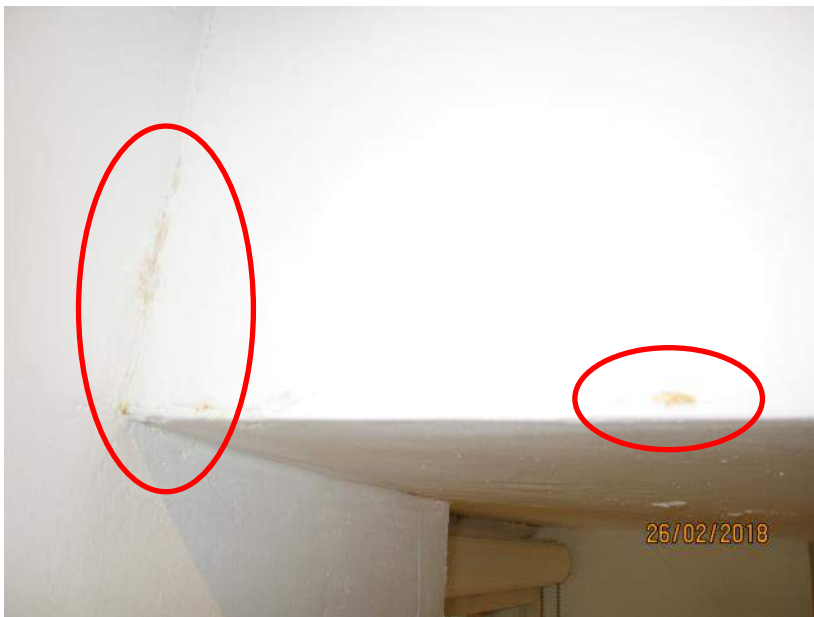
**Fig 22:**

Lower ground floor, west bedroom, west side; showing salt efflorescence and corrosion of plaster beads affecting decorative finishes at high level. H+R were informed that more severe damage has been apparent in the past but has been disguised by redecoration

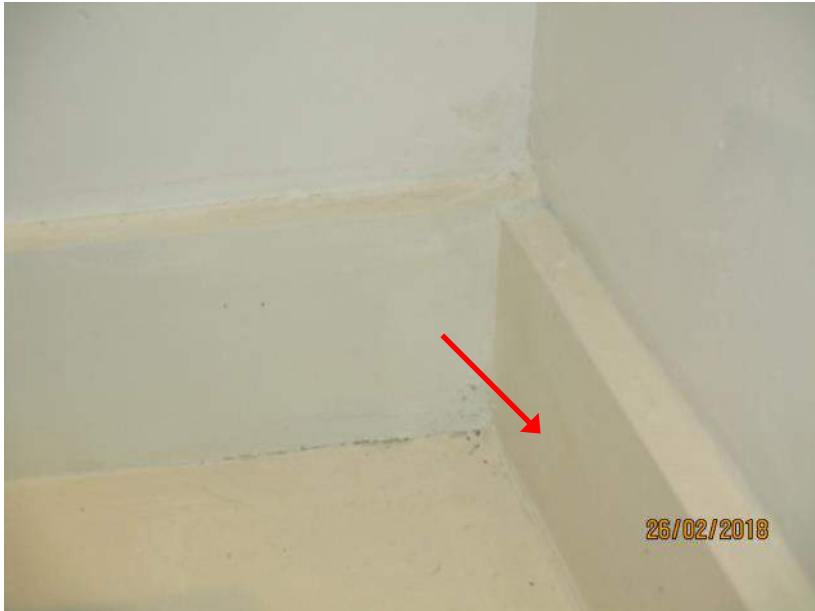
**Fig 23:**

Lower ground floor, west bedroom;  
showing section of skirting at south-  
west corner with moisture content  
significantly above the decay threshold

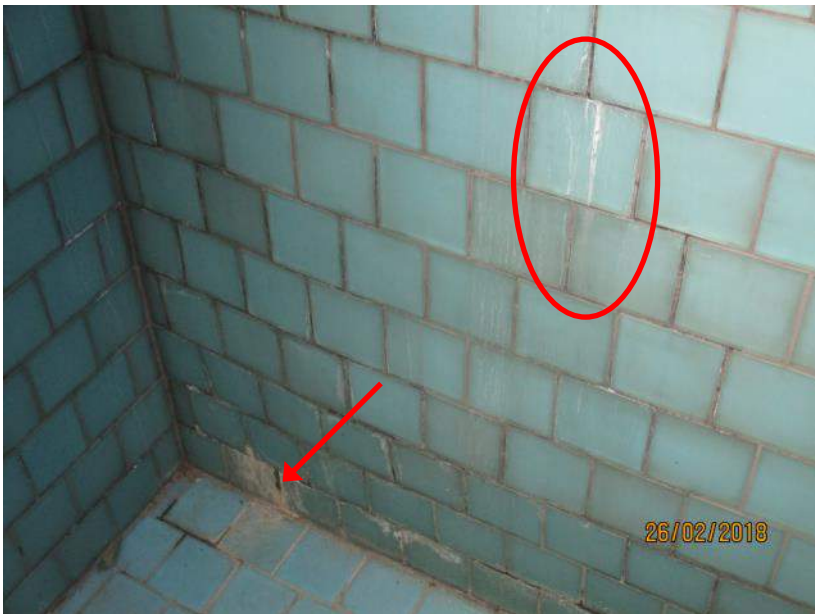
**Fig 24:**

Lower ground floor, lightwell on west  
side; showing soluble minerals draining  
through open joints in the structure,  
where the glass tiles had become  
detached

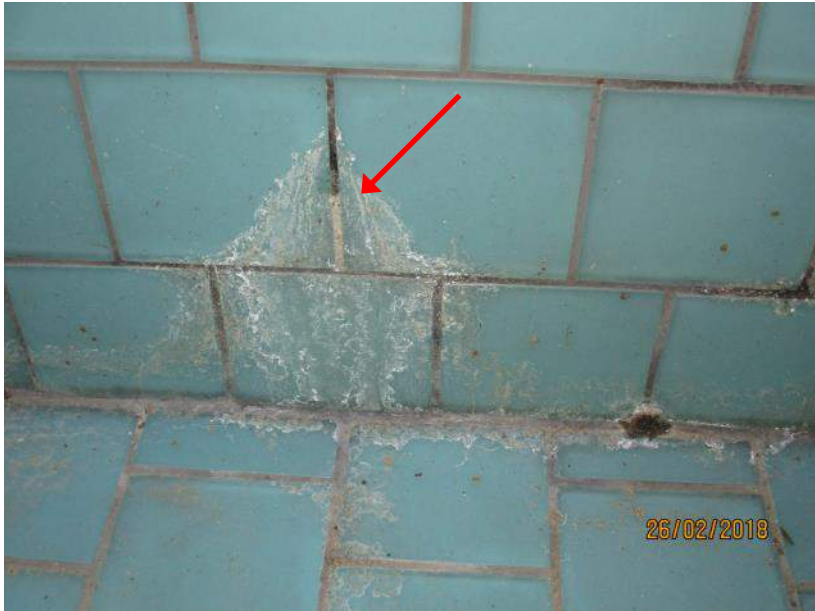
**Fig 25:**

Lower ground floor, lightwell, south side; showing soluble minerals on glass tile surface where water drained below ground level through structures behind

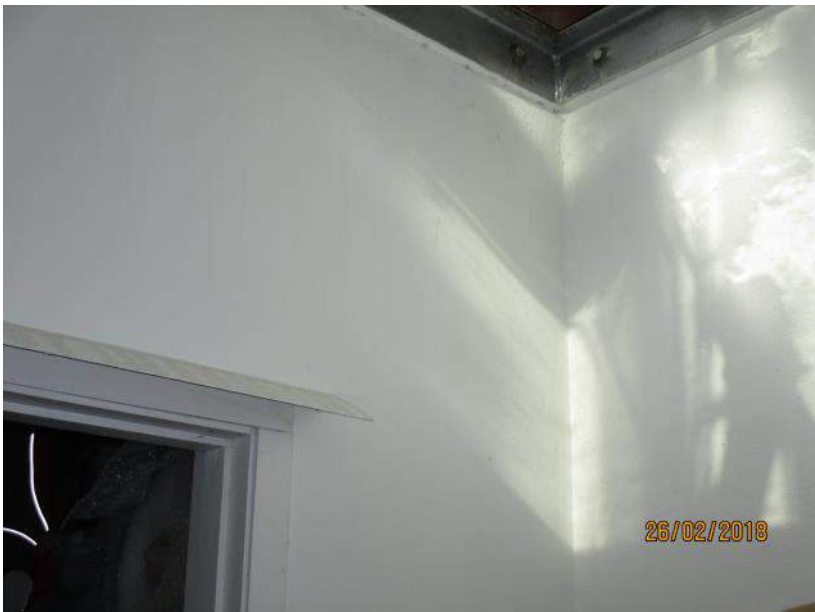
**Fig 26:**

Lower ground floor, west side, lobby to north-west storeroom; showing generally good condition of wall render and decorative finishes

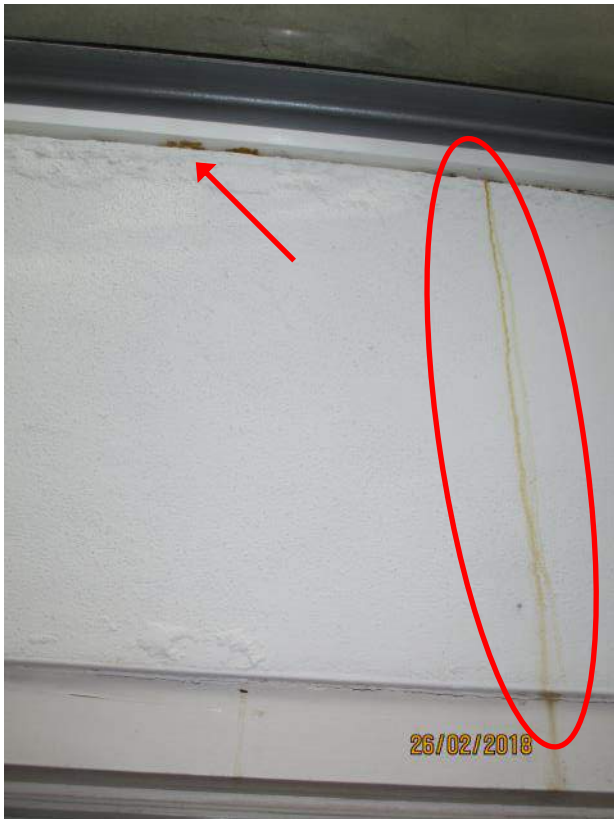
**Fig 27:**

Lower ground floor, lobby to north-west storeroom; showing isolated surface streaking of water contaminated iron oxide, indicating intermittent water penetration where seals around the skylight above had failed. Note blistered paint finishes at high level, indicating that water from outside was draining into the head of the wall around the skylight glazing

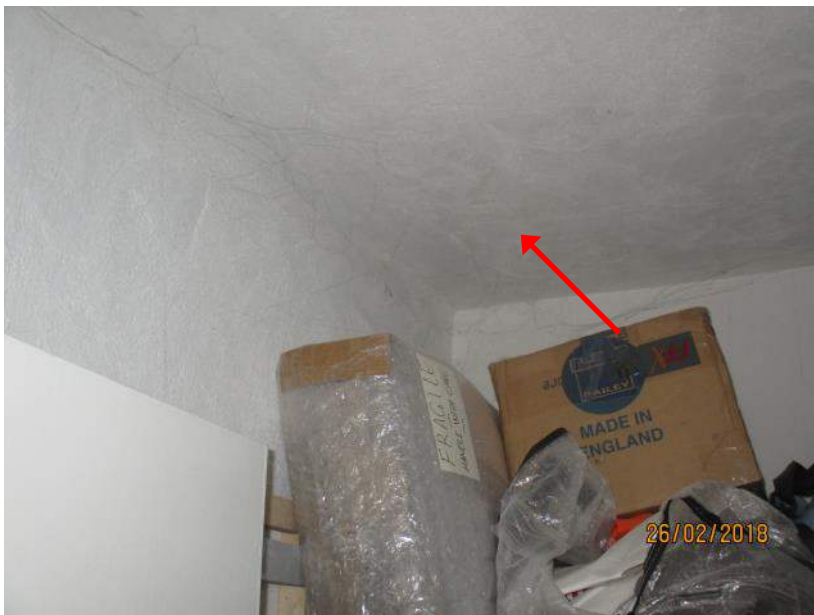
**Fig 28:**

Lower ground floor, north-west storeroom; showing generally good condition of wall and ceiling render and decorative finishes. The structure may be vulnerable to intermittent condensation but no defects associated with moisture or mould growth were reported to H+R by occupants

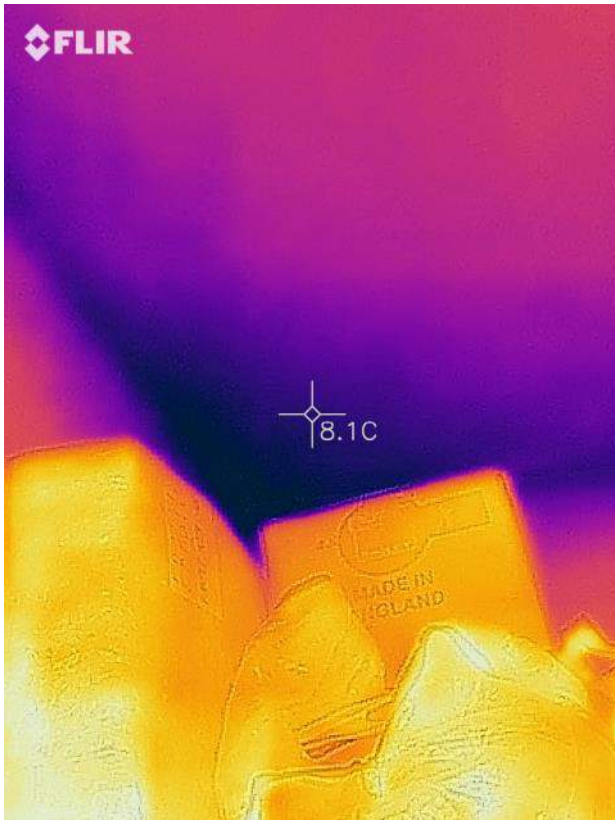
**Fig 29:**

Thermal image, lower ground floor, west side, south-west corner of north-west storeroom; showing surface temperatures within 4°C of dew point at time of inspection. The conditions for intermittent condensation may arise under specific circumstances including those associated with intermittent occupancy

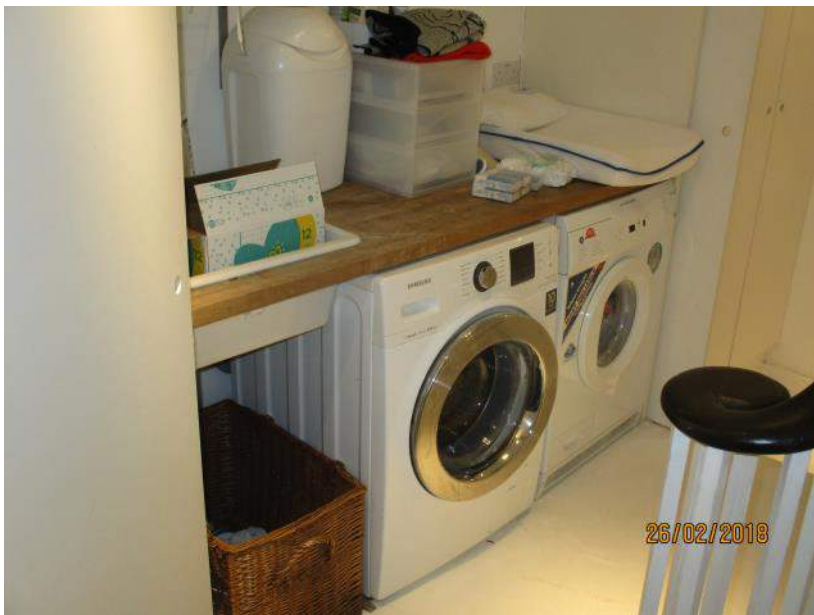
**Fig 30:**

Lower ground floor, central area; showing utility room installation at base of stairwell with no provision for mechanical extract ventilation

*The provision for passive and mechanical ventilation should be reviewed during proposed refurbishment and remedial works, summarised above and described at Sections 3.1 and 3.2 below, to ensure effective control of airborne moisture and condensation on future occupancy*

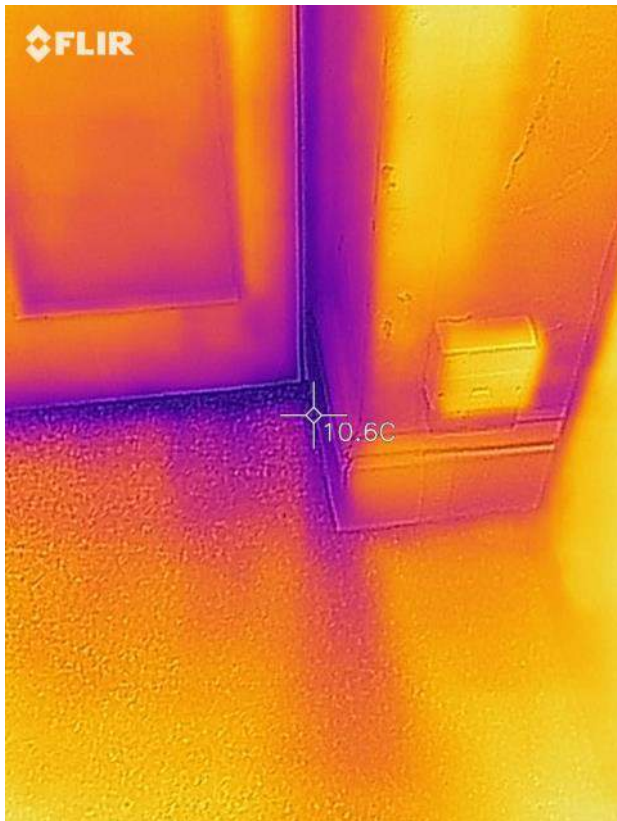
**Fig 31:**

Thermal image, lower ground floor, east room; showing surface temperatures a minimum 6°C above dew point around the doorway to the exterior via an entrance lobby, indicating that the conditions for condensation were not present at time of survey

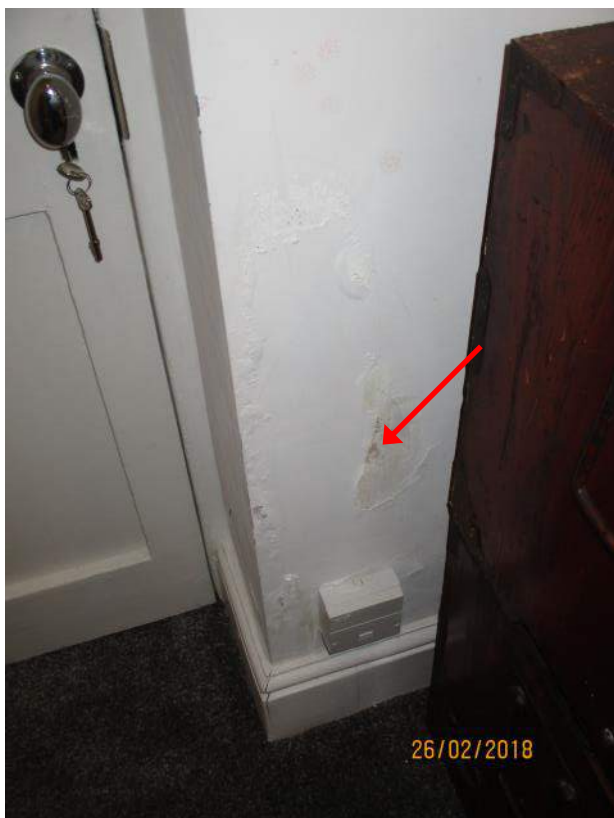
**Fig 32:**

Ground floor, east room, east side; showing damage to decorative finishes consistent with intermittent salt efflorescence adjacent to the external door in the north-east corner

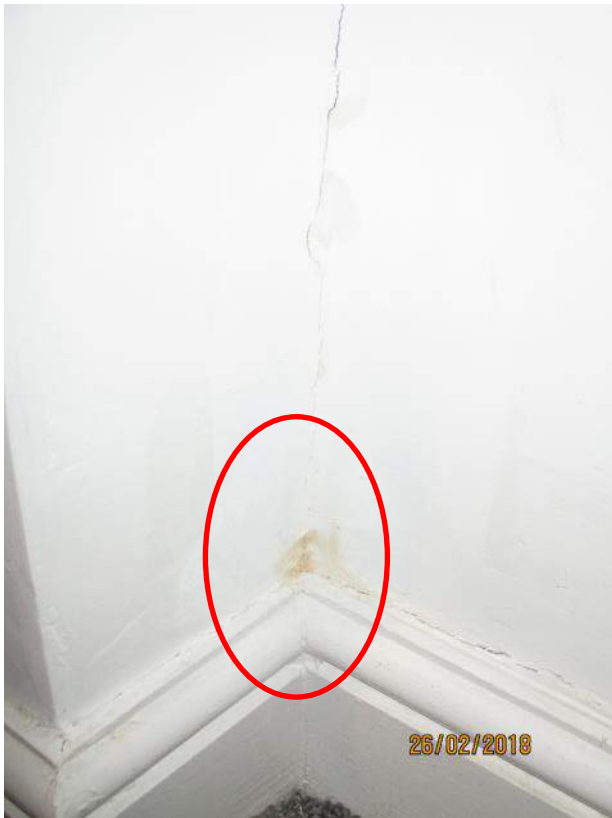
**Fig 33:**

Lower ground floor, east room, east side; showing 'tobacco' staining and failure of decorative finishes at the junction between the skirting and the wall, consistent with intermittent condensation at the wall/floor junction. The indicative moisture content of the skirting boards was above the decay threshold, indicating that water was draining into the base of the wall from outside or that cumulative condensation was taking place on the reverse of the skirting board

*The base of the east wall should be detailed with a ventilated dry lining system, following removal of plaster to expose brickwork. All timber and hygroscopic materials should be isolated from the wall masonry. Pipework in the external lobby/ boiler area should be tested for escape of water and repairs carried out as required*

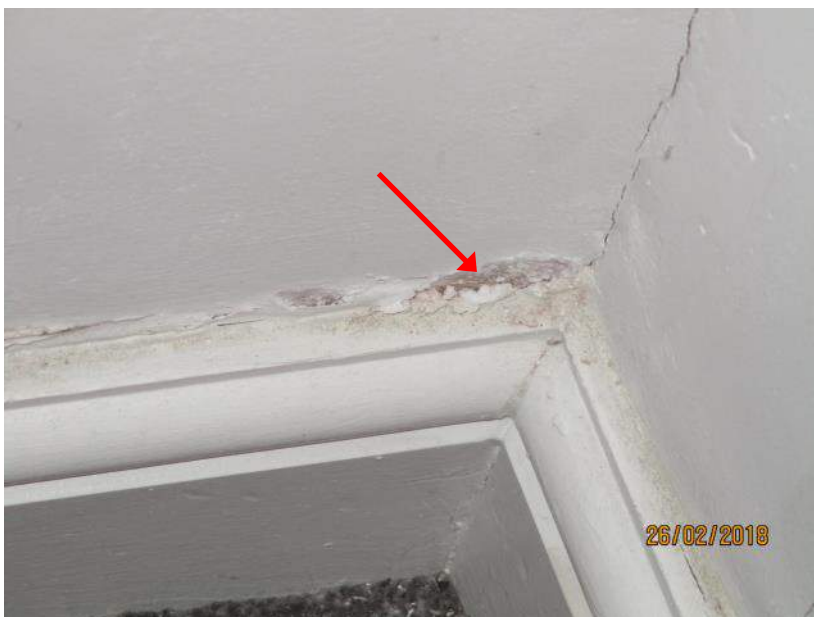
**Fig 34:**

Lower ground floor, east room, east side; showing failure of plaster skim and decorative finishes at low level, consistent with active or historic moisture penetration and intermittent surface condensation

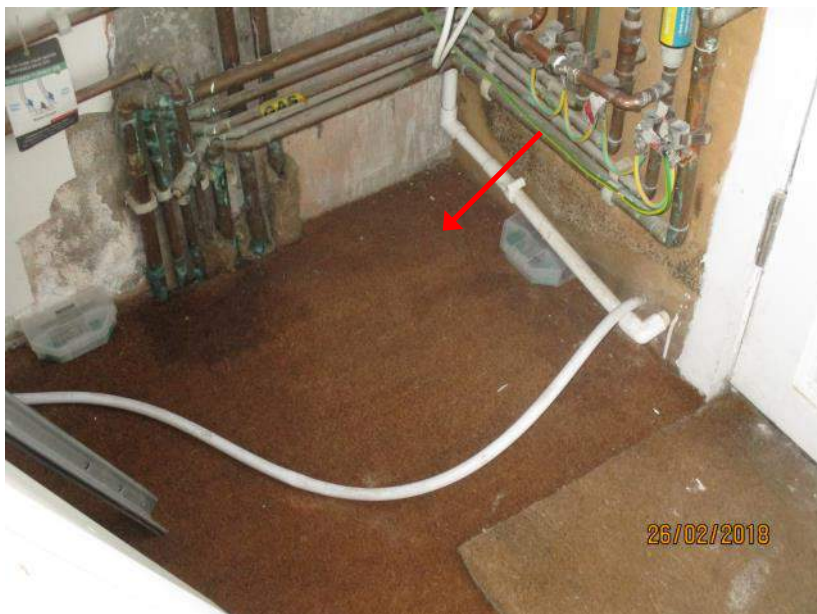
**Fig 35:**

Lower ground floor, entrance lobby and boiler space; showing evidence of damp affecting wall and floor finishes at low level in the south-east corner

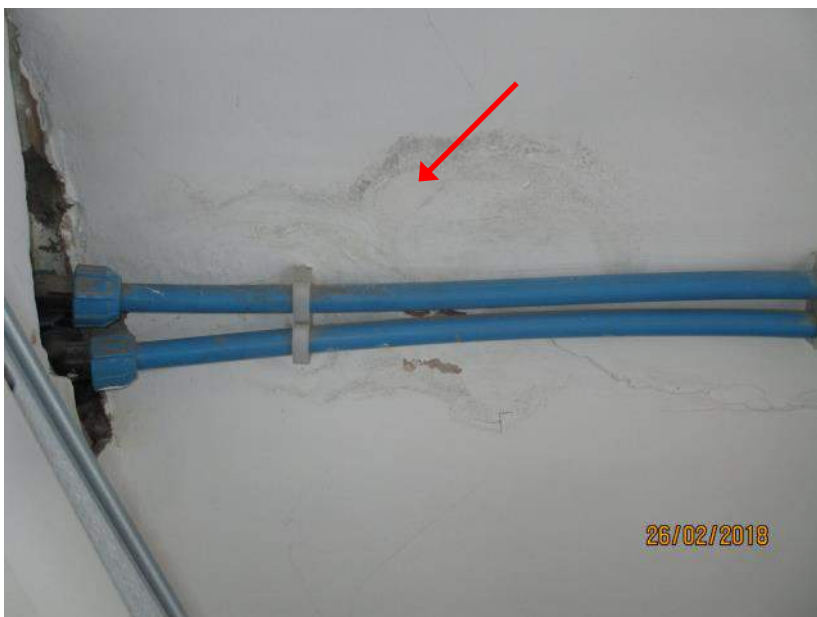
**Fig 36:**

Lower ground floor, entrance lobby and boiler space to north-east; showing condensation affecting decorative finishes behind cold water supply pipes, where surface temperatures would have been reduced locally by proximity to the pipes
