**Title: Statement in Support of Proposed Works  
to the Brickwork Masonry wall at The  
Garden House, 24 Well Road, Hampstead,  
London, NW3 1LH**

**For: Mr & Mrs A Goldstein**

**Ref: AG01/12/16**

**Date: September 2018**

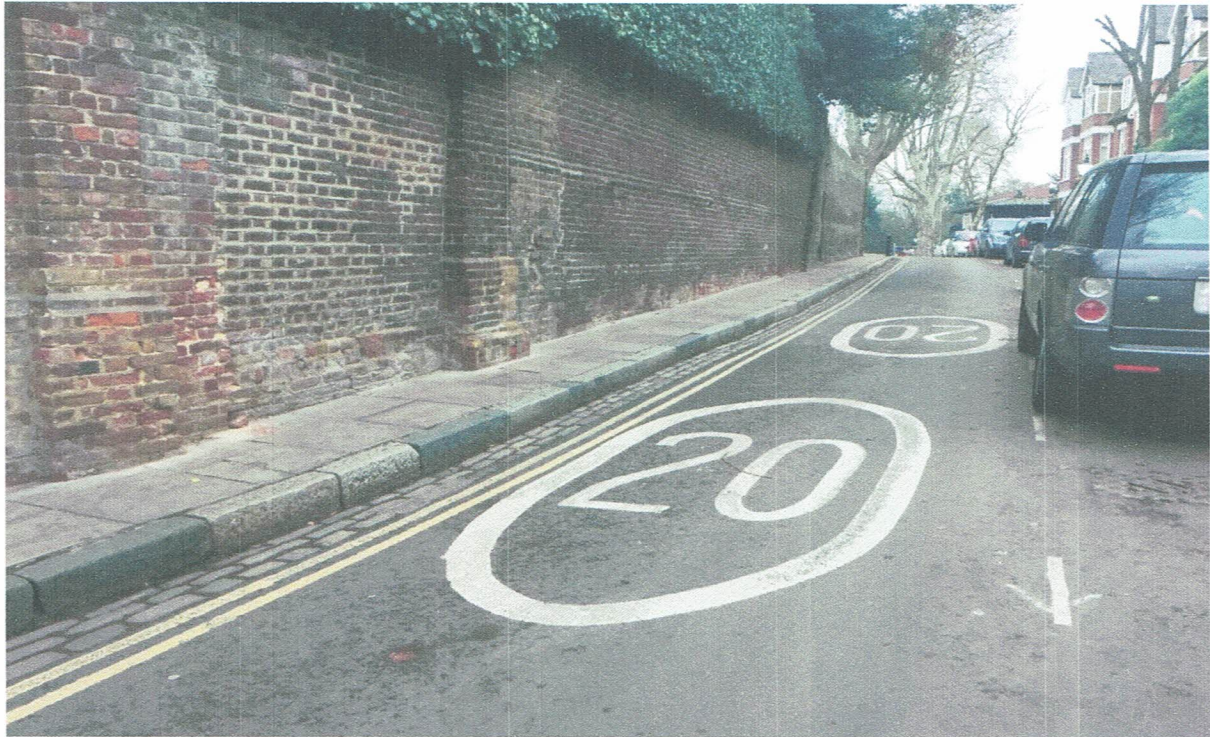
The Garden House wall, looking north east towards Cannon Lane

The length of wall under consideration has been noted to be displaced in the vertical plane such that the face with Well Road leans away from the property towards Well Road i.e. in a south easterly direction. The displacement having existed for many years, with there being no discernible change in the walls condition over this time.

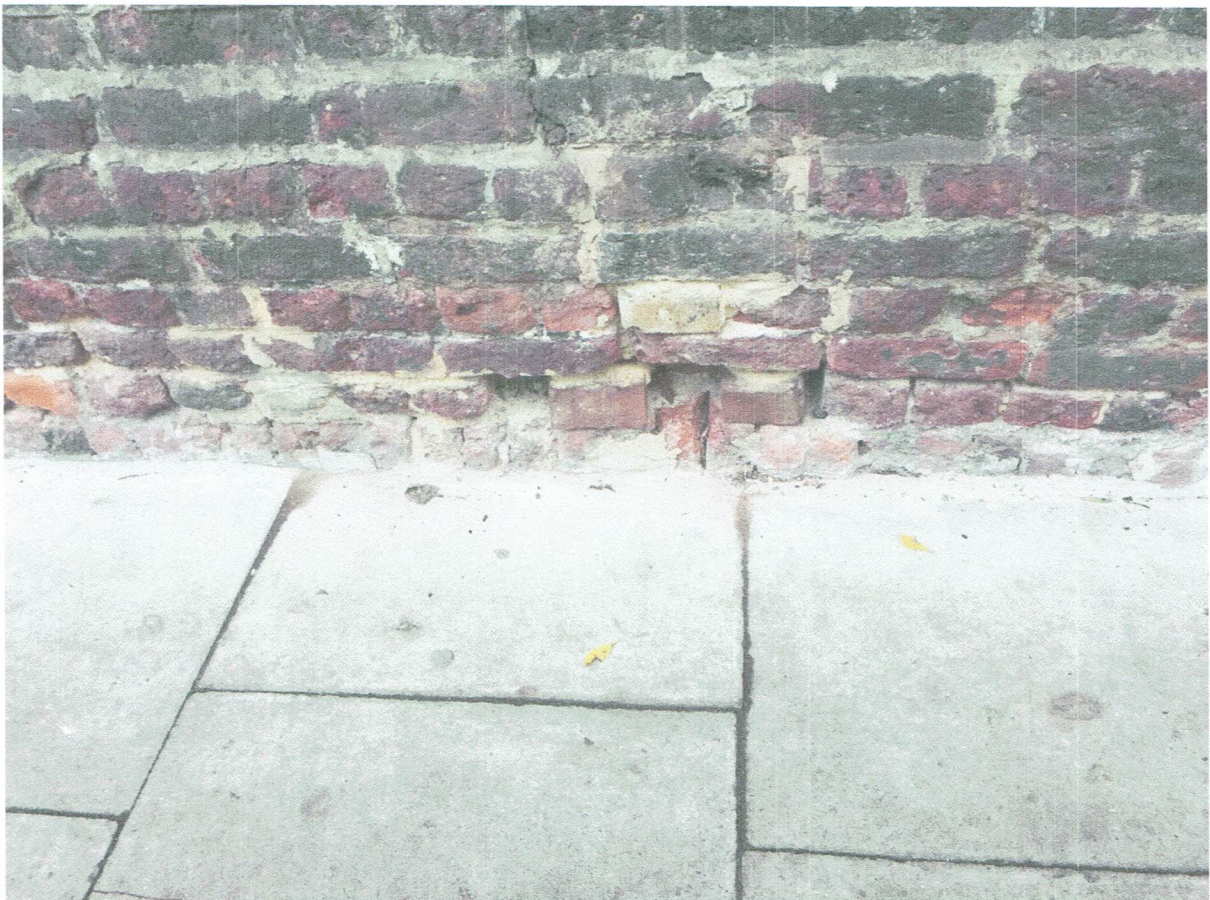
Besides the displacement referred to above, the lower courses of brickwork have suffered from erosion and degradation as a result of de-icing salts being “splashed” against the base of the wall by vehicles using the adjacent public highway, Well Road. A footway exists between the carriageway and the wall, the footway width, distance from carriageway to wall, being approximately 1.1m at some locations. A photograph showing the typical damage that has occurred is provided below;

Typical damage caused by de-icing salts

It is proposed the damage as a result of the de-icing salts also be repaired at the same time as works to stabilise the wall are carried out.

The repointing of the brickwork, both where the helical bar reinforcement is installed , and where the brickwork damaged by de-icing salts is repaired will generally follow the recommendations of the Technical Note produced by the Hampstead Garden Trust, Pointing of Brickwork (A copy of which is appended). All replacement bricks to be used in the areas damaged by de-icing salts will be sourced such that they match the existing.

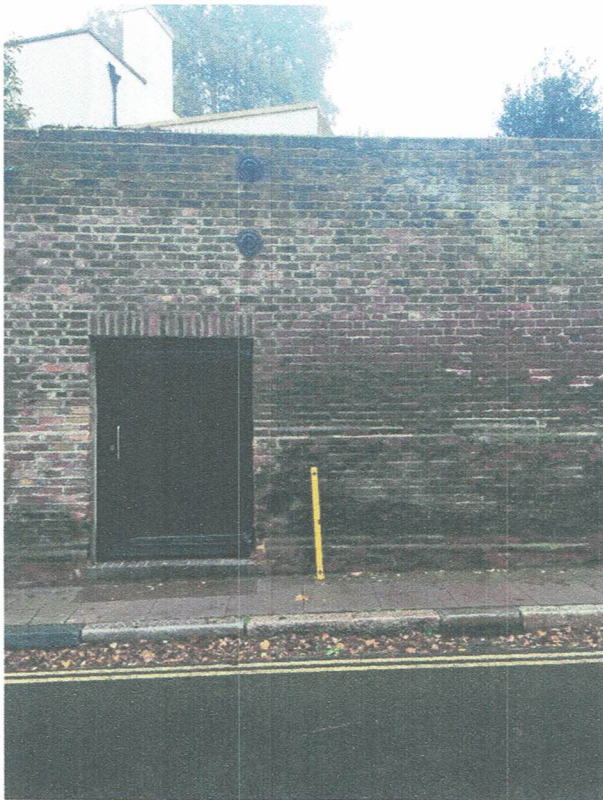
Pattress plates as used in the wall to be stabilised, and as used on the neighbouring property. (The personnel door is at the north eastern end of the proposed works).

The pattress plates will be circular and of a bronze alloy, therefore replicating those which have already been introduced elsewhere in the walls length, and in other walls nearby. A copy of a photograph showing pattress plates of the type proposed, and as used on the same listed wall immediately adjacent to the area to be stabilised, the length of wall that forms the neighbours boundary with Well Road immediately to the north east of The Garden House, is shown below.
