Investigation
Report and
Recommendations

Our Reference No: MP/180833481/CP

RE: 8 WOBURN WALK, LONDON, WC1H OJL

Damp Investigation Report

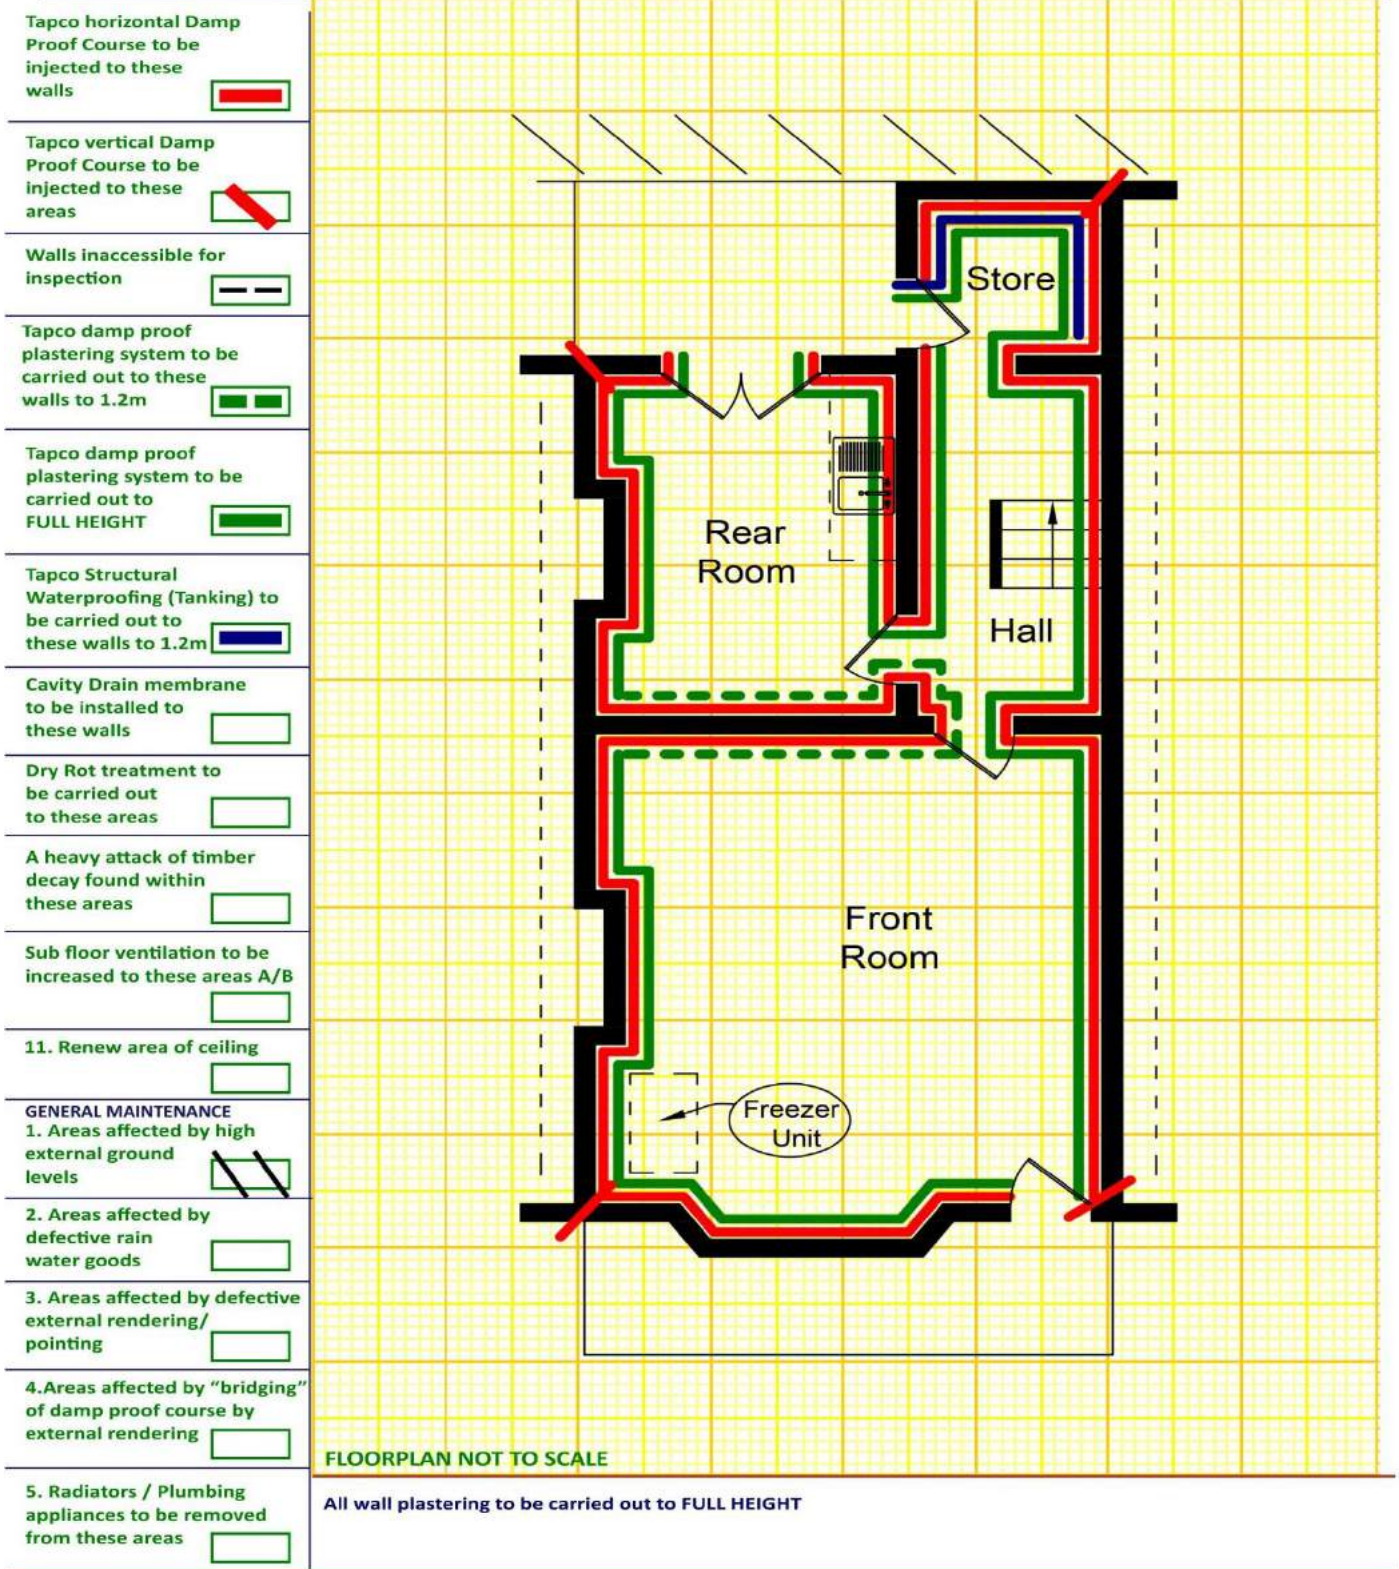
Tapco HomeDry Areas of Damp Proofing and Associated Work

Random, horizontal and vertical moisture readings taken to the internal surfaces of the accessible ground floor walls, recorded high levels of moisture to various areas (shown on our floor plan). In our opinion, moisture from the ground is transmitting through the interconnecting pores of the wall, by capillary action. This is identified by having a high level of moisture at the base of the damp, with a sharp cut off at the top, where it becomes immediately dry. Masonry with an average pore size of 0.01mm gives a theoretical height rise of 1.5 metres above the source of moisture (the ground), therefore any damp above this height has been deemed to be from another source. However, some of the damp appears to be attributable to rain penetration as a result of external defects and damp proofing measures have been recommended.

Damp is also penetrating laterally, through some of the walls that are being breached by high external ground levels (shown on our floor plan). Moisture from below the ground is being forced through the walls under hydrostatic pressure, causing a considerable amount of damp to the internal surfaces.

Remove the damp, salt contaminated wall plaster, to specified heights and take to a designated place for disposal (shown in green on our floor plan).

Pattern drill horizontal holes into a selected mortar joint at the base of the walls and vertically, to create isolation barriers where recommended and inject a Thixotropic Silane/Siloxane, dispersible, emulsion, damp proof cream, in accordance with BS 6576:2005, under the terms of our 20-Year Guarantee (shown in red on our floor plan)

Apply a Tapco HomeDry cementitious, Structural Waterproofing System to the walls specified, under the terms of our insurance backed 10-year guarantee. (shown in blue on our floor plan).

Apply two gauged, 12mm scratch coats of washed, coarse, sharp sand and cement, waterproof render coats and allow to cure (shown in green on our floor plan).

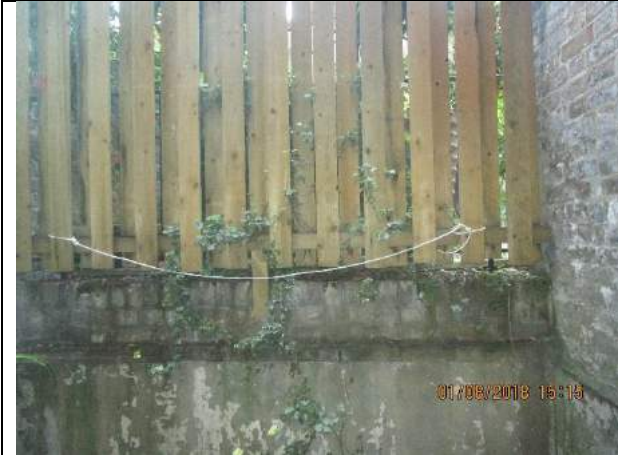
High rear external ground levels abutting the walls

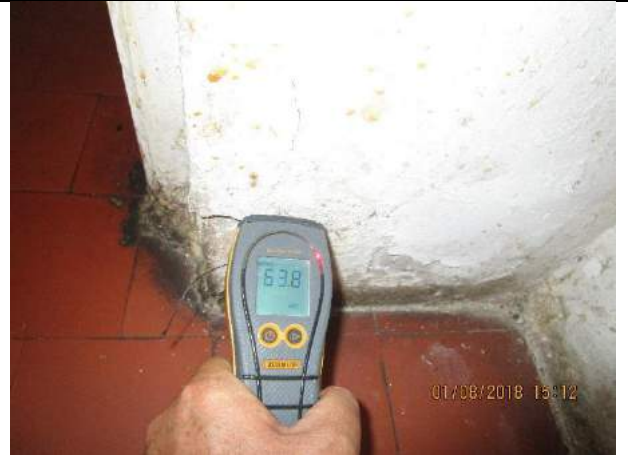
High levels of 63.8% moisture were recorded to the lower areas of the walls as indicated

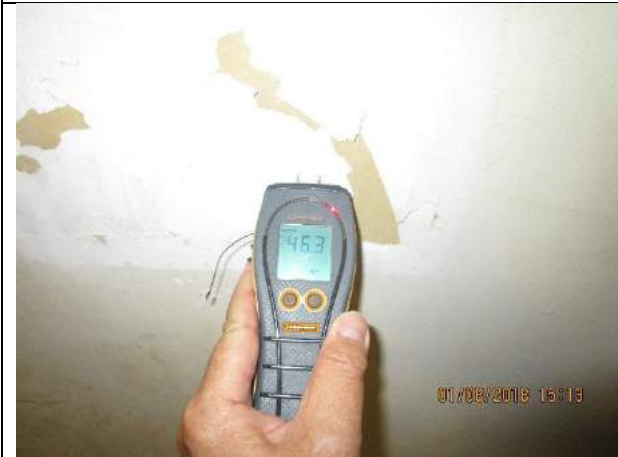
High levels of up to 46.3% moisture were recorded to the walls surfaces, as indicated

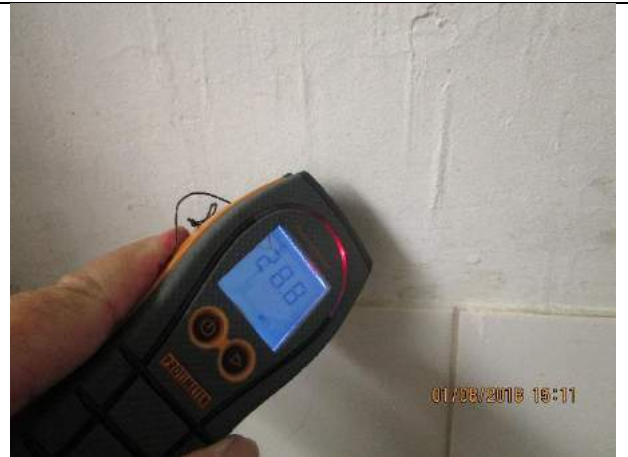
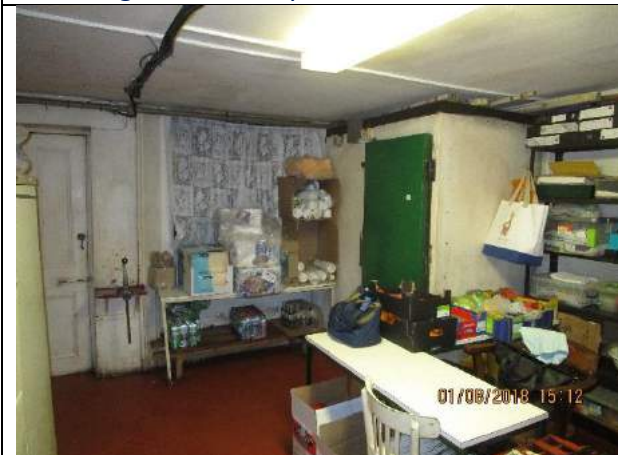
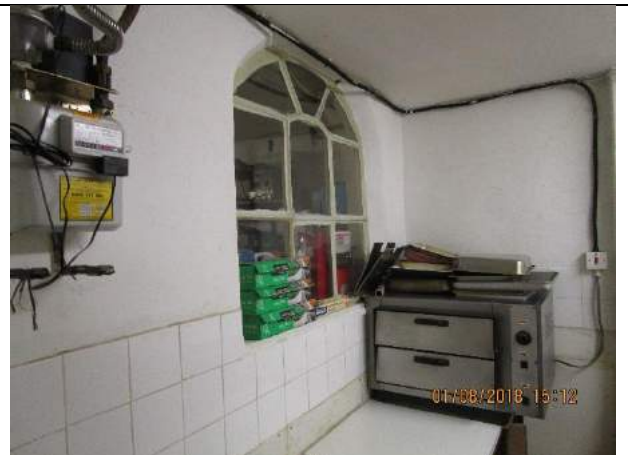
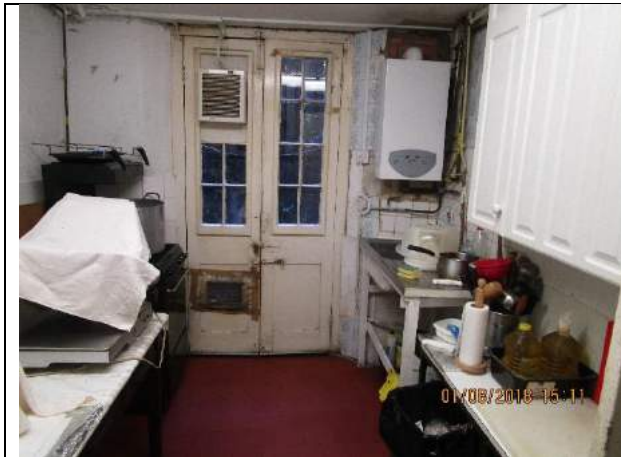
High levels of moisture were recorded to the walls throughout the basement area
